**ACCIDENT**

<b>Aircraft Type and Registration:</b>	Boeing 777-232, N864DA	
<b>No &amp; Type of Engines:</b>	2 Rolls-Royce Trent 892-1-7 turbofan engines	
<b>Year of Manufacture:</b>	1999	
<b>Date &amp; Time (UTC):</b>	20 May 2005 at 0635 hrs	
<b>Location:</b>	Stand 50, London (Gatwick) Airport	
<b>Type of Flight:</b>	Public Transport (Passenger)	
<b>Persons on Board:</b>	Crew - 13	Passengers - 296
<b>Injuries:</b>	Crew - None	Passengers - None
<b>Nature of Damage:</b>	Damage to the leading edge of the left engine intake cowl; substantial damage to the passenger airbridge	
<b>Commander's Licence:</b>	Airline Transport Pilot's Licence	
<b>Commander's Age:</b>	57 years	
<b>Commander's Flying Experience:</b>	18,000 hours (of which 250 were on type) Last 90 days - 225 hours Last 28 days - 80 hours	
<b>Information Source:</b>	AAIB Field Investigation

**Synopsis**

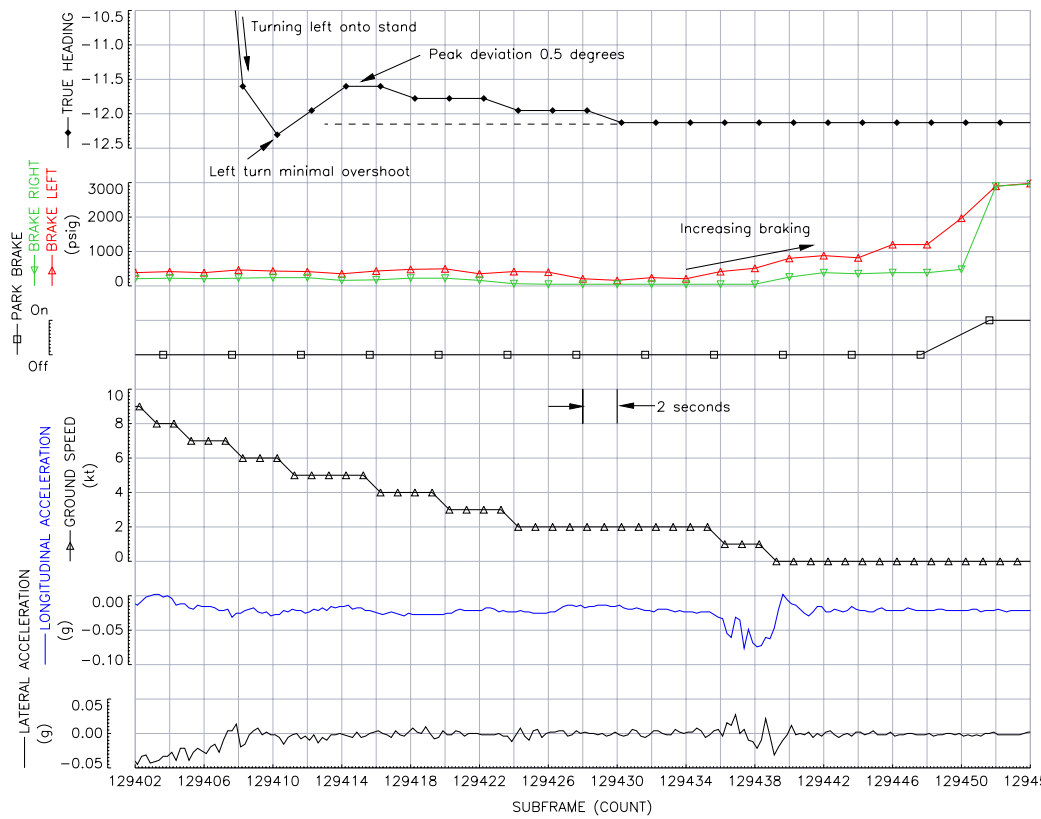
**Figure 1**

The pertinent data from the FDR is shown in Figure 1, commencing at the point when the aircraft had started to turn off the taxiway onto the stand, and ending shortly after the application of the park brake.

The left engine had been stopped prior to the aircraft being turned onto stand and the right engine power lever remained at idle throughout the parking procedure. On turning onto the stand, the aircraft heading passed fractionally through the final heading by 0.2°T followed by a correction to the right by 0.5°T before recovering back onto the final heading. At this time the aircraft had a recorded ground speed of between 4 and 5 kts and was slowing. The aircraft heading had stabilised 17 secs after the peak deviation and the ground speed

Time history of the key FDR parameters during the taxi onto stand.  
Incident to N864DA on 20 May 2005 at Gatwick airport

reduced to approximately 2 kt. About 4 to 5 secs after stabilising at this speed, the data showed disturbances in the lateral and longitudinal acceleration parameters and a drop in ground speed to zero; this is consistent with the aircraft colliding with the stand. The direction of the longitudinal acceleration is consistent with the aircraft decelerating and it peaked at approximately 0.05g from the reading at rest. The direction of the lateral acceleration was consistent with a force pushing to the right, this was followed by a motion back to the left after a further jolt or oscillation. The peak lateral acceleration was less than 0.03g. The time from the first indications of the impact to the time the aircraft had settled was 4 to 5 secs; the park brake was applied 7 to 11 secs later.
