AAIB Bulletin No: 3/94

Ref: EW/C94/1/5

Aircraft Type and Registration: Challenger, N585UC

Location: Block 94B, London Heathrow Airport

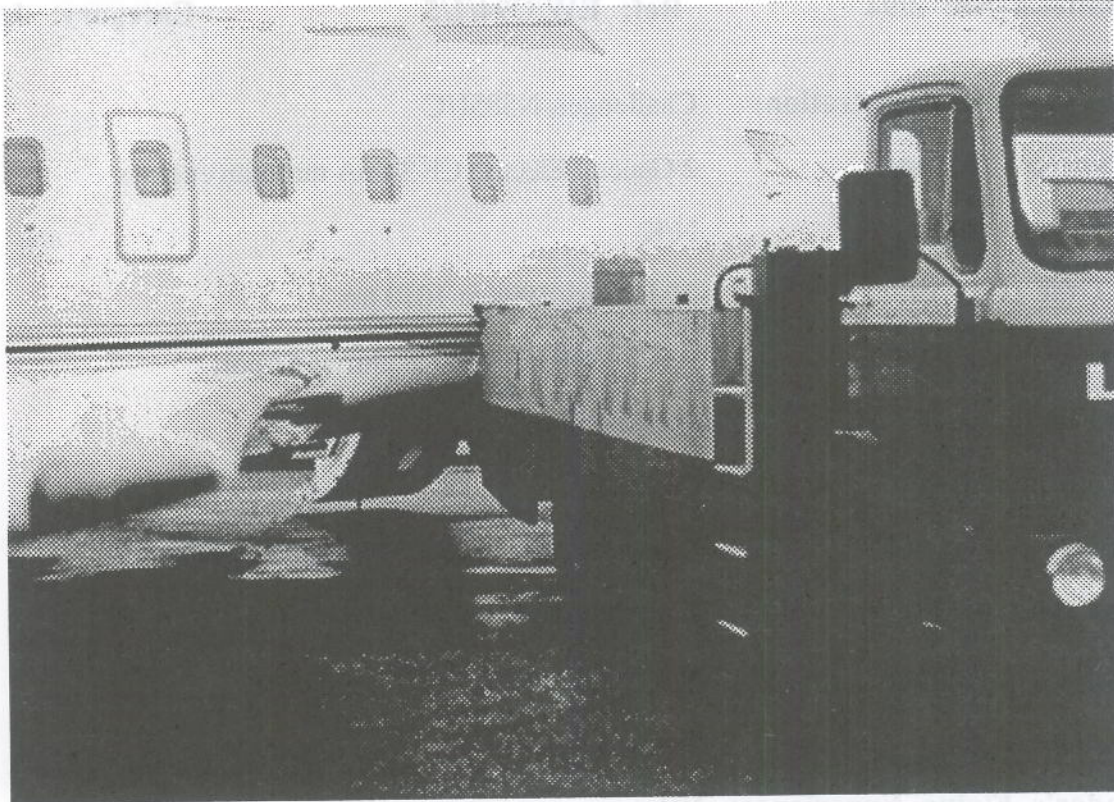
Relative configuration of the wing leading edge and the vehicle

The vehicle's suction hose is about 6 inches in diameter and is stiffened to resist the reduced pressure whilst suction is applied. It is attached to the left-hand side of the truck, about 2 feet from the rear; the length of hose extending beyond the back of the vehicle is just over 6 feet. The configuration of the truck, the position of the Challenger toilet servicing point under the fuselage, and its location relative to the swept wing makes access to this aircraft type particularly difficult for the vehicle used.

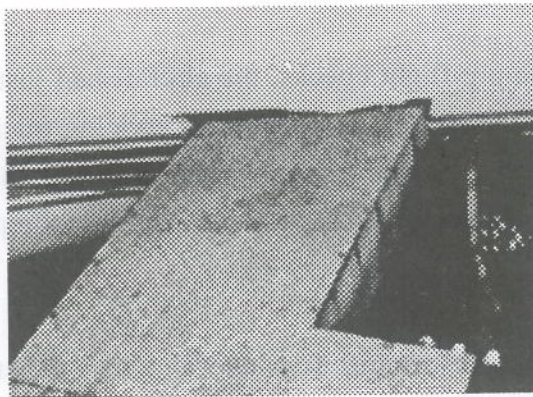
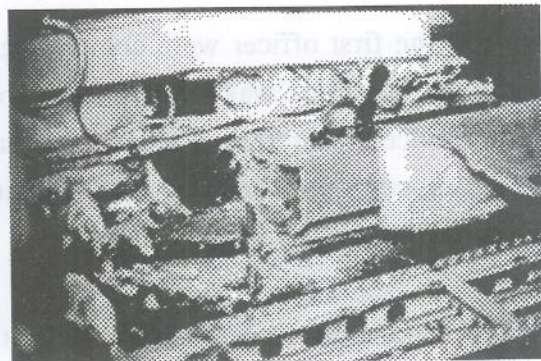
The rear right-hand corner of the truck had struck the aircraft fuselage and had penetrated approximately one foot into the cabin. Tyre marks around the nose gear showed that the aircraft had moved about 6 feet during the impact.

Views showing external and internal penetration
