Cessna F177RG Cardinal, G-BFIV

AAIB Bulletin No: 4/2004	Ref: EW/G2003/09/06	Category: 1.3
Aircraft Type and Registration:	Cessna F177RG Cardinal, G-BFIV	
No & Type of Engines:	1 Lycoming IO-360-A1B6D piston engine	
Year of Manufacture:	1977	
Date & Time (UTC):	5 September 2003 at 1632 hrs	
Location:	Blackbushe Airport, Camberley, Surrey	
Type of Flight:	Private	
Persons on Board:	Crew - 1	Passengers - 1
Injuries:	Crew - None	Passengers - None
Nature of Damage:	Damage to propeller blades and fuselage belly	
Commander's Licence:	Private Pilot's Licence	
Commander's Age:	60 years	
Commander's Flying Experience:	2,031 hours (of which 1,600 were on type)	
	Last 90 days - 27 hours	
	Last 28 days - 7 hours	
Information Source:	Aircraft Accident Report Form submitted by the pilot and further enquiries by the AAIB

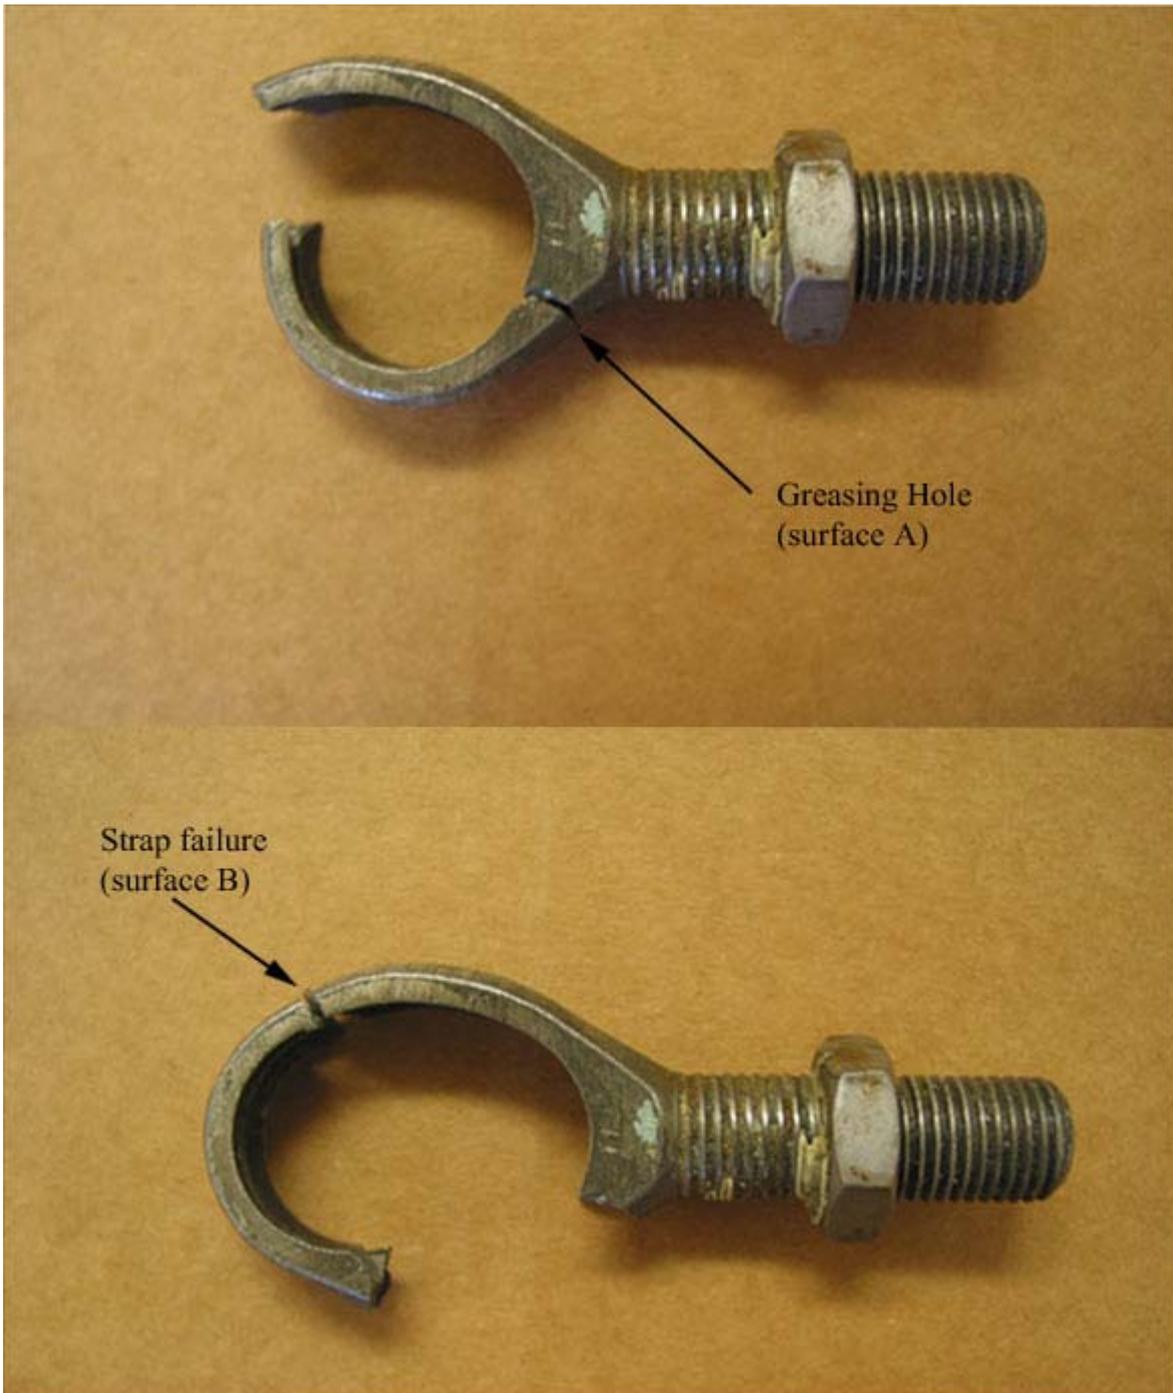
The failed actuator rod end (see Figure 1) was sent to the AAIB for examination. The rod end appeared to have failed first at the greasing hole (surface A) and then the remaining attached strap had elongated plastically until it had failed in tensile overload (surface B). The rod end was taken to a metallurgist for further examination. The metallurgist confirmed that the strap fracture at surface B had failed due to overload. He also reported that the fracture surface at A did not show signs of a classical fatigue failure but it was possible that a very low cycle, high-stress fatigue mechanism had been involved. It was the metallurgist's opinion that the strength of the rod end had been decreased by gross machining abuse within the greasing hole (surface A).

Figure 1 Failed rod end
(greasing hole fracture highlighted above and
strap fracture highlighted below)

The main gear failed to lock down because the main gear actuator rod end had fractured. The 'graunching' noise heard by the pilot at the time of the extension was probably the sound of the rod end failing. A metallurgical examination of the rod end revealed that it had possibly failed due to a very low-cycle high-stress fatigue mechanism at the greasing hole. The aircraft manufacturer discovered that there was a problem with the strength of the rod end and issued a Service Letter in 1979 recommending that it be replaced with a higher strength part. It is not known why the recommendation in this service letter was not carried out on G-BFIV. The aircraft was 27 years old and it is possible that the rod end was still the original part. The aircraft manufacturer stated that the company was not aware of any main gear actuator failures on 177RG aircraft that had had the higher strength rod end installed.

The service letter stated that a new high-strength main landing gear actuator rod end was now available for the 177RG aircraft. It recommended that the old actuator rod end be replaced with the new higher strength part prior to or at the next annual inspection. The rod end that failed on G-BFIV was the older lower strength type that the aircraft manufacturer recommended be replaced.

The higher strength rod end does not have a greasing hole because it uses a Teflon bearing instead of the previous version's brass bearing. This design avoids the stress concentrations that are introduced by the hole; it also precludes any potential machining errors associated with creating the hole.
