AAIB Bulletin No: 8/93

Ref: EW/C93/3/6

Aircraft Type and Registration: Fokker F27 Mark 500 Friendship, G-JEAH

Nature of Damage: Damage to fuselage underside, right wingtip, nacelle and propeller, right engine shock loaded

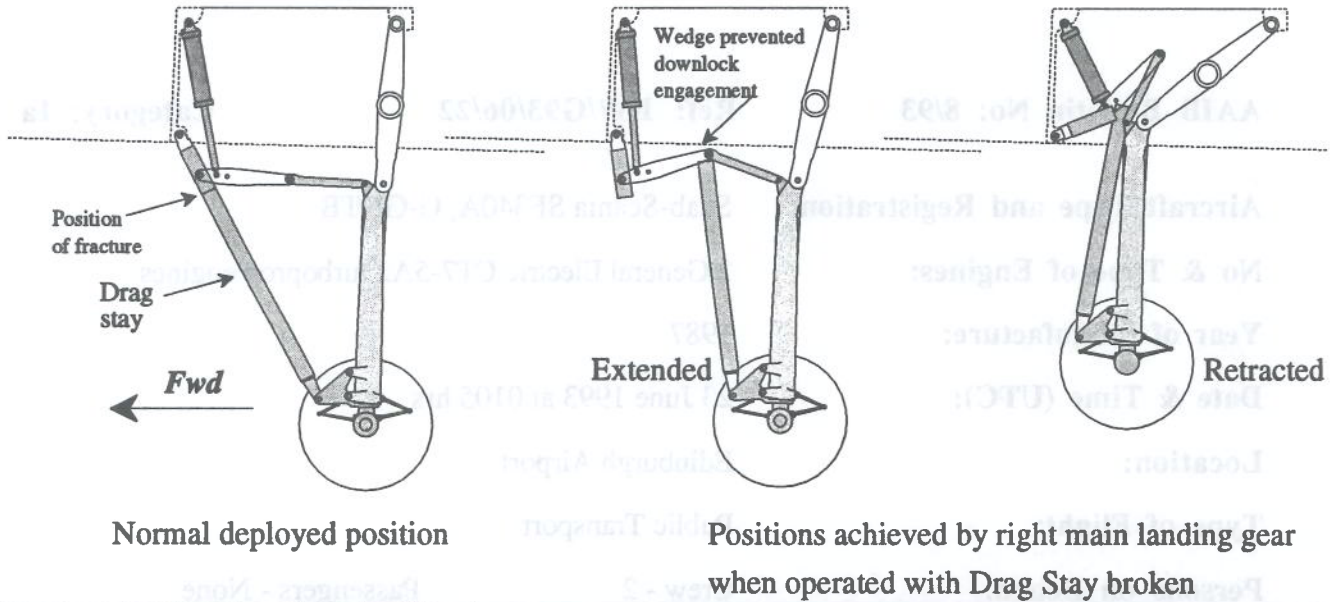
Fokker F27 Main Landing Gear Side views

An examination of the aircraft where it came to rest revealed that the drag stay of the right main landing gear had broken near its upper end, just below the locking link attachment pivot (see diagram). The drag stay was removed for metallurgical examination of the fracture surfaces.

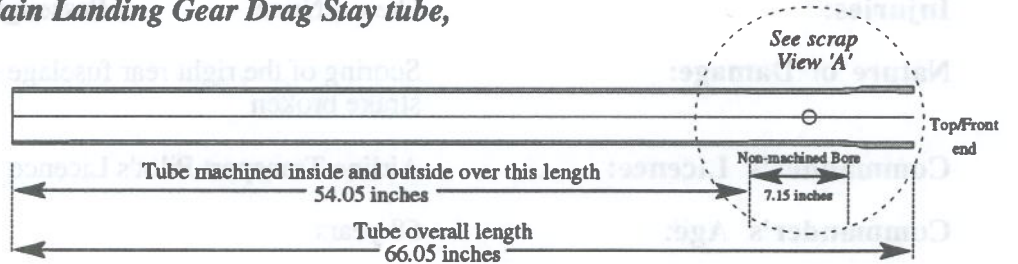
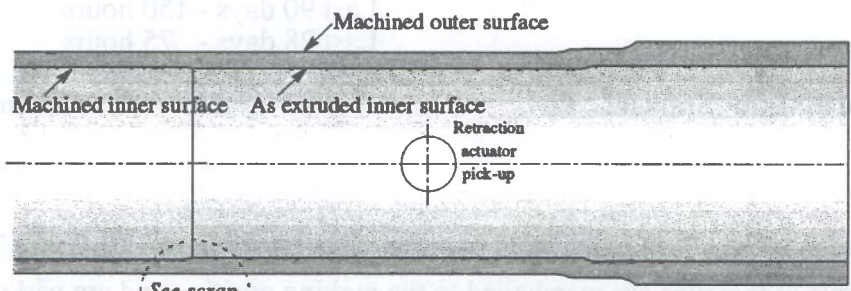
Section of Fokker F27 Main Landing Gear Drag Stay tube, Part No 200259300

This examination revealed that the initial failure was the result of bending fatigue of the drag stay and that this fatigue had originated at an internal change of cross-section where a machined radius intersects the machined parallel bore of the main tube element of the stay. The fatigue had initiated along a linear origin (there were no discrete origins) on the inner surface of the tube, but did not appear to have progressed quite as far as the outer surface before the fracture mechanism had changed to overload fast fracture over most of the remainder of the section with the final separation as a bending hinge. Even if the fatigue had progressed to the outer surface, a steel clamp ring which supports the lower pivot of the landing gear forward door would have been directly covering the position of the crack.

Investigation revealed that there had been a machining error at manufacture which had resulted in the intersection of the radius and bore not being smooth as intended. The machining sequence for the inside of the tube called for a 'roughing' cut to be taken followed by a finish cut which also formed the

blending radius at the end. The 'roughing' cut appeared to have been made using a large drill, as all examples (several drag stays were inspected as a result of this accident) of mis-machined tubes so far discovered revealed a 42° chamfer running into the intended radiused blend (see diagram). It could not be established whether the roughing cut had been taken fractionally too far, or the subsequent finish cut had not been taken far enough down the bore. In this particular case, the effect of the sharp change of section resulting from the drill shape had been exacerbated by 'undercutting' at the corner of the drill, possibly as the result of swarf being caught up when drill extraction began. This problem might affect any drag stay which was built before about 1983, using the basic tube Part No. 200259300. These tubes may be used in drag stays with the assembly Part Nos. 200485001 or 200684001 which may be found in the main landing gear of Fokker F27 Basic, Rough Field and -500 variants, as well as on Fairchild-built F27 and FH227 aircraft (it may also be used on F50 aircraft).

Since this accident, the manufacturer has developed a variant of the inspection called for in the existing Mandatory Service Bulletin, 32-27W. The technique developed will enable operators to determine the

geometry of the intersection between the radius and the bore, and will detect any fatigue crack at this location. The manufacturer has formulated a new Service Bulletin specifying the inspection technique to be used and the variety of actions to be taken in the light of what these inspections reveal. It is anticipated that this inspection will be made Mandatory by Fokker, and RLD, as the Primary Certificating Authority. If this is the case, the CAA has indicated that it will automatically make this Mandatory Service Bulletin an Airworthiness Directive in the United Kingdom, using an established administrative procedure.
