ACCIDENT

Aircraft Type and Registration:	Letov LK-2M Sluka, G-MZOT	
No & Type of Engines:	1 Rotax 447 1-V piston engine	
Year of Manufacture:	1999	
Date & Time (UTC):	6 August 2006 at 1525 hrs	
Location:	On the edge of North Coates Airfield, Lincolnshire	
Type of Flight:	Private	
Persons on Board:	Crew - 1	Passengers - Nil
Injuries:	Crew - 1 (Fatal)	Passengers - N/A
Nature of Damage:	Aircraft destroyed	
Commander's Licence:	Private Pilot's Licence	
Commander's Age:	62 years	
Commander's Flying Experience:	450 hours (of which 16 were on type) Last 90 days -12 hours Last 28 days - 3 hours	
Information Source:	AAIB Field Investigation

Synopsis

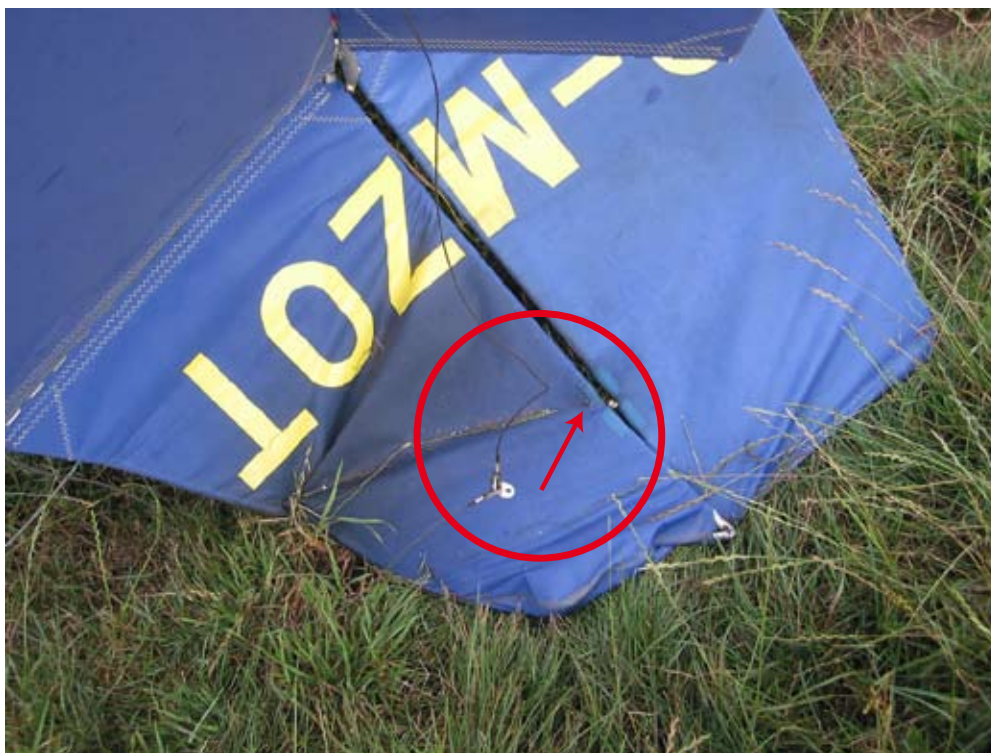
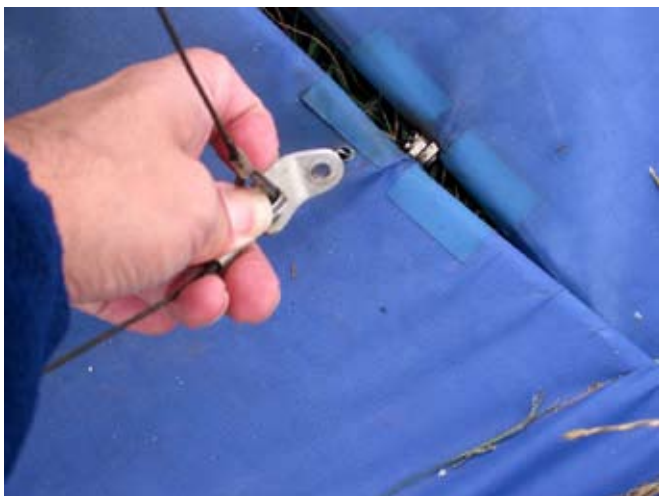
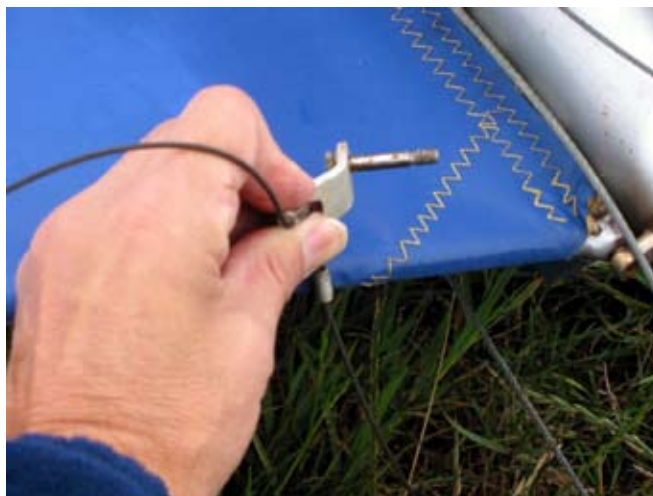
Examination of the empennage revealed that the bracing wires that secured the left and right tailplanes to the vertical fin had become detached from the upper part of the fin. The tailplanes each had a pair of wires anchored at the approximate mid-span points of the leading and trailing edges and these wires were attached to a small steel bracket, or tang. The tangs were attached to each side of the upper part of the fin by means of a bolt and stiff nut. However, it was apparent that the nut was missing, which had allowed both tangs, together with their associated wires, to become detached. The bolt was found loosely inserted in its hole in the tang that was attached to the left wires. Figure 2 shows the bracing wires as they were found at the accident site.

The bolt that had attached the tailplane upper bracing-wire tangs to the fin was identical to that removed from an intact aircraft during the investigation. It was thus established that the bolt was of sufficient length to accommodate the stiff nut safely (referred to in the manufacturer's build manual as a 'Lock Nut'). Similar components were used elsewhere on the aircraft. It was noted that removal of the tang necessitated the use of 9 mm and 8 mm spanners for the nut and bolt respectively. A photograph of a stiff-nut is shown at Figure 3, where it can be seen that it has been manufactured with a saw cut extending across approximately half the diameter of the nut, just above the hexagonal section. The top half of the nut has been slightly bent over, in a manner that tended to close the saw cut. This process results in the axes of the threads in the two halves of the nut being at a slight angle to each other, which is how the 'stiff' function is achieved. However, one feature of this type of nut is that when it is turned onto a bolt, no 'stiffness' is encountered until the threads in the upper portion become engaged.

There was no nut to examine in the case of the accident aircraft, so it was not possible to establish that the correct type had been used, although the components elsewhere on the aircraft were correct. Typical assembly

As-found tailplane bracing wires: arrow indicates attachment point on fin

Right tang

Left tang with bolt

Detached tailplane bracing wires, as they were found

The bolt threads were examined under a microscope and were found to show no evidence of any distress caused by, for example, excessive load or a wrongly sized nut. Similarly, the holes in the tangs attached to the bracing wires also showed no evidence of distress.

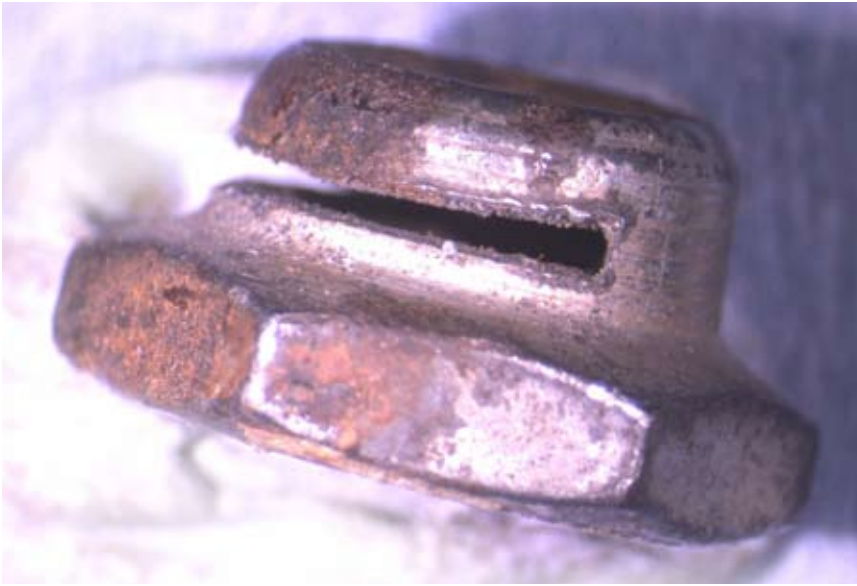
Figure 3

Whilst examining the intact aircraft it was noted that the tailplane wire attachments to the upper fin were approximately at eye level and thus easy to check on a walk-round inspection. In the event that the nut should back off a significant amount, the tangs would no longer lie flush with the surface of the fin, a feature that would be readily visible. The PFA Inspector commented that he had visually checked the attachment prior to the Permit renewal check flight in April.
