ACCIDENT

Aircraft Type and Registration:	Jodel DR1050 Ambassadeur, G-ATGE	
No & Type of Engines:	1 Continental Motors Corp O-200-A piston engine	
Year of Manufacture:	1960	
Date & Time (UTC):	12 June 2009 at 2006 hrs	
Location:	Belmont Road, Kilkeel, Co Down, Northern Ireland	
Type of Flight:	Private	
Persons on Board:	Crew - 1	Passengers - 2
Injuries:	Crew - 1 (Fatal)	Passengers - 2 (Fatal)
Nature of Damage:	Aircraft destroyed	
Commander's Licence:	Private Pilot's Licence	
Commander's Age:	53 years	
Commander's Flying Experience:	1,022 hours (of which over 150 hours were on type) Last 90 days - 25 hours Last 28 days - 14 hours	
Information Source:	AAIB Field Investigation

Synopsis

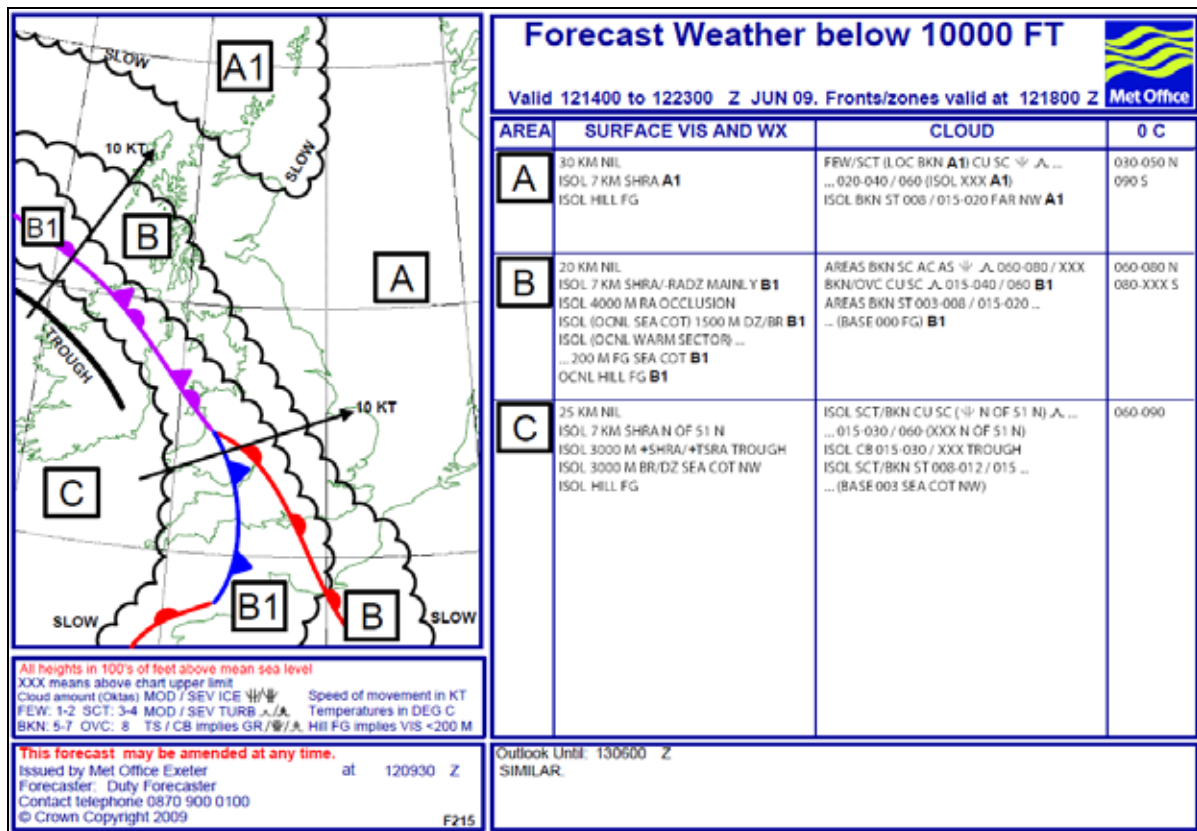
The flight took place predominately in area B1 where visibility was forecast to drop occasionally to 1,500 m in drizzle and mist. Isolated areas with visibility of 200 m were to be expected in coastal areas. Areas of broken stratus were forecast with bases between 300 ft and 800 ft amsl, although the base would be at ground level in any fog.

Figure 1
Met Office weather forecast valid at the time of the accident
