**AAIB Bulletin No: 3/93**      **Ref: EW/G92/11/17**      **Category: 1c**

**Aircraft Type and Registration:** DH82A Tiger Moth, G-AJTW

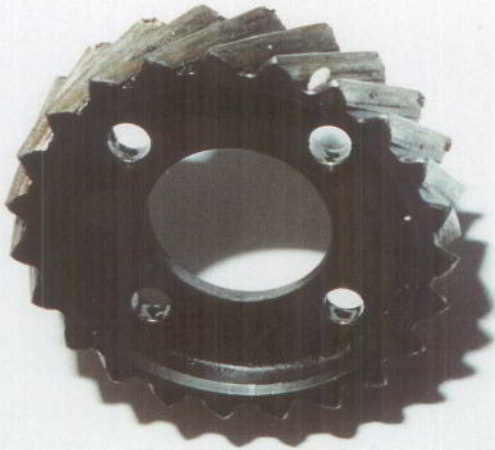
Photo 1

An engine strip revealed that both spiral gears in the magneto drive had worn to the extent that the drive had failed, see photo 1. Oil is fed to the driving spiral gear by jet, and then drops onto the driven spiral gear where it collects in a hollow so that the gear runs in an oil bath. The oil pipe supplying the jet contains a filter screen inside the banjo union on the pressure filter, see photo 2: the filter screen was found to be blocked preventing the supply of oil to the magneto spiral gears. The gauze filter screen is not called up for any scheduled inspection.

MAGNETO DRIVING SPIRAL GEAR

**93-10** It is recommended that the CAA introduce an inspection of the magneto gear oil supply filter screen and oil jet at the next appropriate inspection and subsequently at intervals to be determined by experience. (Issued 22 February 1993)

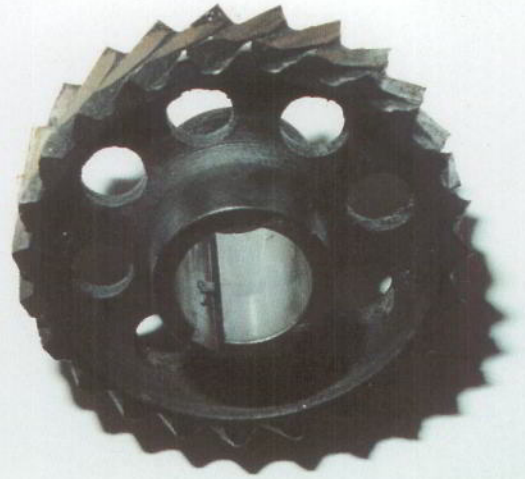
MAGNETO DRIVEN SPIRAL GEAR

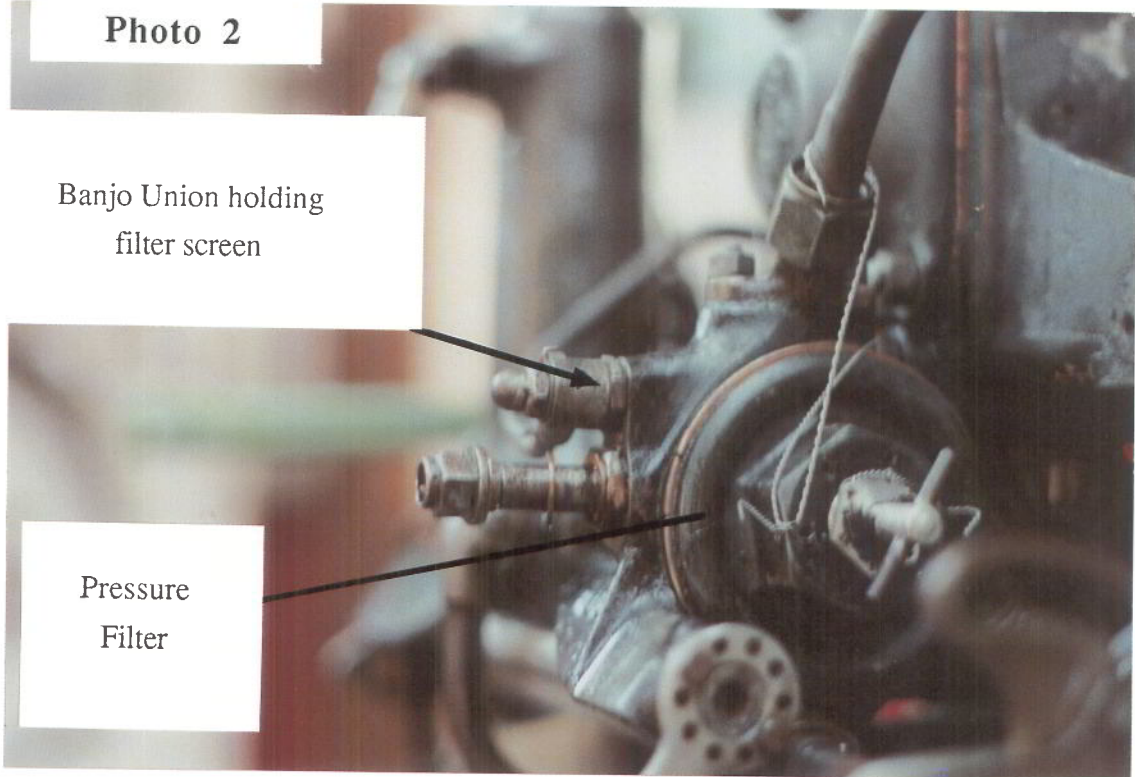
Photo 2

Banjo Union holding  
filter screen

Pressure  
Filter
