Aircraft type and registration: Percival Gull Six G-AERD (light single engine fixed wing aircraft)
Piper PA-28-140E G-BEEU (light single engine fixed wing aircraft)

Date and time (GMT): 8 July 1984 1205 GMT

Location: Cranfield Airfield

Fig.1 COLLISION BETWEEN G-AERD AND G-BEEU CRANFIELD 8TH JULY 1984

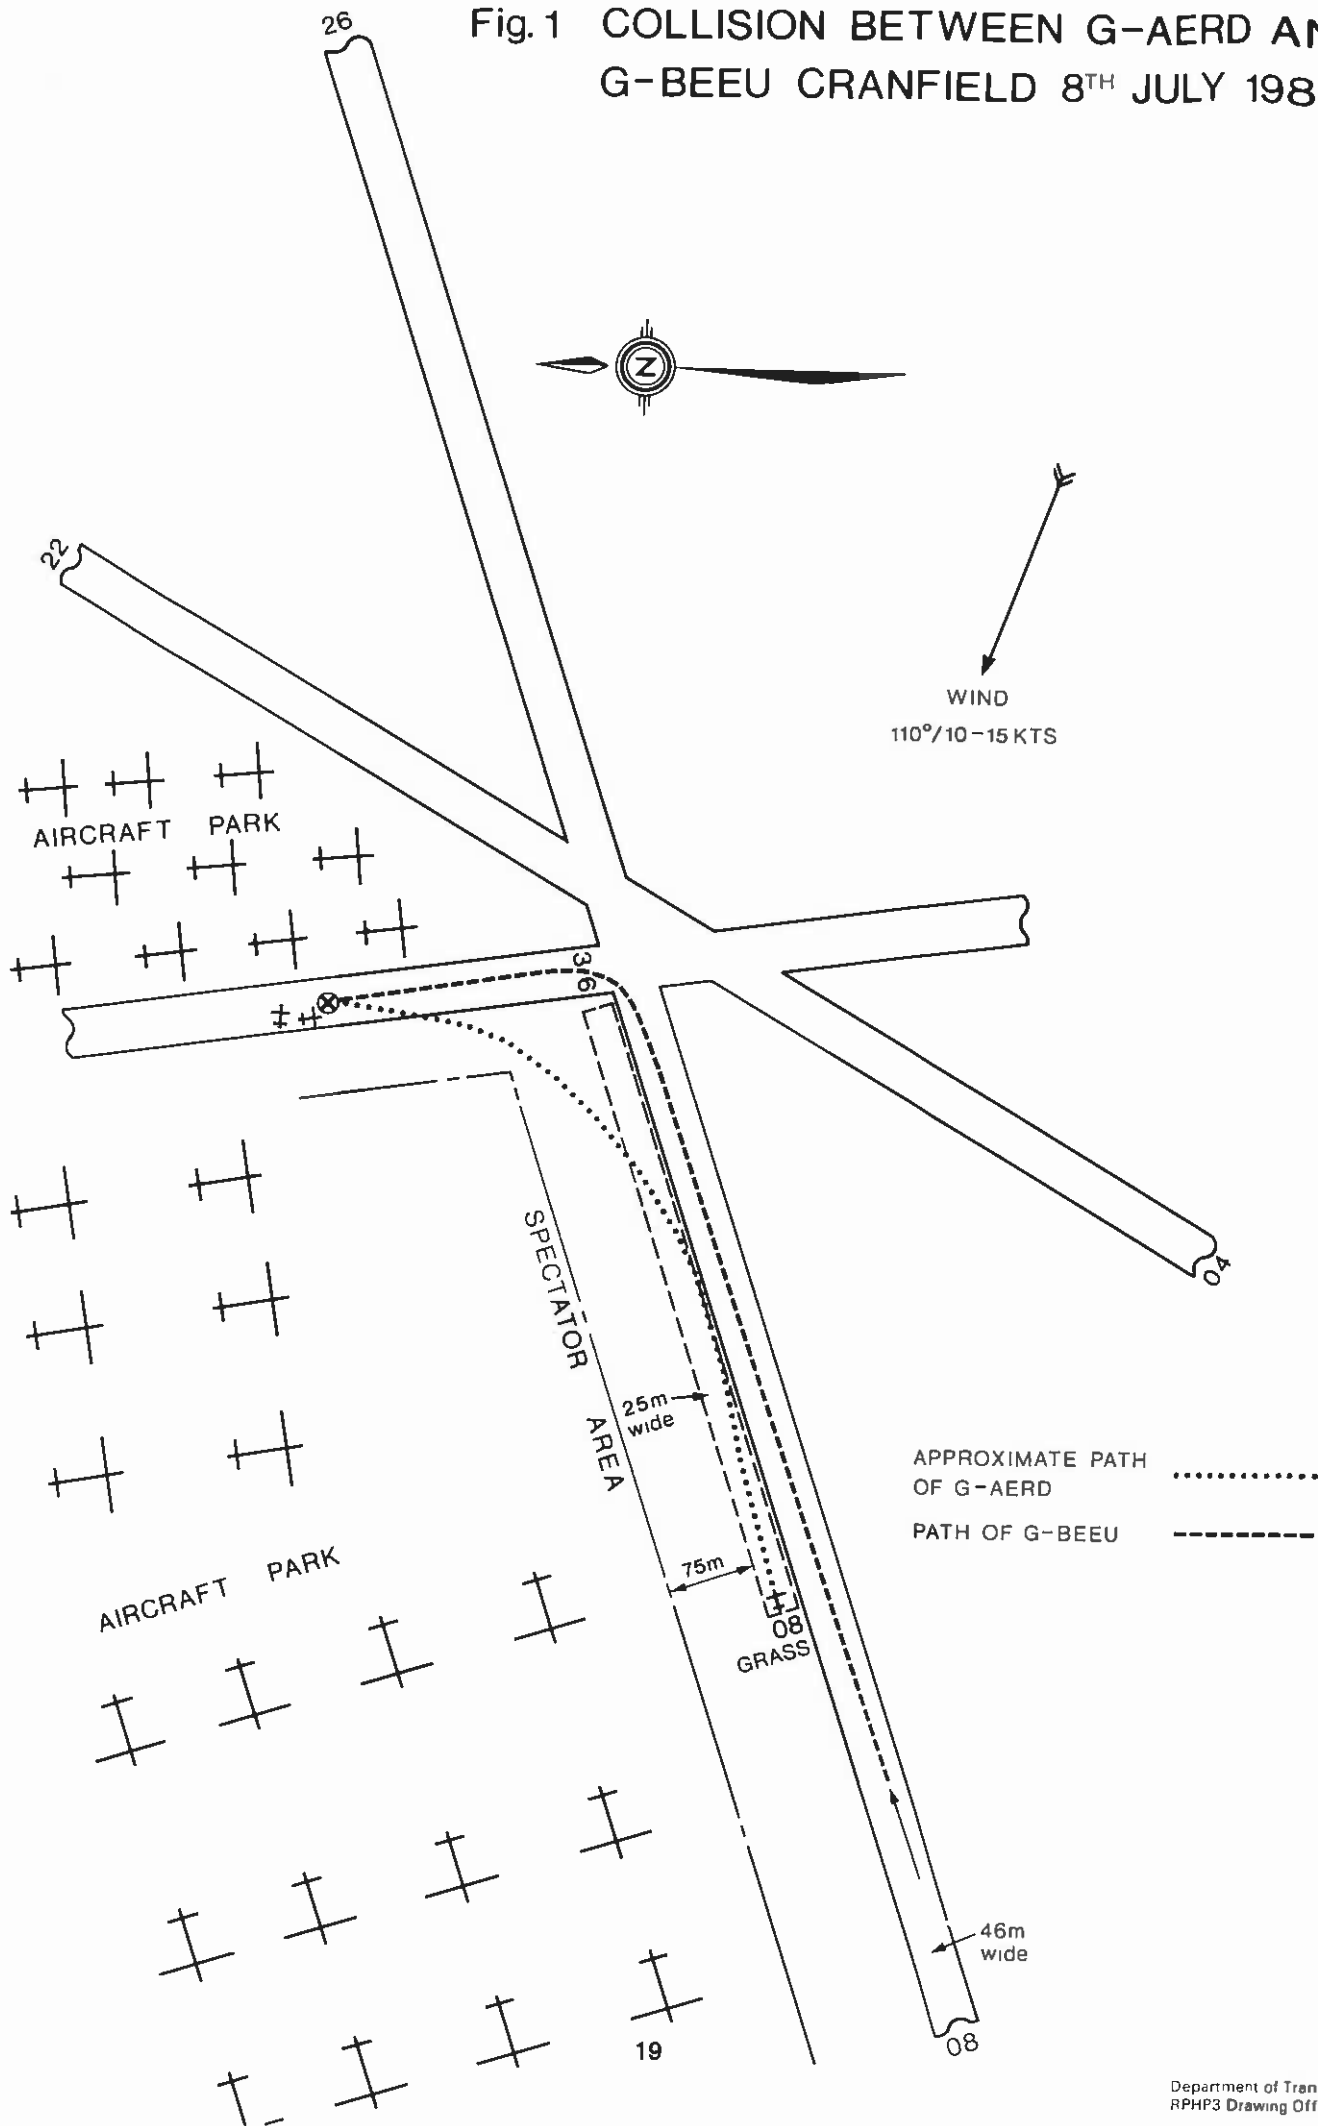
The aircraft, on this occasion, had been partitioned such that the spectator and aircraft parking areas were confined to the north of R/Ws 08/26 and 22/04, allowing the full length of these runways to be available for take-off and landing. A grass runway, 1870 ft in length, had been marked out adjacent to the northern edge of R/W 08 for use by tail wheel or skid aircraft unable to use the hard runways. It terminated at the intersection of R/Ws 08 and 36 (inactive but used as a taxiway). It was 25 m wide and 75 m south of the spectator area boundary fence, ref. figure (1).

Coincidentally, following ground marshallars' directions, G-AERD had lined up on R/W 08 (grass) and commenced the take-off run. The pilot later stated that he was very much aware of aircraft using the tarmac R/W 08, immediately on his right, and turning left to taxi across the upwind end of the grass R/W 08.

As the take-off run continued the aircraft started to swing right, which the pilot had expected it to do in the crosswind of 110°/10–15 kt, so he harshly applied left brake in an attempt to prevent the aircraft from running onto the active R/W 08. This action was partially effective but also had the effect of reducing the aircraft's acceleration and causing the nose to dip. Further along the runway, as it became airborne, the left wing dropped and the pilot states that use of rudder and aileron proved ineffective in correcting the situation. By now the aircraft was at a height estimated at 20 ft, was turning to the left and heading for the aircraft parking/spectator area. As a crash now appeared inevitable to the pilot he closed the throttle and the aircraft immediately contacted the ground on the inactive runway/taxiway 36. As it did so, G-AERD struck the fin and rudder of G-BEEU, with its left wing tip and also the right wing with the underside of its left wing. Both aircraft pivoted to the left and came to rest on the taxiway several hundred yards from R/Ws 08 and 36 intersection. There was no fire, none of the occupants or spectators were injured and the rescue services were quickly on the scene.

The pilot of G-AERD assessed the cause of the accident as being due to a combination of the difficult crosswind characteristics of his aircraft and the relatively confined position of R/W 08 grass.
