INCIDENT

Aircraft Type and Registration:	ATR 42-300, G-TAWE	
No & Type of Engines:	2 Pratt & Whitney Canada PW120 turboprop engines	
Year of Manufacture:	1994	
Date & Time (UTC):	20 January 2006 at 2107 hrs	
Location:	Runway 31 at Glasgow Prestwick Airport	
Type of Flight:	Public Transport (Passenger)	
Persons on Board:	Crew - 3	Passengers - 34
Injuries:	Crew - None	Passengers - None
Nature of Damage:	Nose gear uplock bent and five runway edge lights damaged	
Commander's Licence:	Airline Transport Pilot's Licence	
Commander's Age:	57 years	
Commander's Flying Experience:	13,233 hours (of which about 5,000 were on type) Last 90 days - 123 hours Last 28 days - 38 hours	
Information Source:	Aircraft Accident Report Form submitted by the pilot and report by Glasgow Prestwick Airport

Synopsis

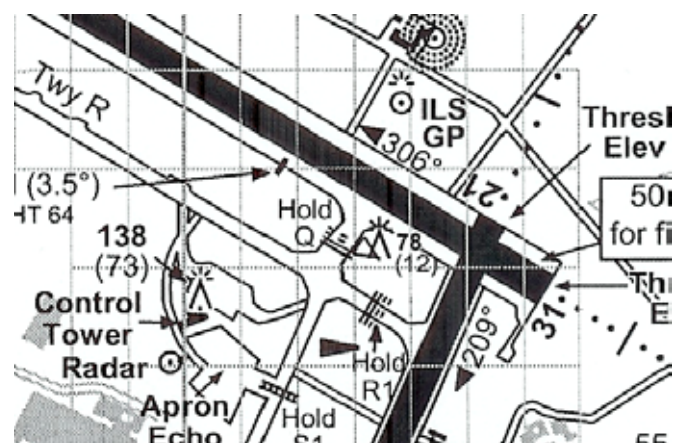
Figure 1

While taxiing for a departure from Runway 31, the commander was given clearance to enter the runway by either 'R1' or 'Q'. The disposition of these holding points is as shown in Figure 1. He elected to enter by 'Q' and lined up the aircraft in a position he thought was just to the left of the runway centreline. The first officer then commented that he did not think that the 'perspective' looked quite right and the commander taxied G-TAWE to the left until it was lined up exactly over lights.

Disposition of the holds for Runway 31

The UK AIP contains a warning about the possibility of mistaking the runway edge lights for the centreline lights. In the incident involving G-TAWE, the use of ‘Q’, which has no centreline lights as a lead-in to the runway was a contributing factor. Since the incident, ATC no longer allow aircraft to use ‘Q’ when entering the runway at night or in poor visibility.
