ACCIDENT

Aircraft Type and Registration:	Skyranger J2.2(1), G-RAFR	
No & Type of Engines:	1 Jabiru Aircraft PTY 2200 piston engine	
Year of Manufacture:	2004 (Serial no: BMAA/HB/410)	
Date & Time (UTC):	6 January 2013 at 1330 hrs	
Location:	Hollym Airfield, East Yorkshire	
Type of Flight:	Private	
Persons on Board:	Crew - 2	Passengers - None
Injuries:	Crew - None	Passengers - N/A
Nature of Damage:	Damage to propeller and cowlings	
Commander's Licence:	Private Pilot's Licence	
Commander's Age:	68 years	
Commander's Flying Experience:	1,344 hours (of which 16 were on type) Last 90 days - 16 hours Last 28 days - 9 hours	
Information Source:	Aircraft Accident Report Form submitted by the pilot

Synopsis

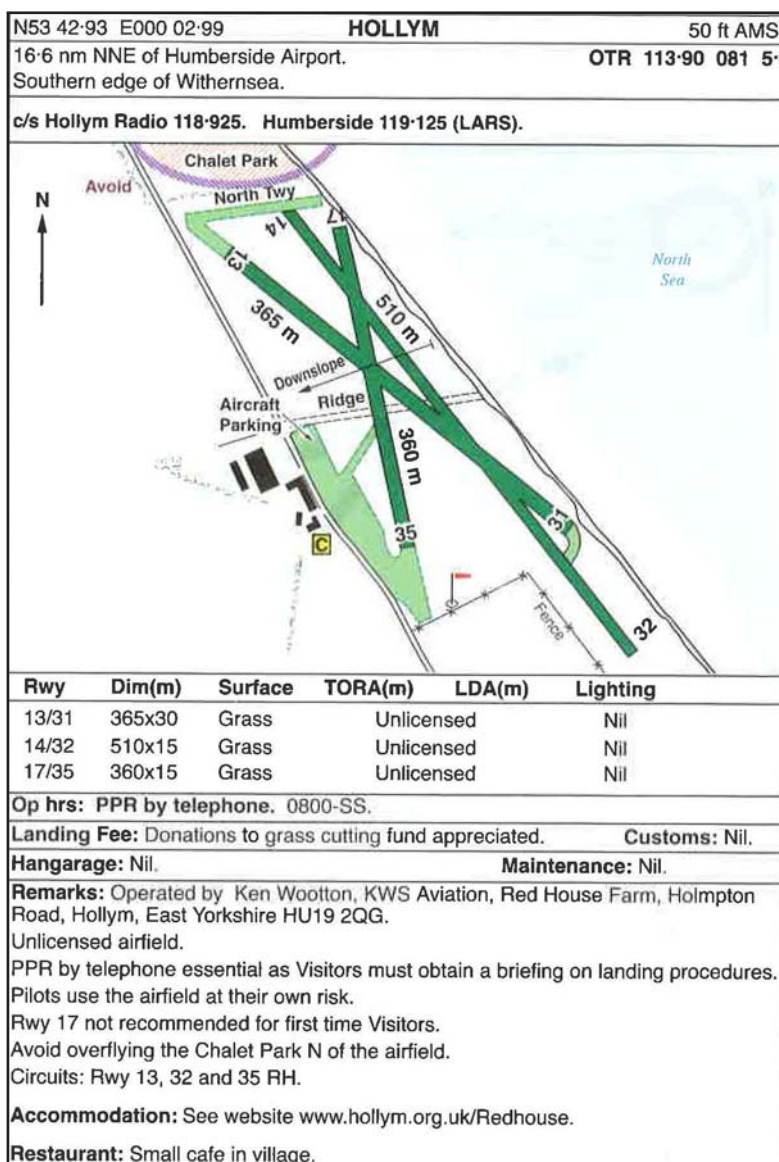
Figure 1
Airfield chart for Hollym

He contacted Hollym on the radio and informed them that he was downwind for Runway 17 (Figure 1) but, as he approached the cliff edge, he realised that he was too high and decided to go around. He was now concerned about his fuel state and the airfield suggested that he used the “cliff-top” runway as this was the longest. The pilot turned left and approached on what turned out to be Runway 31, touching down just after the threshold, however when he applied the brakes “nothing happened”. He tried to steer the aircraft into the long grass at the side of the runway, but the rudder also appeared ineffective

The pilot now realises that the term “cliff-top” runway was intended to describe Runway 32 but he states that it was difficult to discern this runway due to a lack of recent mowing and that it appeared closer to the cliff edge than depicted on the airfield chart. He

states that other diverting aircraft also had similar problems in establishing which the suggested runway was. He believes that it was the very wet condition of Runway 31 which led to the lack of braking action but is of the opinion that he made the correct decision to
