# Cessna 310R, G-BGTT

| AAIB Bulletin No: 12/2001 | Ref: EW/G2001/06/07 | Category: 1.2 |

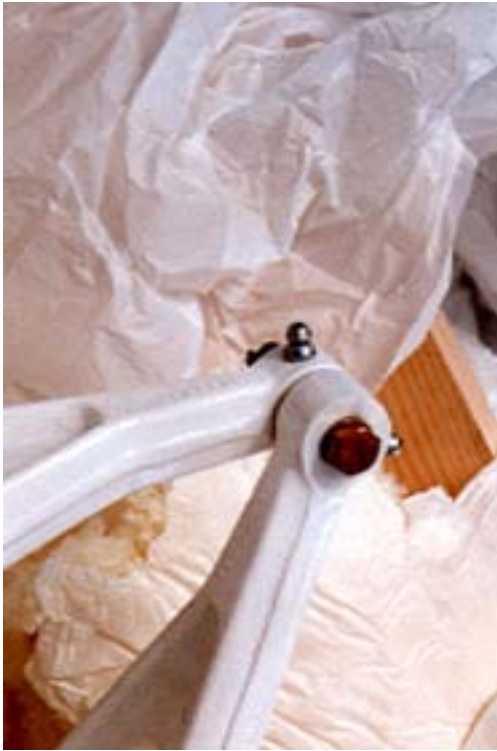
Inspection of the washer found under the nut revealed an indentation corresponding to the diameter of the land under the head of the bolt. This suggested that the washer had been installed under the head of the bolt at some time. From the aircraft's maintenance records it was established that the starboard main landing gear torque links had been disconnected on 21 February 2000 for replacement of worn components. The washer may have been inadvertently transferred from under the head of the bolt to under the nut at this time, leaving no washer under the head of the bolt. A visual inspection of the torque links was completed on 22 May 2001 during the aircraft's Annual

It was established that the washer found under the nut was the incorrect size. The outside diameter of the washer was 9/16" (0.5625"), whereas the correct part number 5045018-1 washer has an outside diameter of 0.75". (Item 66 in Section 04-00 [Figure 2](#) of the Cessna 310R Illustrated Parts Catalogue refers). According to the Illustrated Parts Catalogue (IPC), a part number 5045018-1 washer should be installed under the head of the bolt and under the nut. Although the washer found under the nut was incorrect, had it been installed under the head of the bolt it would have most likely prevented the bolt and bushing from pulling through the torque link, due to the diameter of the washer being slightly larger than the nominal diameter of the hole in the torque link (0.5622" - 0.0000/+0.0010"). Had the washer pulled through the torque link, there would have been tell-tale scoring of the hole in the torque link, but this was not seen, providing further confirmation that there had been no washer under the head of the bolt.

**Figure 1:**  
Incorrect 9/16" Washer

The aircraft manufacturer should as soon as possible issue an All Operators Letter, or similar, to all Cessna 310 operators to inspect the main landing gear torque link assemblies on their aircraft to ensure that they have been assembled with the correct washers.

The aircraft manufacturer should amend the Cessna 310 IPC and Maintenance Manual to clearly identify the locations of the part number 5045018-1 washers to reduce the possibility of incorrect assembly of the torque links.

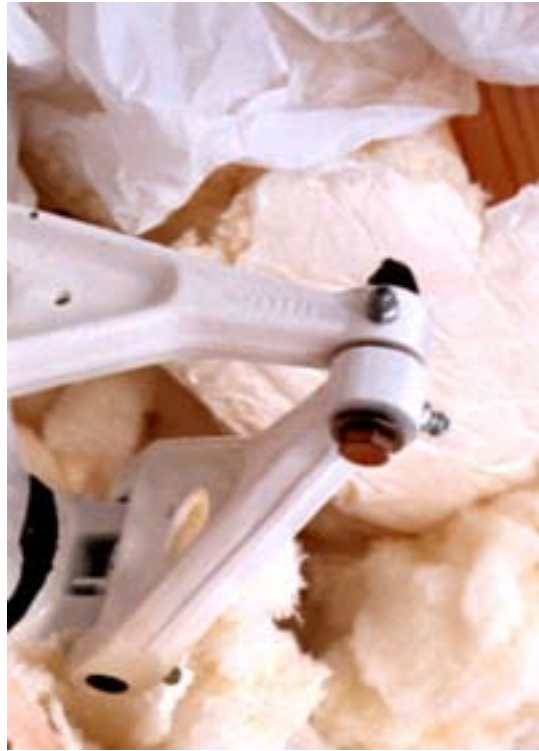
**Figure 2:**  
Correct P/N 5045018-1 0.75" washer
