**Aircraft Type and Registration:** i) Reims Cessna FA152 Aerobat, G-BGXZ  
ii) Grob Astir glider, BGA 2450

**Date & Time (UTC):** 23 July 1994 at 1314 hrs

**Location:** 1 nm south west of Farnborough Airfield datum

**Information Source:** AAIB Field Investigation

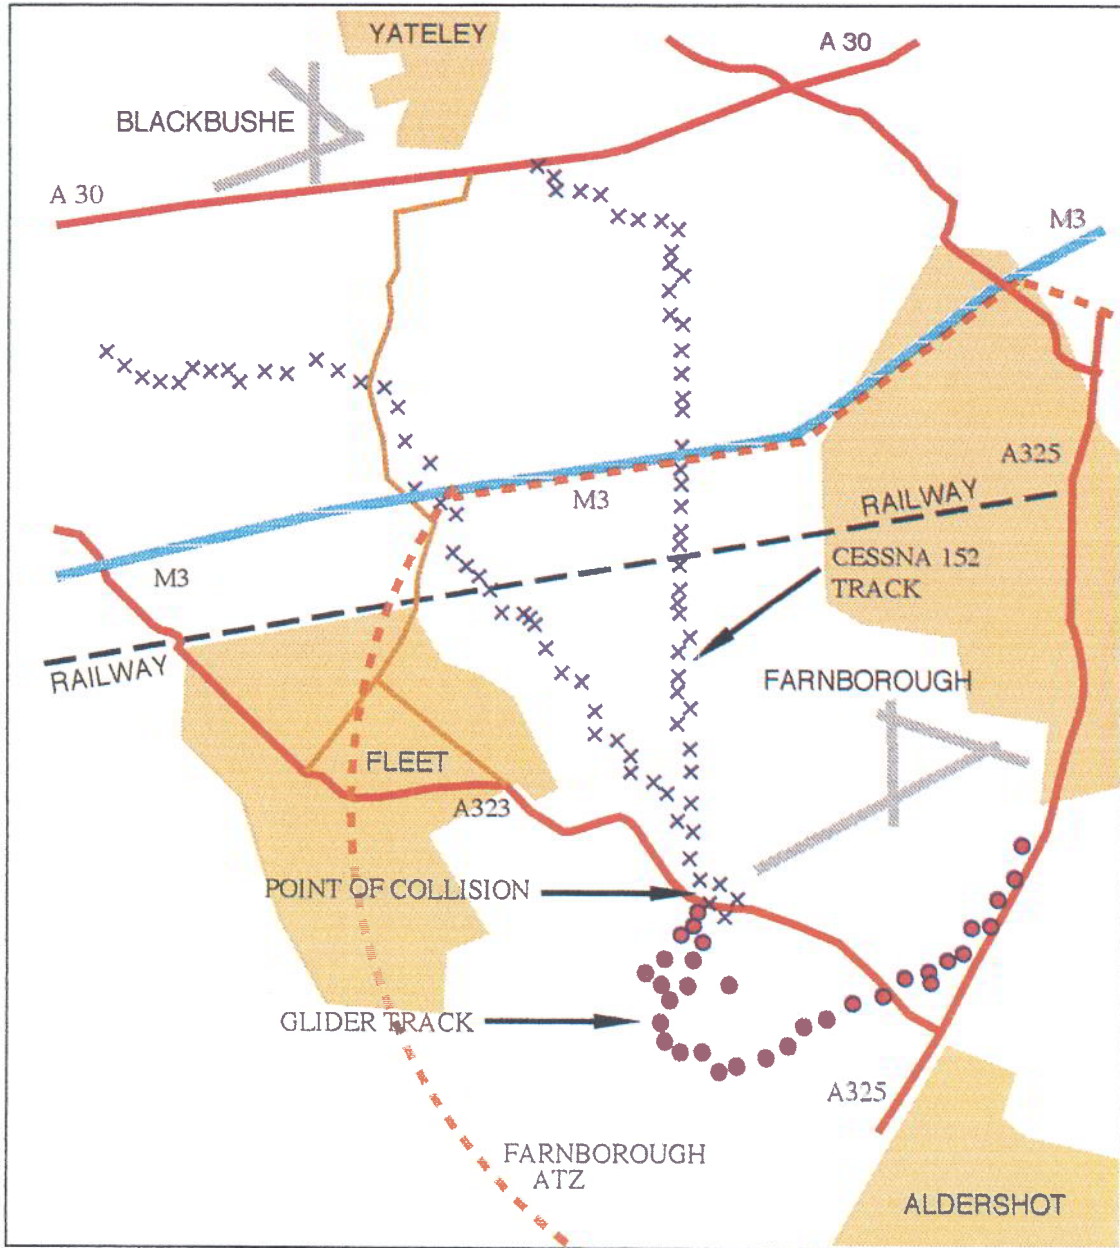
RADAR POSITIONS OF CESSNA 152 AND GLIDER AS RECORDED BY HEATHROW 23 CM RADAR

At approximately 1306 hrs the Cessna 152 departed Blackbushe, from Runway 08, with an instructor and student on board for a routine training flight. The purpose of the flight was for the student, who was the handling pilot, to revise stalling exercises and to reconnoitre the local flying area. Aircraft departing Blackbushe from Runway 08 normally climb on runway heading to 500 feet and then turn right downwind, remaining north of the M3 motorway and clear of the Farnborough ATZ, climbing clear of the Blackbushe circuit on a westerly heading. The instructor reported that after completing the crosswind leg and passing 800 feet the aircraft turned onto a downwind heading of 260° and continued to the west to within 1 nm of Hartley Wintney whereupon it turned onto a heading of 210° to avoid the village. Analysis of radar information (see figure), recorded from the Heathrow 23 cm radar, however, showed that the aircraft turned right onto a track of approximately 190° and continued on that heading entering the Farnborough ATZ as it crossed the M3 motorway. The aircraft, still climbing, crossed the extended centreline of Runway 07 at Farnborough 400 metres west of 07 threshold.

The glider was sighted just before impact approaching the Cessna from the 2 o'clock high position at a height estimated by the instructor to be just above 2,000 feet agl. The student, who saw the glider moments before the instructor, initiated a turn to the right. The instructor, on seeing the glider, took control and tightened the turn. This manoeuvre was not sufficient to prevent the left wingtip of the Cessna colliding with the 'T' tail of the glider.

The glider crashed onto rough ground inside the airfield perimeter about 350 metres west of Runway 07 threshold. It had evidently fallen in a flat spin with the empennage attached only by the control rods. It then struck the top of a tree removing the empennage which was found a few metres from the main wreckage. The pilot's parachute was found 200 metres to the south west of the fuselage, hanging from a tree with the harness almost touching the ground. With the prevailing wind conditions, this would put the point of collision just north of the Runway 07 undershoot.
