## ACCIDENT

<b>Aircraft Type and Registration:</b>	Rans S6-ESD XL (Modified), G-MZDA	
<b>No &amp; Type of Engines:</b>	1 Rotax 582 piston engine	
<b>Year of Manufacture:</b>	1995	
<b>Date &amp; Time (UTC):</b>	29 May 2007 at 1348 hrs	
<b>Location:</b>	Carlisle Airport, Cumbria	
<b>Type of Flight:</b>	Private	
<b>Persons on Board:</b>	Crew - 1	Passengers - 1
<b>Injuries:</b>	Crew - None	Passengers - None
<b>Nature of Damage:</b>	Propeller and hub detached from gearbox, superficial damage to nose cowling	
<b>Commander's Licence:</b>	National Private Pilot's Licence	
<b>Commander's Age:</b>	80 years	
<b>Commander's Flying Experience:</b>	602 hours (of which approximately 500 were on type) Last 90 days - 4 hours Last 28 days - 2 hours	
<b>Information Source:</b>	Aircraft Accident Report Form submitted by the pilot and AAIB enquiries

### Synopsis

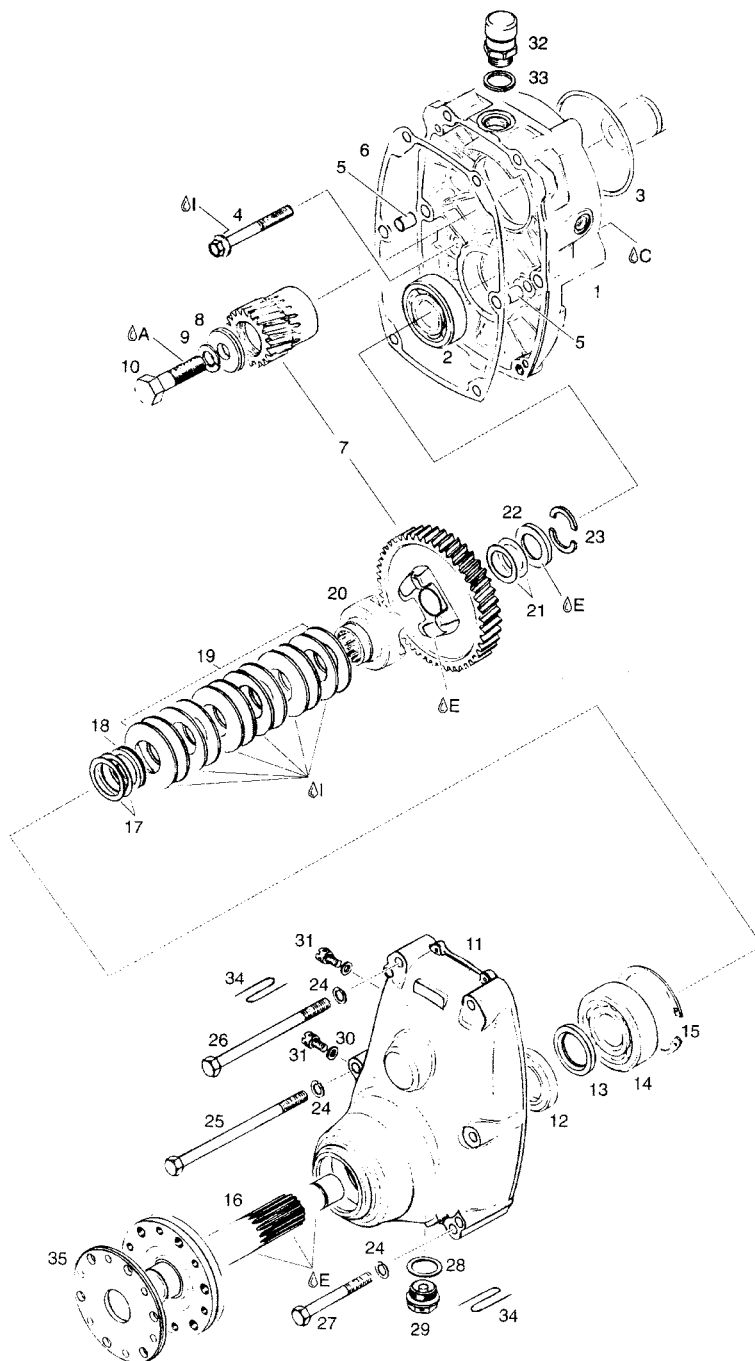
Figure 1

The Rotax 582 is a two-stroke engine and this unit was fitted with a reduction gearbox (see Figure 1). The propeller shaft, item 16 on Figure 1, rotates in two bearings

in the gearbox and is retained by two half-rings that sit in an annular groove in the shaft; these half-rings are housed inside an annular collar. The half-rings are known to wear and as a result require replacing during maintenance.

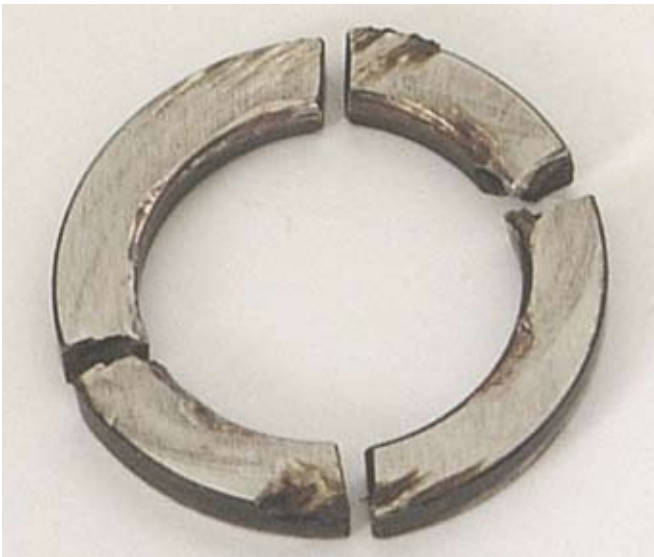
The propeller shaft and the gearbox components were sent to the AAIB, and subsequently to a metallurgist for examination. The components that failed are shown in Figures 2 and 3; note that the collar had broken into two pieces, and that each of the half-rings had broken into two pieces.

The metallurgist concluded that there were high cycle fatigue fractures in the collar and both the half-rings. There was, however, no evidence of wear on the half-rings.

The parts were sent to the UK service agent for the engine who reported that, whilst they had seen failures of the split rings before, they had never seen such a failure within 30 hours of gearbox overhaul. Moreover, they had never seen a failure of the annular collar.

The half-rings had recently been replaced by an experienced engineer and hence incorrect installation would seem unlikely. This would appear to be an unusual failure and hence the components have been sent to the manufacturer for further analysis. This may take some time. Should further significant and relevant information be obtained by AAIB, a supplementary report will be published.

**Figure 2**  
Half rings

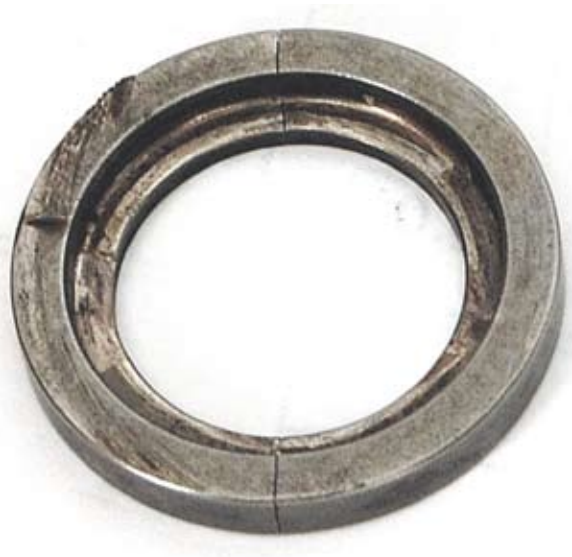
**Figure 3**  
Collar
