Introduction

At 2222 hrs on 29 November 2013 a Eurocopter EC135 T2+ helicopter, operating in support of police operations, descended onto the roof of The Clutha Vaults bar, on Stockwell Street in central Glasgow. The roof collapsed and the helicopter came to rest embedded in the single storey building. The three occupants of the helicopter and six people in or adjacent to the bar were fatally injured. Thirty-two other people suffered injuries, twelve seriously. One of those seriously injured subsequently died of his injuries on 12 December 2013.

AAIB Special Bulletin S9/2013 was published on 9 December 2013 to provide initial information on the AAIB's investigation and the circumstances of the accident. This Special Bulletin is published to provide more factual information and an update on the progress of the investigation. No analysis of the facts is attempted.

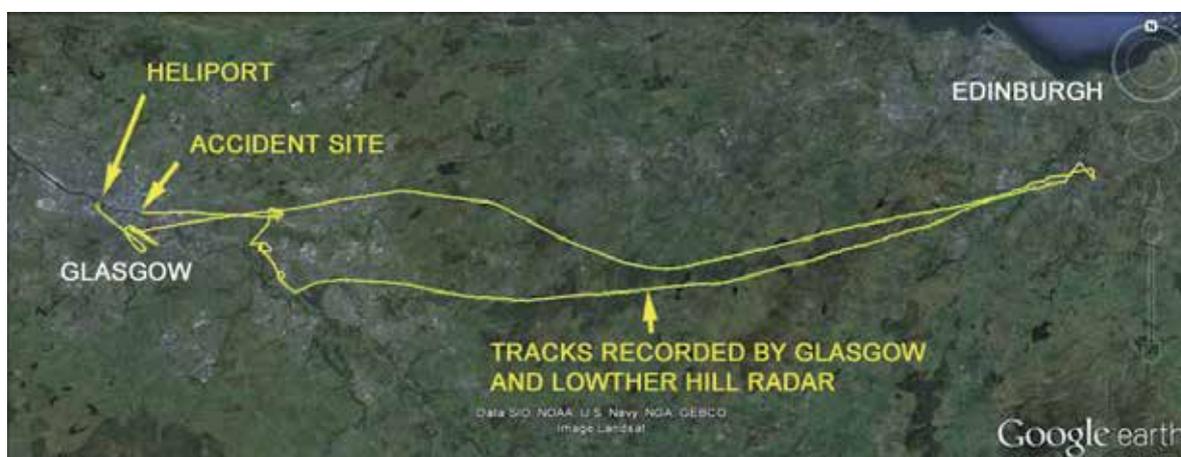
Figure 1

and Bargeddie, North Lanarkshire, where it carried out non-urgent tasks, orbiting in each location for less than five minutes (see Figure 1). At 2218 hrs, the pilot requested clearance from ATC to re-enter the Glasgow Control Zone, to return to GCH. This was approved. No further radio transmissions were received from the pilot.

The helicopter's track, as recorded by radar

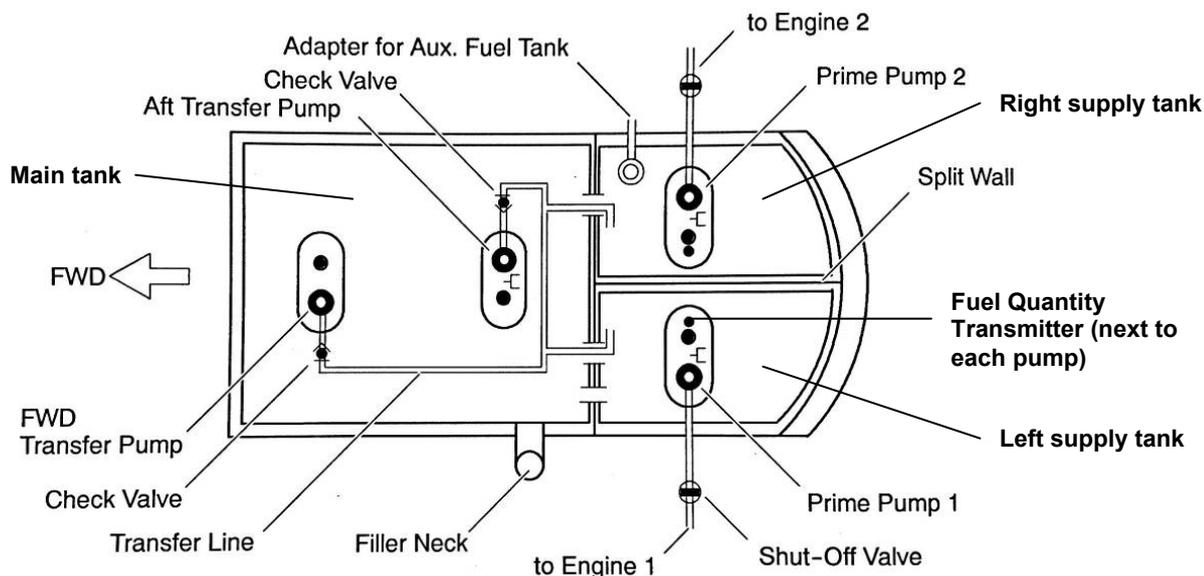
Figure 2

The helicopter's fuel tank group was drained and the contents were measured immediately after it was extracted from the building. It was found that the main fuel tank contained 76 kg of fuel, whilst the No 1 supply tank (left) contained 0.4 kg of fuel and the No 2 supply tank (right) was empty. It has also been confirmed, by examination and measurement of the internal design features, that this was the fuel disposition at the time of the accident. That is; fuel had not moved within the tank group whilst the helicopter was at rest in the building. Also, there was no evidence that fuel leaked from the helicopter before or during the impact with the building.

Since the helicopter's recovery to the AAIB facility, a very close examination of the fuel system has continued. It has been determined that the fuel tank group suffered sudden elastic compression during the impact, whilst retaining its basic shape. The compression was sufficiently severe to collapse all four internal fuel quantity transmitters, as they are designed to do, and the tank group bladders remained fuel-tight. Examination of all internal pipe work and transfer passages has not revealed any pre- or post-impact failure and all paths still permit uninterrupted fuel flow. It has been established that unrestricted flow was also available from each supply tank to the corresponding engine fuel control unit, through the relevant fuel shut-off valves which were found set to the OPEN position.

Fuel Tank Group Schematic
