## MCR-01 ULC Banbi, G-BZXG

<b>AAIB Bulletin No: 10/2003</b>	<b>Ref: EW/G2003/04/28</b>	<b>Category: 1.4</b>
<b>Aircraft Type and Registration:</b>	MCR-01 ULC Banbi, G-BZXG	
<b>No &amp; Type of Engines:</b>	1 Rotax 912ULS piston engine	
<b>Year of Manufacture:</b>	2001	
<b>Date &amp; Time (UTC):</b>	18 April 2003 at 1620 hrs	
<b>Location:</b>	Scone, Perth	
<b>Type of Flight:</b>	Private	
<b>Persons on Board:</b>	Crew - 1	Passengers - None
<b>Injuries:</b>	Crew - None	Passengers - N/A
<b>Nature of Damage:</b>	Nose leg bent. Propeller spinner damaged. Small hole in left wing tip. Nose leg securing struts bent	
<b>Commander's Licence:</b>	Private Pilot's Licence	
<b>Commander's Age:</b>	47 years	
<b>Commander's Flying Experience:</b>	740 hours (of which 5 were on type)	
	Last 90 days - 6 hours	
	Last 28 days - 2 hours	
<b>Information Source:</b>	Aircraft Accident Report Form submitted by the pilot

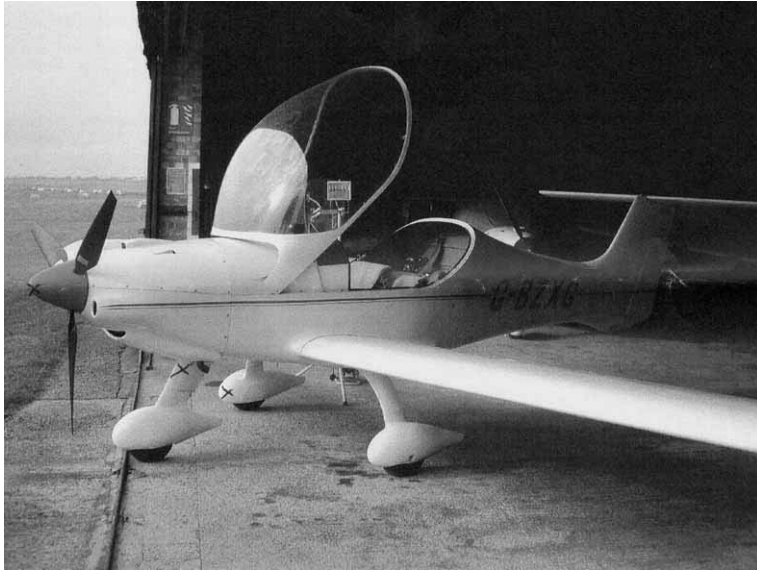
### G-BZXG

The pilot was planning a touch and go on paved Runway 09 with a reported surface wind of 100°/5 kt. The aircraft touched down on the left side of the runway and when the pilot applied power, the aircraft veered sharply towards the runway's left edge. The pilot could not recover the aircraft to a straight track and so he reduced the engine power to idle and allowed the aircraft to roll onto the grass alongside the runway. The aircraft rolled over a small ridge in the grass which caused the nose landing gear leg to fold backwards. The aircraft pitched forwards causing the propeller spinner and left wing tip to hit the ground. The pilot shut down the engine and turned off the fuel before evacuating the aircraft.

In a frank assessment of the cause of the accident the pilot admitted that he probably should not have attempted a takeoff from the edge of the runway and that he should have been quicker in applying rudder to counteract the yaw effect of adding power. The aircraft kit manufacturer has recently increased the diameter of the nose leg on the MCR-01 to conform to that of their four-seat variant. However, had the design change been implemented on the accident aircraft, it would not necessarily have prevented the nose gear collapse.
