MCR-01 ULC Banbi, G-BZXG

AAIB Bulletin No: 10/2003	Ref: EW/G2003/04/28	Category: 1.4
Aircraft Type and Registration:	MCR-01 ULC Banbi, G-BZXG	
No & Type of Engines:	1 Rotax 912ULS piston engine	
Year of Manufacture:	2001	
Date & Time (UTC):	18 April 2003 at 1620 hrs	
Location:	Scone, Perth	
Type of Flight:	Private	
Persons on Board:	Crew - 1	Passengers - None
Injuries:	Crew - None	Passengers - N/A
Nature of Damage:	Nose leg bent. Propeller spinner damaged. Small hole in left wing tip. Nose leg securing struts bent	
Commander's Licence:	Private Pilot's Licence	
Commander's Age:	47 years	
Commander's Flying Experience:	740 hours (of which 5 were on type)	
	Last 90 days - 6 hours	
	Last 28 days - 2 hours	
Information Source:	Aircraft Accident Report Form submitted by the pilot

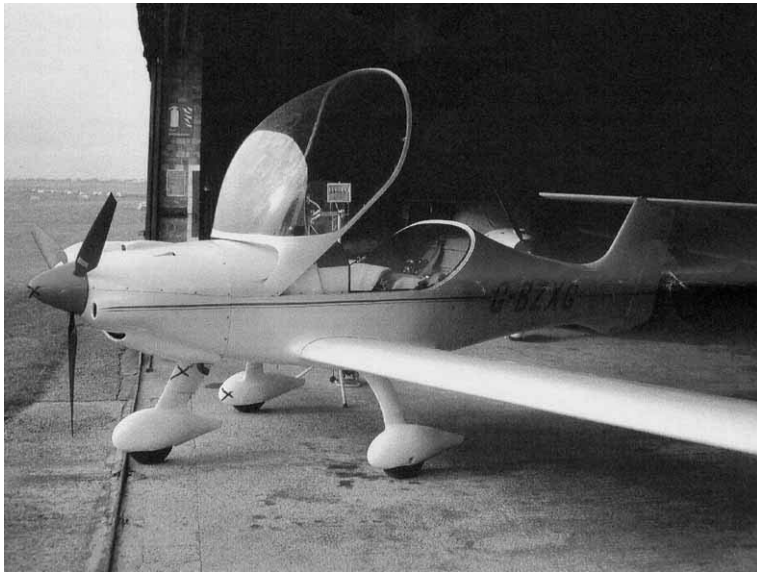
G-BZXG

The pilot was planning a touch and go on paved Runway 09 with a reported surface wind of 100°/5 kt. The aircraft touched down on the left side of the runway and when the pilot applied power, the aircraft veered sharply towards the runway's left edge. The pilot could not recover the aircraft to a straight track and so he reduced the engine power to idle and allowed the aircraft to roll onto the grass alongside the runway. The aircraft rolled over a small ridge in the grass which caused the nose landing gear leg to fold backwards. The aircraft pitched forwards causing the propeller spinner and left wing tip to hit the ground. The pilot shut down the engine and turned off the fuel before evacuating the aircraft.

In a frank assessment of the cause of the accident the pilot admitted that he probably should not have attempted a takeoff from the edge of the runway and that he should have been quicker in applying rudder to counteract the yaw effect of adding power. The aircraft kit manufacturer has recently increased the diameter of the nose leg on the MCR-01 to conform to that of their four-seat variant. However, had the design change been implemented on the accident aircraft, it would not necessarily have prevented the nose gear collapse.
