ACCIDENT

Aircraft Type and Registration:	Boeing 777-236, G-ZZZC
No & Type of Engines:	2 GE 90-76B turbofan engines
Year of Manufacture:	1995
Date & Time (UTC):	10 January 2006 at 0840 hrs
Location:	London (Heathrow) Airport
Type of Flight:	Public Transport (Passenger)
Persons on Board:	Crew - 14 Passengers - 106
Injuries:	Crew - None Passengers - None
Nature of Damage:	Minor damage to left wing tip
Commander's Licence:	Airline Transport Pilot's Licence
Commander's Age:	39 years
Commander's Flying Experience:	8,600 hours (of which 3,600 were on type) Last 90 days - 150 hours Last 28 days - 78 hours
Information Source:	Aircraft Accident Report Form submitted by the pilot and a detailed incident report from the aircraft operator

Synopsis

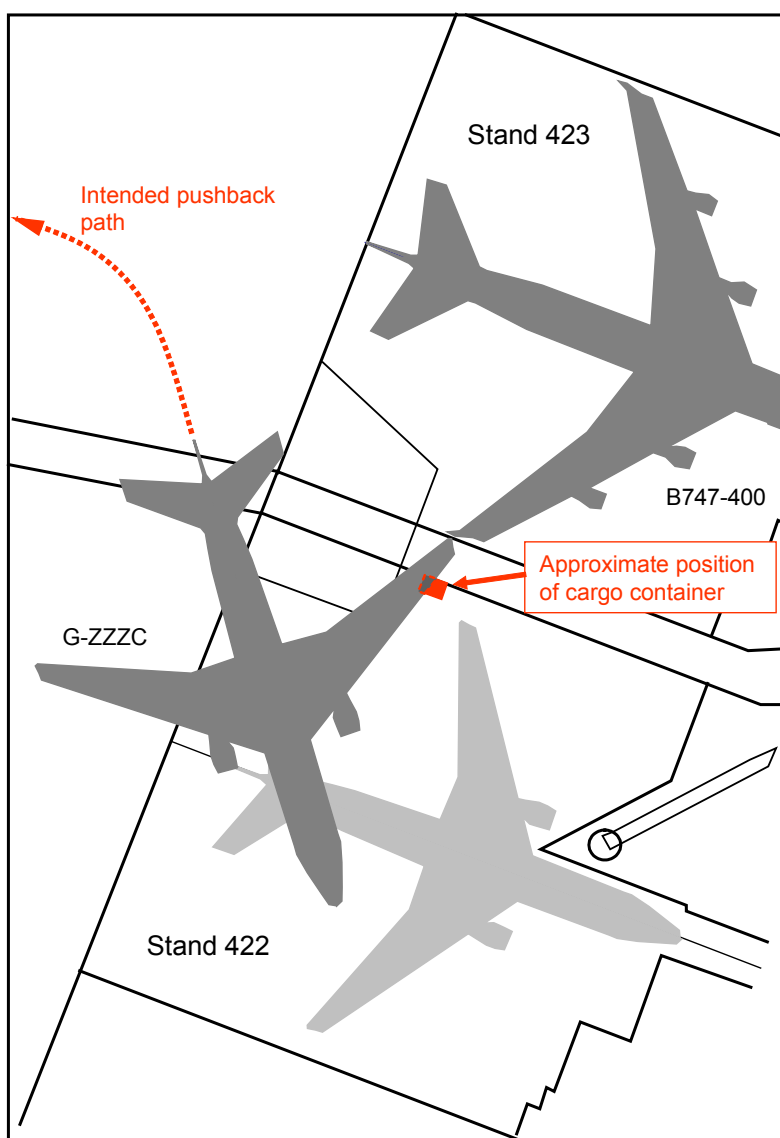
Figure 1

Aircraft positions at point of collision

As the pushback progressed and the wing of G-ZZZC approached the Boeing 747-400, the wing observer found himself behind the container and may have been momentarily out of the driver's sight. As the wing observer moved around the container he continued to indicate a safe clearance by holding his arms out horizontally but shortly afterwards quickly changed the signal to an arms crossed 'stop' signal and shouted to the TBL driver. The driver saw the signal and stopped the pushback, but not before the left wing tip had struck the right winglet of the parked aircraft.

The Boeing 747-400 right winglet was punctured by G-ZZZC's left wing tip, which suffered damage to three static discharge wicks and the navigation light assembly. Both aircraft were taken out of service for repairs.

The TBL driver had initially over-steered to the extent that the subsequent straight pushback took the aircraft on a collision course with the Boeing 747-400. Since this was a recognised risk with pushbacks from Stand 422, the driver was dependent upon the presence and effectiveness of the wing tip observer who would be expected to signal if clearance was inadequate. Prior to pushback, the headset operator had drawn the driver's attention to the container and dollies, and together they had agreed that these did not present a hazard to the pushback. Although the items may have presented no physical hazard to the aircraft, they were situated in the general area that the wing observer would be required

It is likely that the presence of the container and dolleys in his path distracted the wing tip observer at a critical time from his primary task of monitoring wing tip clearance, and may have prevented the driver from seeing the 'stop' signal straight away.

- a. the provision of visual guidance to assist drivers with the initial turn from Stand 422,
- b. adherence to the requirements for minimum numbers of team members for pushback from certain stands, including Stand 422,
- c. the need for staff to arrive on stand with time to plan and execute their allocated tasks adequately, including the recording of times when staff are allocated duties,
- d. the need for ramp equipment to be parked in designated safe areas, with particular emphasis on Stand 422 and other stands where wing observers are required.
