## ACCIDENT

| <b>Aircraft Type and Registration:</b> | Grob G115E Tutor, G-BYWE | |
| <b>Date &amp; Time (UTC):</b> | 24 May 2007 at 1543 hrs | |
| <b>Location:</b> | Colerne Airfield, Wiltshire | |

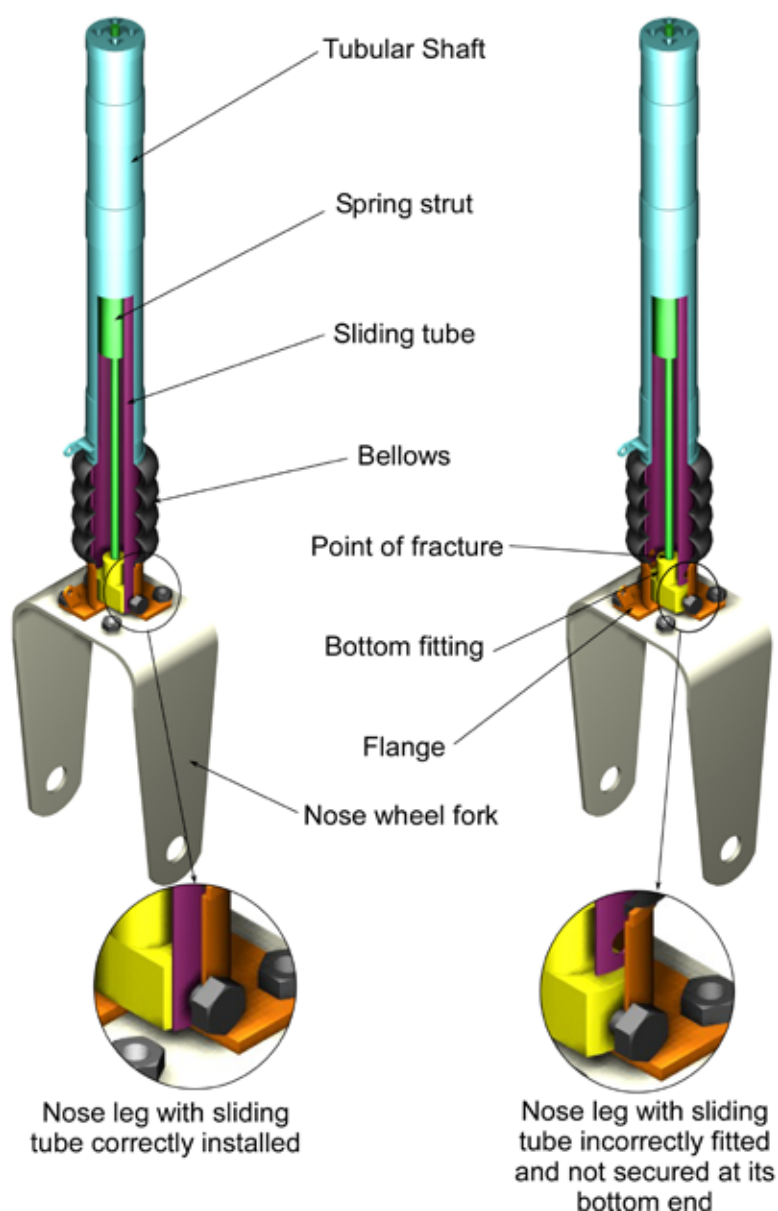
**Figure 1**

The nose leg of the Grob 115 consists of a steel housing secured to the airframe, into which fits a tubular shaft. A diagram of the nose leg is shown in Figure 1. Fitted within the tubular shaft is a gas spring strut shock-absorber. The upper end of the strut is attached to the tubular shaft; the lower end is screwed into the bottom fitting. A sliding tube surrounds the spring strut and the bottom fitting, and is secured at its

Simplified drawing of the nose leg, with the steel housing, wheel and torque links removed for clarity

bottom end by the same bolt that secures the bottom fitting to the flange.
