**INCIDENT**

<b>Aircraft Type and Registration:</b>	Gazelle HT Mk 2, G-GAZL	
<b>No &amp; Type of Engines:</b>	1 Turbomeca Astazou IIN2 turboshaft engine	
<b>Year of Manufacture:</b>	1974	
<b>Date &amp; Time (UTC):</b>	4 November 2004 at 0948 hrs	
<b>Location:</b>	On approach to Sheffield City Airport, Sheffield	
<b>Type of Flight:</b>	Private	
<b>Persons on Board:</b>	Crew - 1	Passengers - None
<b>Injuries:</b>	Crew - None	Passengers - N/A
<b>Nature of Damage:</b>	Separation and destruction of right-hand engine cowling plus superficial damage to main rotor blades	
<b>Commander's Licence:</b>	Private Pilot's Licence	
<b>Commander's Age:</b>	58 years	
<b>Commander's Flying Experience:</b>	2,657 hours (of which 384 were on type) Last 90 days - 46 hours Last 28 days - 6 hours	
<b>Information Sources:</b>	Aircraft Accident Report Form submitted by the pilot, plus aircraft examination by the AAIB and a metallurgy report

**Synopsis**

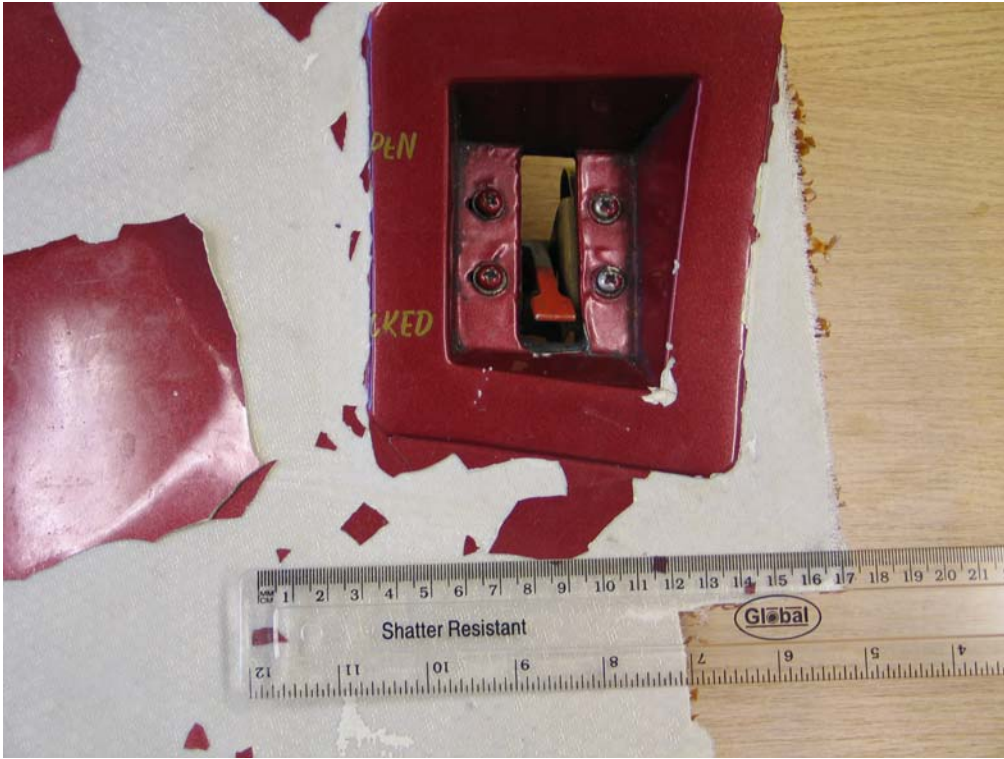
**Figure 1 - Engine cowling - Aft latch (outside) and latch lever**

This aft latch on each cowling is designed to engage automatically when the cowling is closed (see Figure 1). The latch is a very simple mechanism, with a latching lever marked OPEN and LOCKED. In addition, there is an 'anti-chatter' device; a length of spring steel formed into a curved W-shape (see Figure 2).

lever will move momentarily towards the OPEN position as the latch engages the roller fitting on the engine and then to its sprung LOCKED position. There is no additional visual indication to confirm that the roller is engaged in the latch.

G-GAZL was examined by the AAIB with the replacement cowlings in place. In operating the latches and opening and closing the cowlings, it was clear that if the forward latch joining the cowlings was left undone, it was visually obvious and untidy. With the aft latches, however, it was possible to close the cowlings so that these latches did not engage and the cowling appeared very similar to the same cowling with the latch fully engaged. In each case, the lever was in its sprung LOCKED position.

As a trial, the fractured item of cowling panel containing the aft latch was engaged with the roller on the engine. It engaged correctly and the application of forces in a variety of directions failed to disengage the latch indicating that it had very probably not been engaged at the time the cowling opened in flight.
