Aerospatiale AS332L Super Puma, G-TIGT, 4 January 1996

AAIB Bulletin No: 6/96 Ref: EW/C96/1/2 Category: 2.1

Aircraft Type and Registration:Aerospatiale AS332L Super Puma, G-TIGT

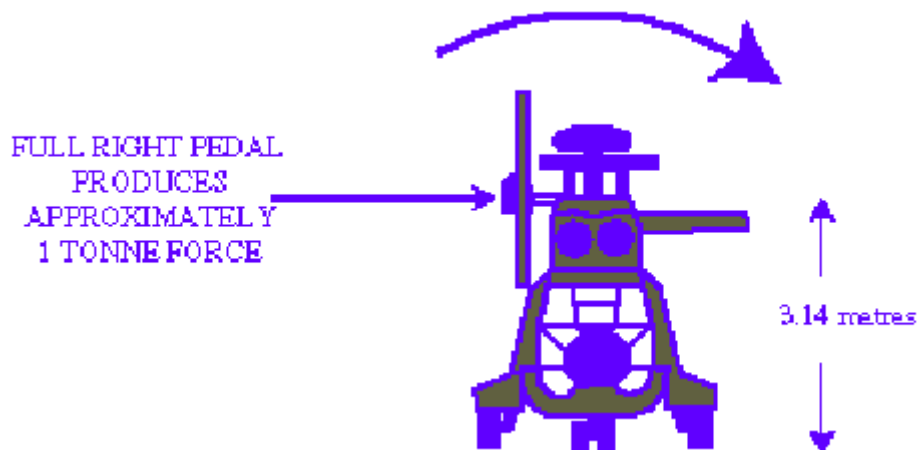
When the collective lever is fully lowered for taxiing, lift from the main rotor is negligible. The major forces which produce fuselage rolling moments are weight, crosswind, tail rotor force and main rotor hinge moment. Forces arising from cornering, ground slope and fuel slosh may also be present but generally their effect is small. On the ground the helicopter's rolling axis tends to be along a line drawn between a main wheel and the nose wheel. The effect of weight is always to provide a stabilising moment provided that the centre of gravity remains inboard of this axis. On the other hand, the tail rotor force in a right turn tends to roll the helicopter to the left. The rotor hub is nominally 3.14 metres above the ground and full right pedal creates a force to the left of approximately one tonne as shown below. In some conditions the rolling moment generated is sufficient to overbalance the helicopter. This phenomenon is known as 'static rollover'.

Although the effect of weight is stabilising when the helicopter starts to roll, once the centre of gravity (cg) moves outside the rolling axis, the effect of weight is de-stabilising and the rollover becomes self-sustaining. The boundary (expressed as a roll angle) between stabilising and de-stabilising moments varies with weight and the position, particularly the vertical position, of the cg. The Super Puma's fuel is carried under the floor and the cg is highest when there is no payload and little fuel remaining. This condition, which is often encountered at the end of a flight when taxiing from a hot spot to a parking spot, is when the helicopter is most vulnerable to static rollover.

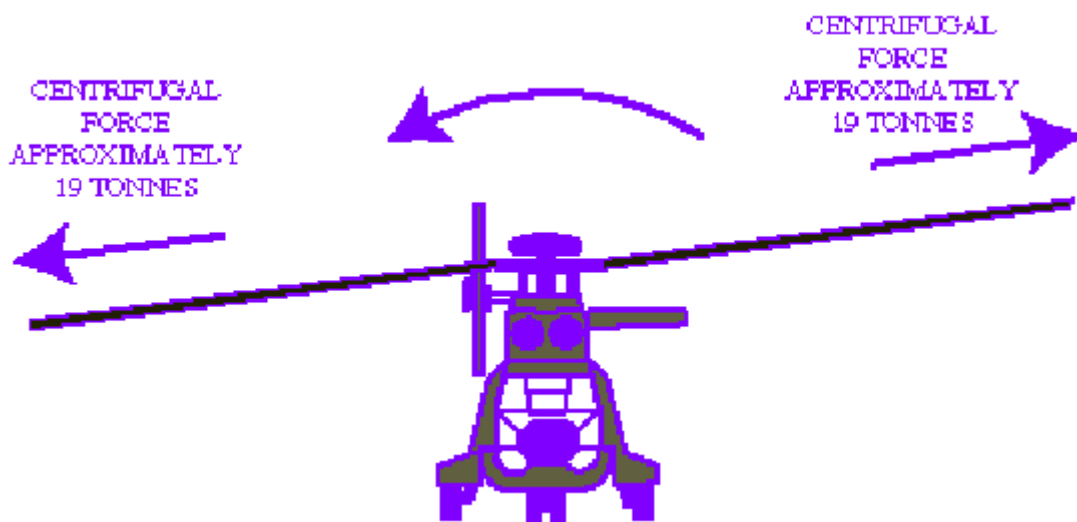
The risk of static rollover can be minimised by using in-turn cyclic roll inputs to counterbalance the destabilising moments. Left or right cyclic input causes the main rotor disc to tilt and the centrifugal forces from the blades act upon the rotor hinges to produce a strong moment which tries to align the hub with the blades. This force is transmitted to the fuselage by the rotor mast which results in a rolling moment in the same direction as the cyclic input as shown below.
