Aircraft Type and Registration:	Boeing 777-236B, G-VIIA	
No & Type of Engines:	2 GE90-85B turbofan engines	
Year of Manufacture:	1997	
Date & Time (UTC):	26 June 2003 at 1000 hrs	
Location:	Near Reigate, Surrey	
Type of Flight:	Public Transport (Passenger)	
Persons on Board:	Crew - 14	Passengers - 272
Injuries:	Crew - None	Passengers - None
Nature of Damage:	Access door detached, cabin windows damaged, minor damage to fuselage and fin	
Commander's Licence:	Airline Transport Pilot's Licence	
Commander's Age:	49 years	
Commander's Flying Experience:	14,750 hours (of which 2,350 were on type) Last 90 days - 190 hours Last 28 days - 36 hours	
Information Source:	AAIB Field Investigation

Synopsis

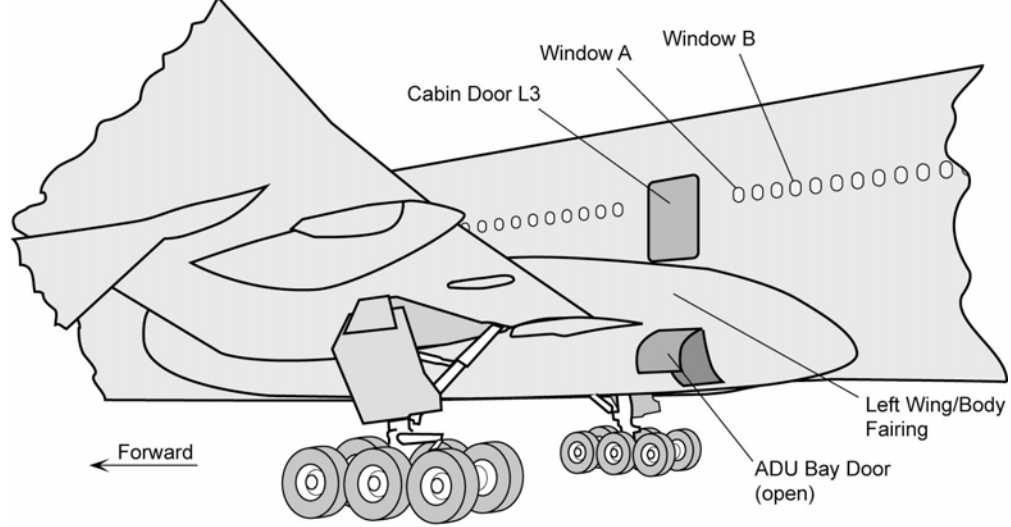
Figure 1

Examination of the aircraft revealed the absence of the ADU bay door and the presence of paint deposits, scraping and gouge markings on the side of the fuselage just below and aft of L3 Cabin Door. All three ADU door hinges were found fractured. The markings showed that the ADU bay door had rotated open on its hinges until its outer surface had struck the fuselage skin immediately above the door aperture. The hinges had over-travelled and failed in overload and the door had travelled upwards and rearwards with parts of its outer surface in firm contact with the fuselage. Six deep gouges in the fuselage skin, with progressively increasing spacing, were evident near the forward edge of the scrape markings. With the catches closed, the outer surface of the door is smooth and it appeared highly likely that the gouges corresponded to sequential contact by the protruding latch levers of the six catches on the door forward edge. The spacing suggested that the door had rotated as it had translated and accelerated upwards and rearwards relative to the aircraft.

The fuselage scrape marks passed over the lower aft corner of Door L3 and over the first two cabin windows aft of the door. A piece of blue-painted carbon-fibre laminate, approximately 2 x 2 inch in size, reportedly entered the cabin at the first window ('Window A', Figure 1), adjacent to Seat 26A. It was clearly part of the external skin of the ADU bay door, although its original location on the door could not be established. Inspection indicated that it had been forced in between the window unit seal and the window frame. Some of the retaining clips for Window A had been distorted or displaced and the retaining screws bent, allowing the window unit to displace inwards at its aft top corner. The sidewall trim panel adjacent to Seat 26A had been displaced slightly and a sidewall light cover in the area had detached.

A portion of carbon-fibre laminate approximately 3 x 6 inch in size was found at the fourth window ('Window B', Figure 1) embedded between the window unit seal and the aft upper corner of the fuselage window aperture. This piece, identified as the outer skin of the aft lower corner of the ADU bay door (Piece 6, Figure 3), protruded partially into the cabin at Seat Row 29. The outer pane of Window B exhibited heavy scrape marks terminating in an approximately 3.5 x 0.7 inch irregular penetration hole, with associated local fracturing of the pane. The damage profile and paint deposits

on the pane were consistent with impact by a latch lever protruding from one of the catches. Additional damage consisted of an approximately 6 inch long gouge in the composite skin forming the left side of the fin, about one third of the way up.

Air driven unit access door location

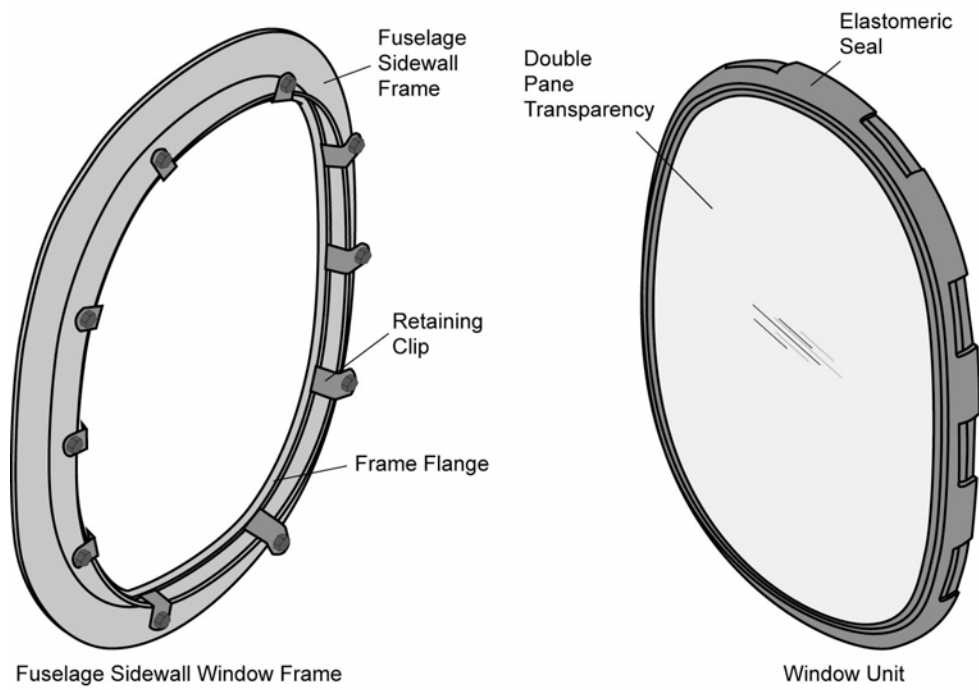
Figure 2

frame at Windows A and B as the door slid up the side of the fuselage and been driven between the frame and the window unit. This had allowed small parts of the door skin to enter the cabin and caused minor displacement of the cabin trim.

The window unit displacement was unsurprising as the fastening arrangement did not appear to be particularly robust, consistent with the lack of a design requirement for the fasteners to normally withstand substantial inward forces. The usual forces on the window unit are predominately outward-acting cabin differential pressure loads reacted by the frame flange. At the time of the door detachment only a small differential pressure would have been present to assist in reacting the impacts. The slight recessing of the window unit in this condition, together with the effect of the outer pane bevel, may have assisted in the snagging of the door. At greater altitudes a higher differential pressure would be expected both to reduce these effects and to increase the resistance to both window seal and window unit displacement.

Cabin window unit

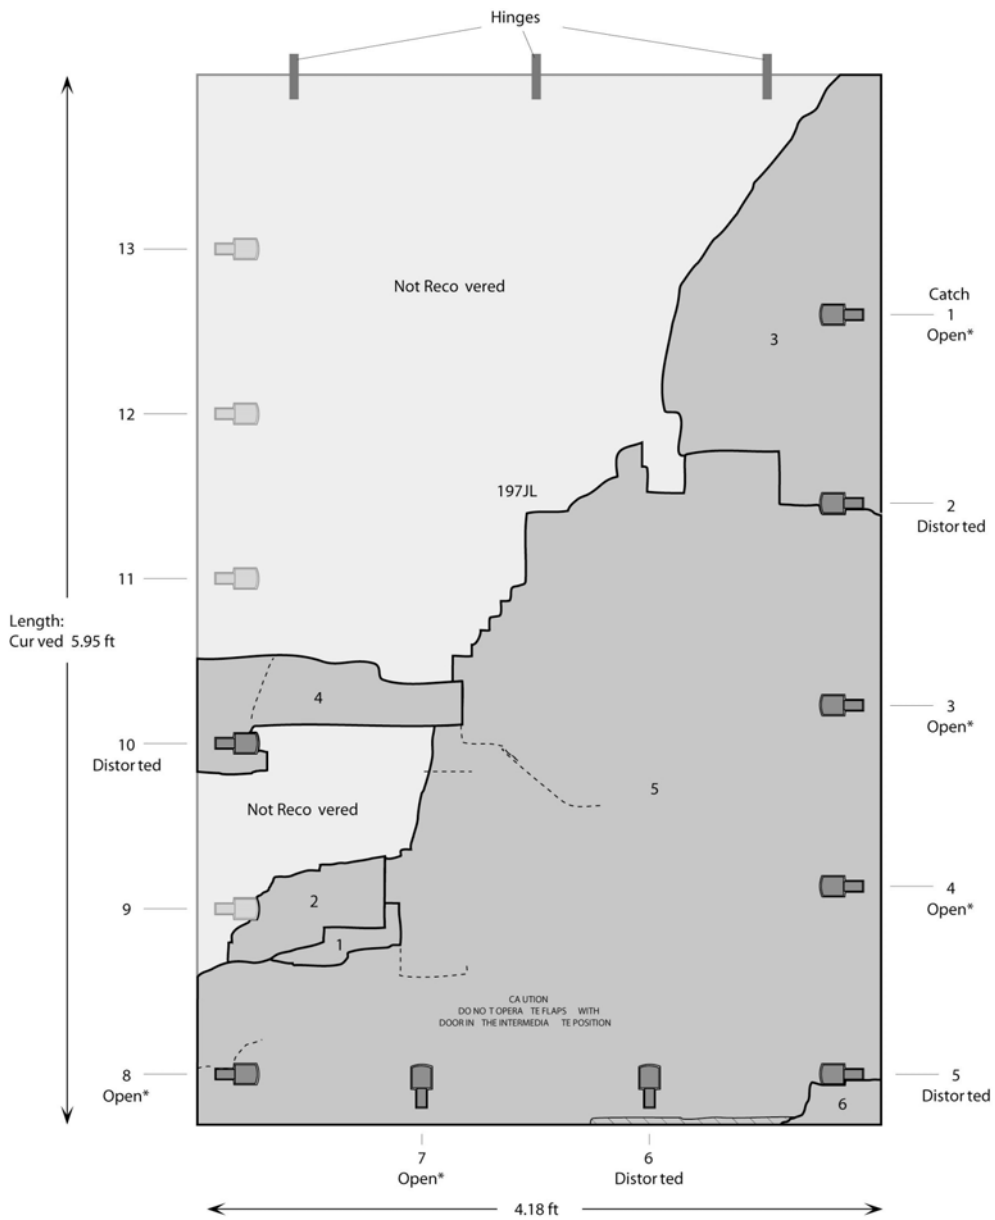
Figure 3

Debris lying in a wooded area near Reigate, discovered by a dog walker, was identified as part of the missing door. A search of the area located other parts and a large portion was found when a couple who had been out walking described having seen it fall nearby after their attention had been drawn by another substantial part of the door impacting the ground around 20 feet from them. Around 60% of the door was recovered (Figure 3), all from the ground beneath the flight path, apart from the small portions of door skin that remained with the aircraft. Much of the ground area was covered with dense, high undergrowth and in spite of a prolonged search the remainder was not located.

The recovered parts included 9 of the 13 catches. Five of these were found in the open state, with no apparent damage. The other four catches had been distorted. In the case of two of these (Catches 2 and 10) the damage was consistent with the effects of door fractures that passed through their location. Catch 10 also had marks suggesting that some damage had resulted from impact on the protruding latch lever. One (Catch 5) was located immediately adjacent to the door skin piece that had penetrated the cabin at Window B. The evidence suggested that the protruding latch lever of this catch had caused the hole in the window's outer pane and that the catch had been damaged in the process. The remaining distorted catch (Catch 6) had not been in a region of appreciable door damage; the evidence was consistent with it having been damaged by an inward overload applied to the closed latch lever.

<p>NOTE</p> <ol style="list-style-type: none"> 1. Door drawn flattened. 2. All recovered items shown except for several small pieces whose location on the door could not be established 3. All recovered items found on ground beneath flight path, except as noted below. 4. Piece 6 found embedded between Seal and fuselage aperture for Window B 5. Piece 8 (approx 2x2 inch, not shown) entered cabin between Seal and fuselage aperture for Window A. 	<p>KEY</p> <ol style="list-style-type: none"> 1. Recovered items in darker shading. 2. * Apparently undamaged. 2. Paint scraped off. 3. Crack in outer skin.
--	---

G-VIIA ADU access door schematic

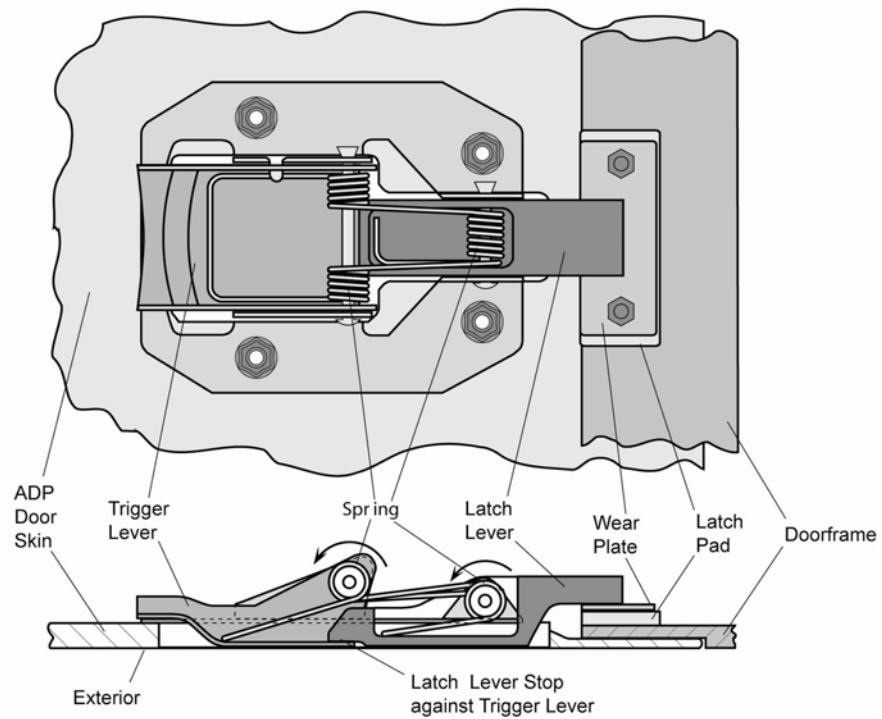
Figure 4

Each catch consists of a mechanism attached to the inner face of the door lip by 4 bolts (Figure 4). Cut-outs in the door skin provide external access to each catch and clearance for it to open. When the catch is closed, a pivoting latch lever bears against a latch pad fixed to the doorframe and fitted with a wear plate. Door adjustment is achieved by fitting different thickness wear plates; those on G-VIIA were between 0.015-0.040 inch thick.

ADU bay door latch

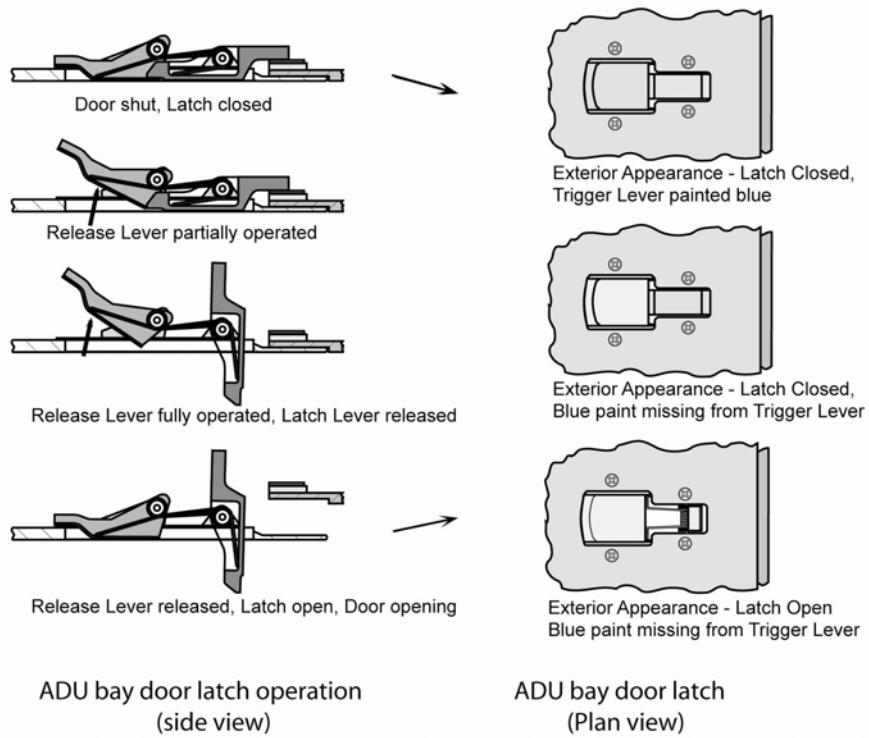
Figure 5

The latch lever is spring-loaded to open and is retained closed by contact with a trigger lever, which itself is spring-loaded to close against a stop on the catch frame. The latch lever/trigger lever contact point is positioned so as to over-centre the mechanism; ie an increased latch lever opening force provides an increased trigger lever closing force.

The catch is released by manually pushing the trigger lever inwards until it disengages from the latch lever, allowing the latch lever to rotate under spring loading and disengage from the pad (Figure 5). The latch lever rotates 90°, its inner end passing through the door cut-out and protruding 0.85 inch beyond the outer surface of the door. The protruding portion has a generally rectangular cross section of approximately 0.7 x 0.4 inch; on G-VIAA the exterior face (when closed) was painted the same dark blue as the door and the side and inner faces were generally unpainted silver-coloured aluminium. It was noted that the side faces of the latch levers on the replacement door were painted orange. The trigger lever returns to its flush position when released. The outer face of the trigger lever was generally painted dark blue; in G-VIIA's case this paint had disappeared from some of the catches, leaving the silver-coloured metal surface of the trigger levers visible (Figure 6).

ADU bay door latch operation
(side view)
