**INCIDENT**

<b>Aircraft Type and Registration:</b>	Avro 146-RJ100, G-CFAE	
<b>No &amp; Type of Engines:</b>	4 Lycoming LF507-1F turbofan engines	
<b>Year of Manufacture:</b>	2001	
<b>Date &amp; Time (UTC):</b>	11 January 2006 at 0830 hrs	
<b>Location:</b>	Edinburgh	
<b>Type of Flight:</b>	Public Transport (Passenger)	
<b>Persons on Board:</b>	Crew - 5	Passengers - 98
<b>Injuries:</b>	Crew - None	Passengers - None
<b>Nature of Damage:</b>	Nil	
<b>Commander's Licence:</b>	Airline Transport Pilot's Licence	
<b>Commander's Age:</b>	48 years	
<b>Commander's Flying Experience:</b>	7,300 hours (of which 65 were on type) Last 90 days - 65 hours Last 28 days - 30 hours	
<b>Information Source:</b>	AAIB Field Investigation

**Synopsis**

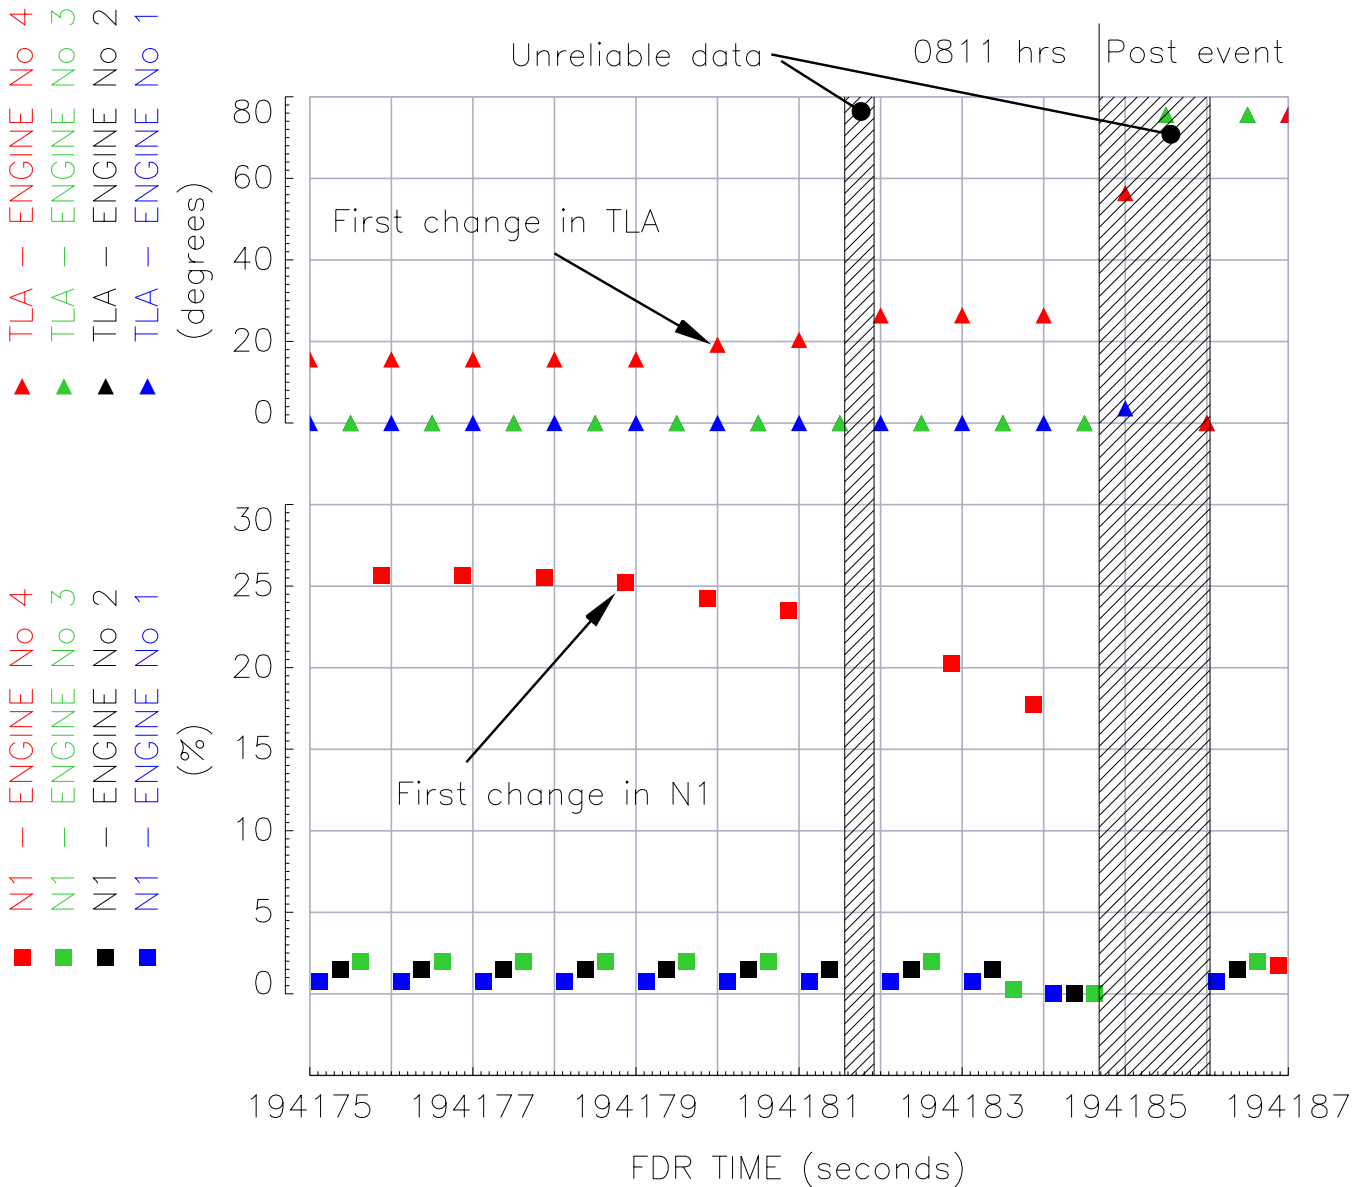
**Figure 1**

Figure 1 shows the FDR recording just prior to the loss of power. The TLA for engine No 4 did not change until after the N1 for engine No 4 started dropping. The FDR recording stopped for less than a second and then restarted briefly, operating for approximately three further seconds before it stopped again.

Within the limitations of data being recorded only once every second, there is no indication that the N1 of engine No 4 was increased above the idle state. Therefore, it is reasonable to conclude that the N2 of engine No 4 was below the required value of 65% when the start of engine No 3 was attempted.

FDR recorded N1 and TLA parameters. Note that TLA No 2 is hidden behind TLA No 3
