ACCIDENTS INVESTIGATION BRANCH
Department of Trade

AESL Airtourer T6/24 G-AYMF
Report on the accident near
Lands End (St Just) Aerodrome,
Cornwall on 9 June 1972

Accidents Investigation Branch
Civil Aircraft Accident Report No 15/74
(EW/C410)

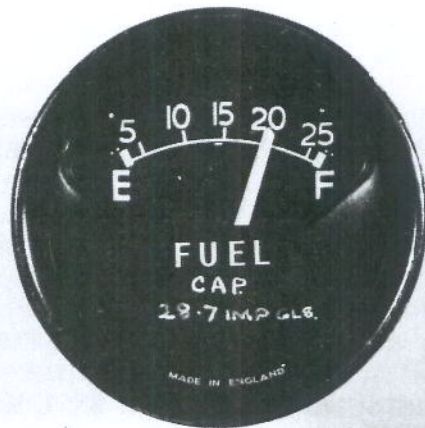
Fuel was contained in a single flexible tank of 29 imp/gal capacity, and was drawn from a sump located in the rear of the tank by an electrically driven pump and also an engine driven pump. Each pump could supply the engine with adequate fuel should either fail. The fuel gauge system was of the motor car 'hot wire' type and the gauge was calibrated from 0 to 29 gallons. The full size photograph below shows that the 5 gallon mark is close to the empty mark, particularly in comparison with the width of the needle.

Be that as it may, the Commander was operating with too narrow a margin in fuel reserves. The presentation of the fuel contents gauge with its thick needle and the 5 gallon mark so close to the empty mark suggests that there was little to be gained in trying to read quantities of fuel remaining of less than 5 gallons.
