## ACCIDENT

| <b>Aircraft Type and Registration:</b> | Cirrus SR20, N470RD | |

## Synopsis

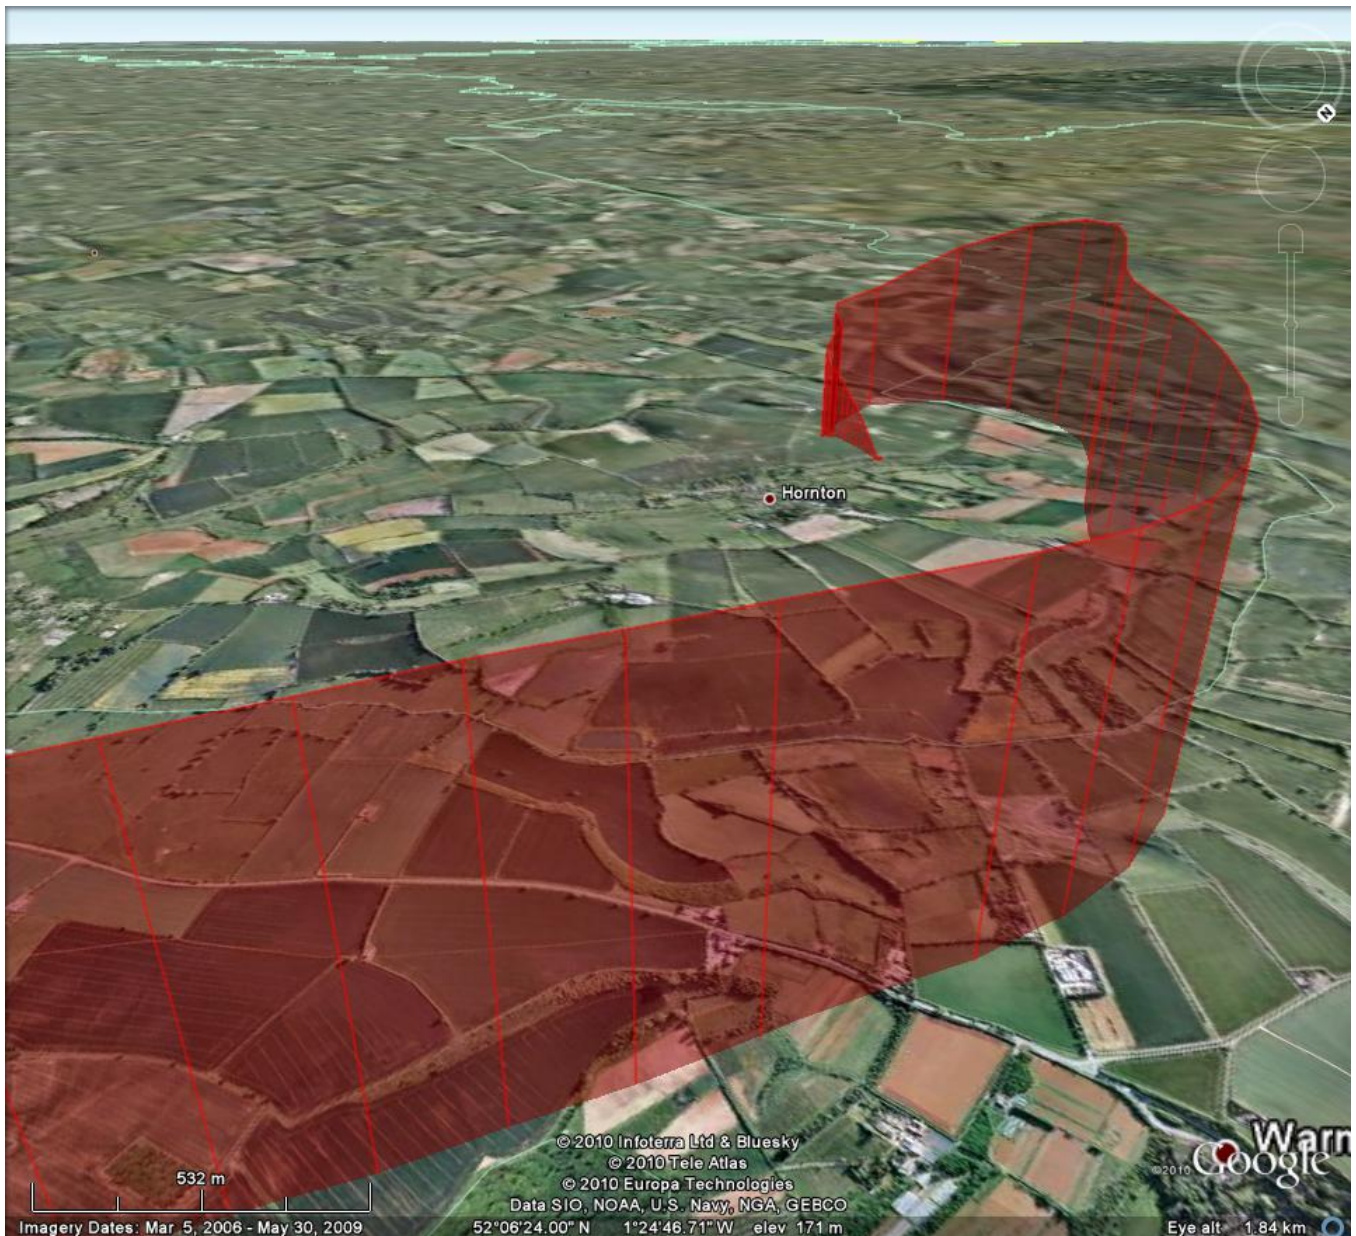
**Figure 1**

Recording began as the aircraft taxied at Turweston and ended with the aircraft on the ground following the accident. The later part of the accident track, based on the GPS positions and recorded pressure altitude, is presented in Figure 1. Selected recorded flight parameters are plotted in Figure 2 for the whole of the accident flight. The accelerations, which were recorded from accelerometers within the PFD, were converted to units of 'g' and corrected to the aircraft's centre of gravity position before being plotted. The altitude bug

3D view of the latter part of the aircraft's track  
from GPS position and recorded pressure altitude

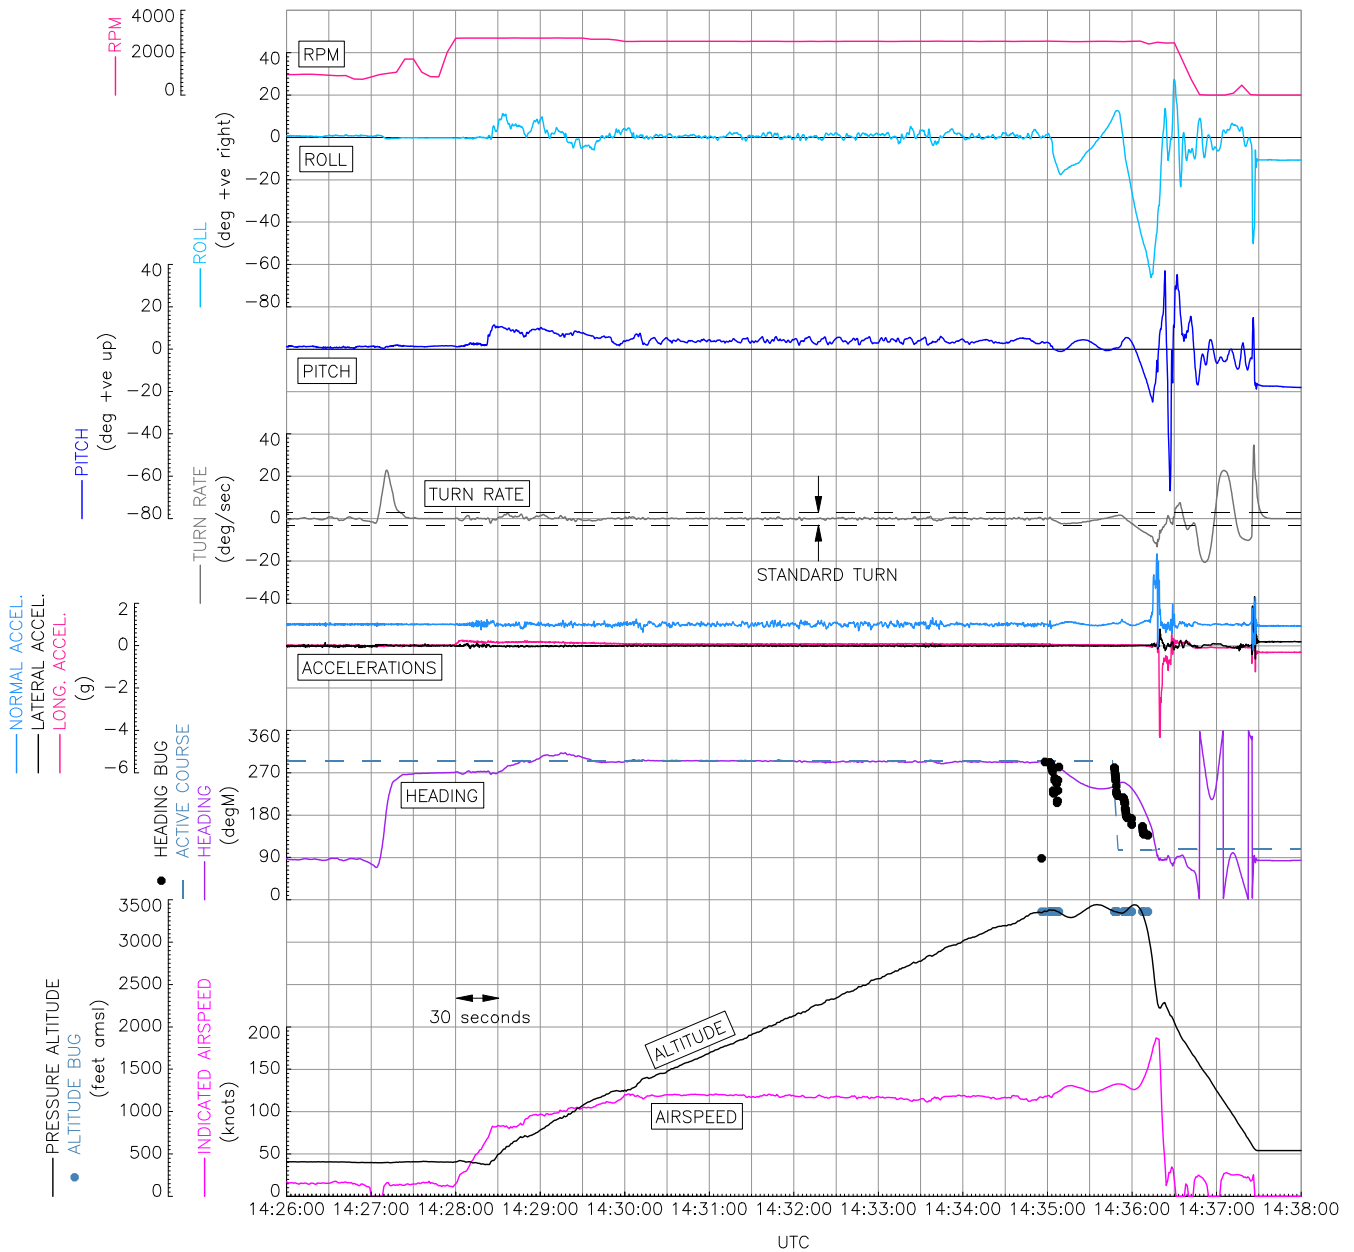
Figure 2 shows that between 1430:30 hrs and 1434:30 hrs, the aircraft was climbing at a constant 400 ft/min on a heading of 295°M. The recorded engine speed was 2,530 rpm and the indicated airspeed

120 kt, reducing to 115 kt. The aircraft then began to level off. 25 seconds later, at 1434:55 hrs, the aircraft reached 3,360 ft amsl and this altitude was selected on the altitude bug. During the next 75 seconds of flight the data is smoother than data recorded up to this point. The recorded data covering this portion of the flight is presented in more detail in Figure 3, which includes the

Salient recorded parameters from the PFD and MFD showing the whole flight

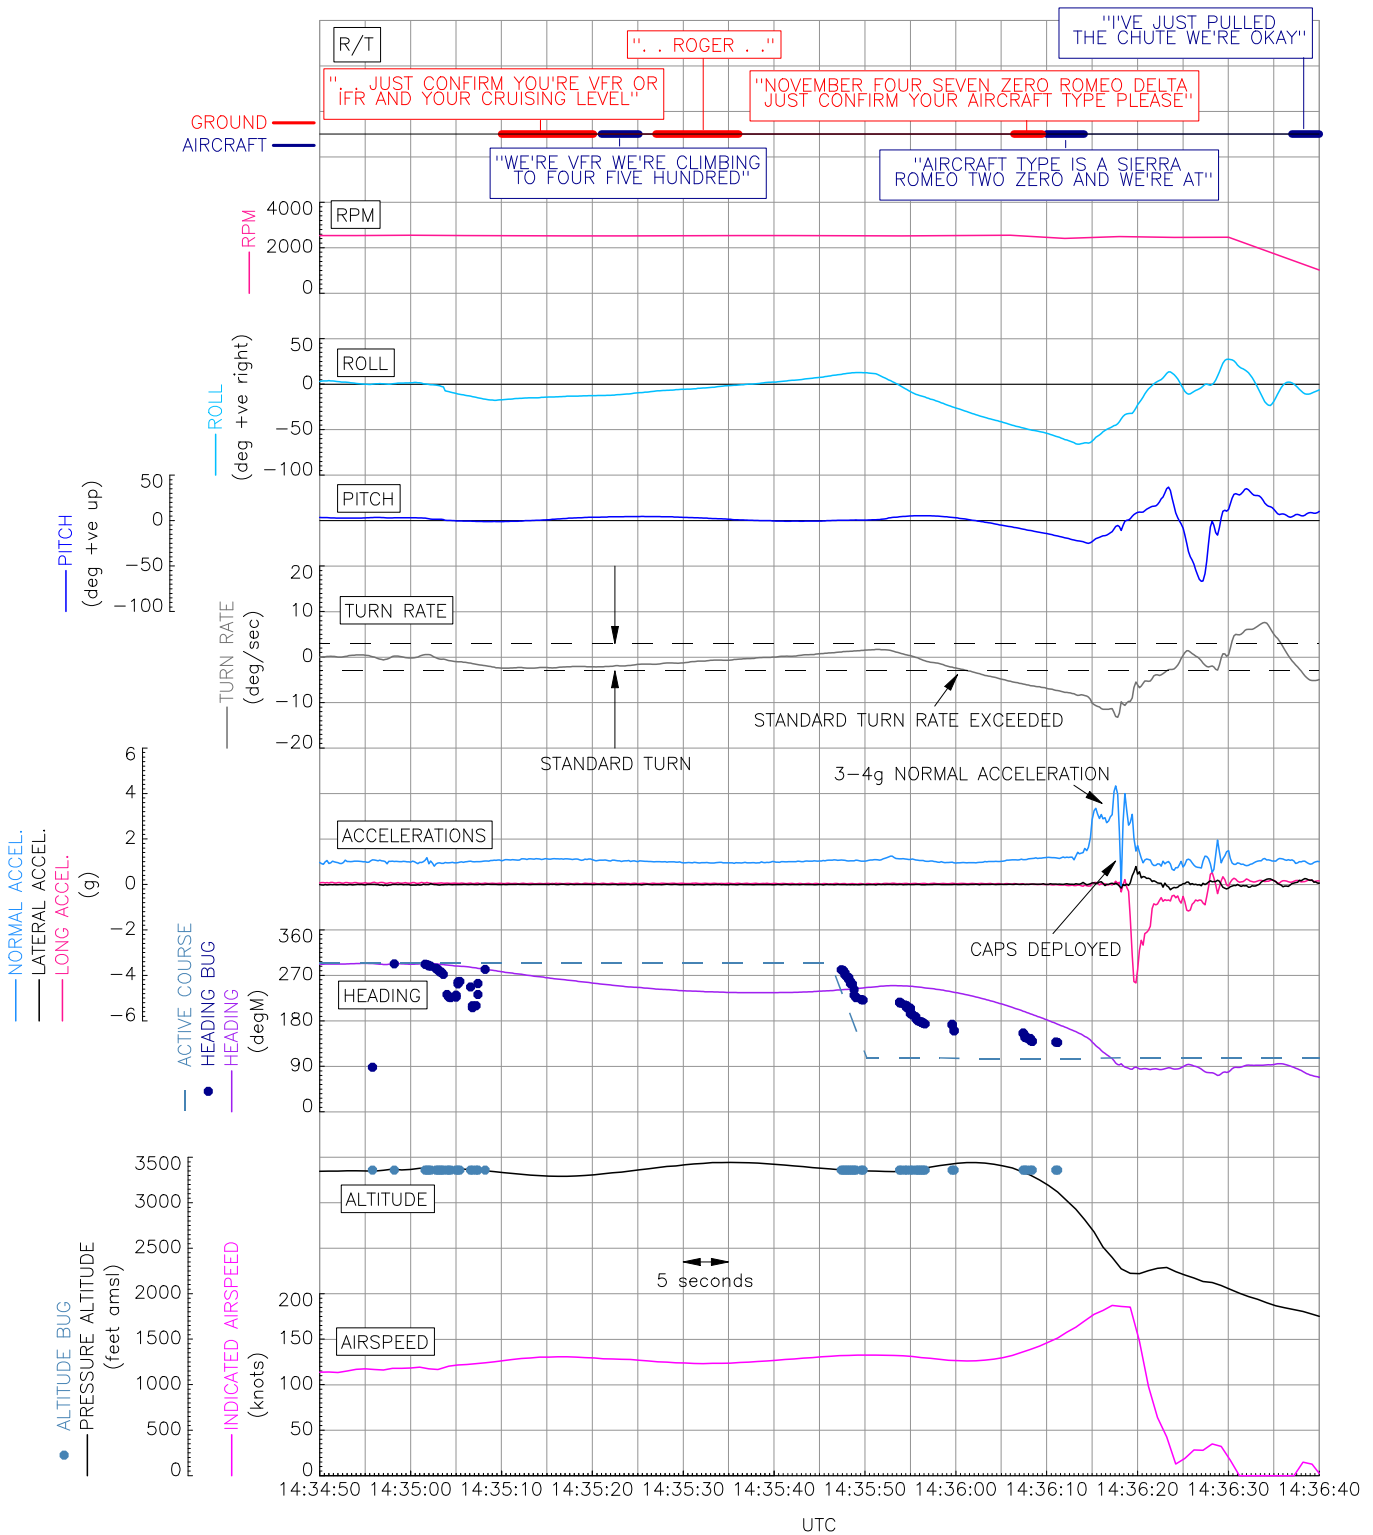
Between times 1434:55 hrs and 1436:15 hrs, the aircraft’s flight path and attitude were not stable.

The altitude climbed gradually by about 50 ft while oscillating two and a half times through  $\pm 75$  ft, with corresponding oscillations in pitch ( $\pm 3^\circ$ ) and airspeed ( $\pm 5$  kt and increasing by 10 kt). The roll was less oscillatory (and also not in phase with the pitch oscillations), initially rolling to  $18^\circ$  left wing down then to  $13^\circ$  right wing down, and then to the left again.

**Figure 3**  
Salient recorded parameters from the PFD and MFD from top of climb to the CAPS deployment

A corresponding heading change can be seen as the aircraft initially turned to the left from 295°M through 50°, at less than the standard turn rate of 3°/sec. As the aircraft started to turn there were a number of changes to the heading bug over a period of seven seconds. On reaching 235°M in the left turn, the aircraft started a similarly gentle turn to the right through 15° during which the active course changed from 295°M to 197°M. The heading bug also changed in stages to 221°M. The aircraft then started another turn to the left, during which the turn rate exceeded the standard value and continued to increase. A similar divergence was recorded in the aircraft's attitude as it banked left and pitched down, with increasing airspeed and loss in altitude. Further heading bug changes were recorded, to a final value of 137°M.

At 1436:13 hrs, as the bank angle reached 66° left wing-down and the pitch 25° nose-down, there was a sharp rise in the normal acceleration from a nominal 1g to 3g, and then to 4g two seconds later, consistent with recovery from a developing spiral dive. A review of the recorded data made by the aircraft manufacturer confirmed that from 1436:17 hrs, the aircraft's flight profile and dynamics were consistent with the CAPS having been deployed. At the time of deployment (1436:17 hrs) the aircraft's altitude and airspeed were 2,400 ft amsl and 187 kt, respectively. The pitch attitude was 9° nose-down and aircraft was banked 45° to the left.
