**ACCIDENT**

<b>Aircraft Type and Registration:</b>	Socata TB10 Tobago, G-CFME	
<b>No &amp; Type of Engines:</b>	1 Lycoming O-360-A1AD piston engine	
<b>Year of Manufacture:</b>	1996 (Serial No: 1795)	
<b>Date &amp; Time (UTC):</b>	30 September 2013 at 1051 hrs	
<b>Location:</b>	11 nm south-east of Bristol International Airport	
<b>Type of Flight:</b>	Private	
<b>Persons on Board:</b>	Crew - 1	Passengers - None
<b>Injuries:</b>	Crew - 1 (Fatal)	Passengers - N/A
<b>Nature of Damage:</b>	Aircraft destroyed	
<b>Commander's Licence:</b>	Private Pilot's Licence	
<b>Commander's Age:</b>	66 years	
<b>Commander's Flying Experience:</b>	332 hours (of which 34 were on type) Last 90 days - 9.5 hours Last 28 days - 3 hours	
<b>Information Source:</b>	AAIB Field Investigation

**Synopsis**

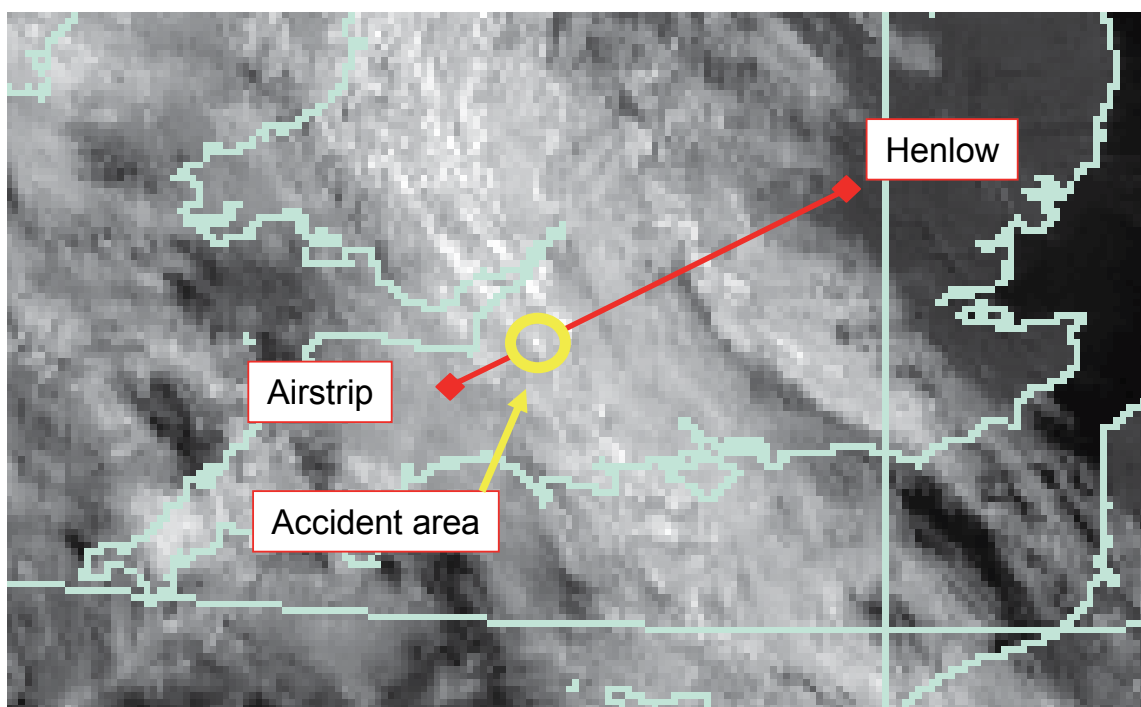
**Figure 1**

Surface analysis charts indicated that the accident area was subject to a light to moderate east to south-easterly airflow, with a weakening warm front moving north-east across the area during the morning. Infra-red and visible satellite images showed thick frontal cloud over southern Wales and central southern England. Figure 1 shows a visible spectrum satellite image taken about the time of the accident.

High Resolution Visible Spectrum Satellite Image  
30 September 2013 at 1100 hrs UTC

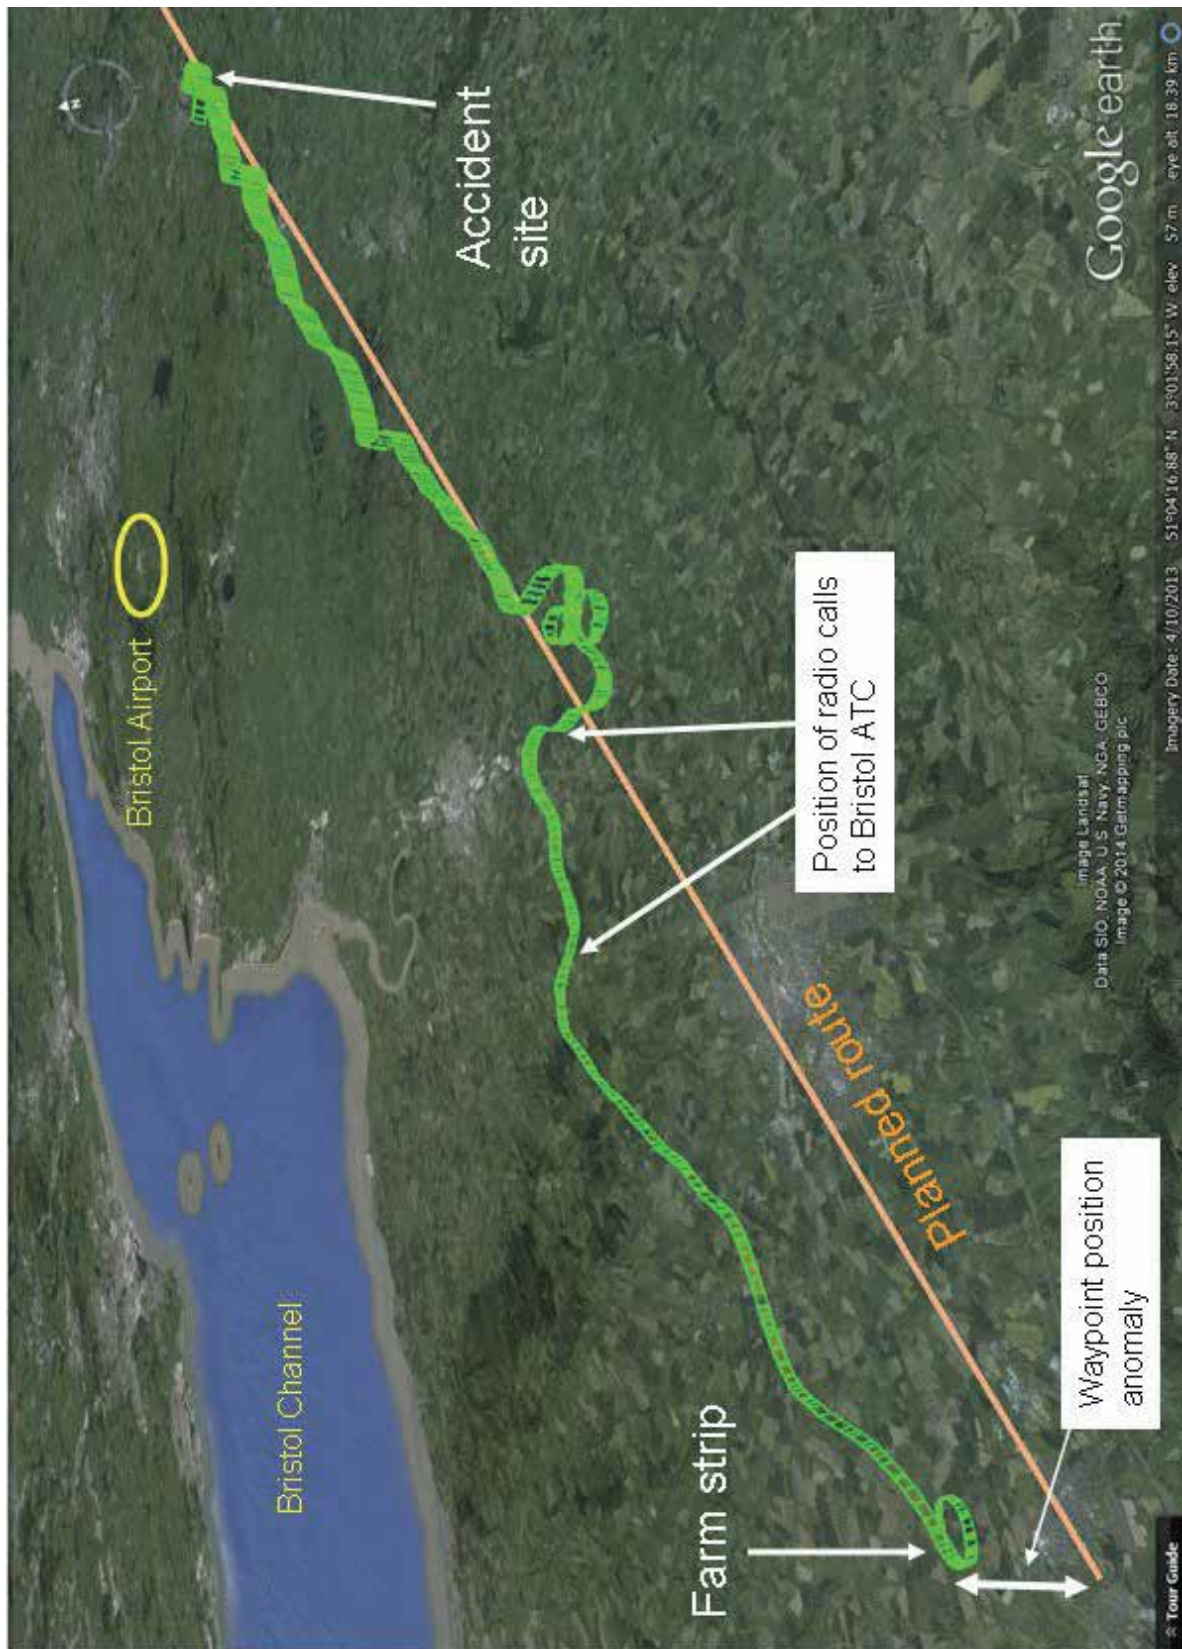
The planned route was from Henlow to the farm strip, ie applicable to the outbound flight. The application allowed the planned route to be reversed by the user, thus generating navigation data relevant to the return flight to Henlow. However, this had not been done (otherwise the route would have been modified to reflect the change). The route would still have been depicted on the tablet's display and could have been followed by the pilot, although associated navigation data (time and distance to destination) would have been inaccurate. The route contained an anomaly in that it did not go direct to the farm strip, but to a waypoint 1.7 nm south of it, over the town of Wellington. This manually-entered waypoint was labelled with the name of the farm, but its position appears to have been input incorrectly. Part of the planned route is shown in Figure 2.

The aircraft took off at 1023 hrs. Instead of converging on the planned route after takeoff as would be expected, the observed track continued to deviate northwards from it until the aircraft was about 8 nm from the farm strip (Figure 2). At range 10 nm, the aircraft turned right through about 150° before flying across the planned route and reversing course again to follow its direction, this time to the south of it. The aircraft then entered a 'figure of eight' manoeuvre before turning to establish on the planned route. There were further deviations from the route but, within 5 nm of the accident site, the position remained within 0.5 nm of it.

**Figure 2**  
Planned route line and GPS track (oblique view)

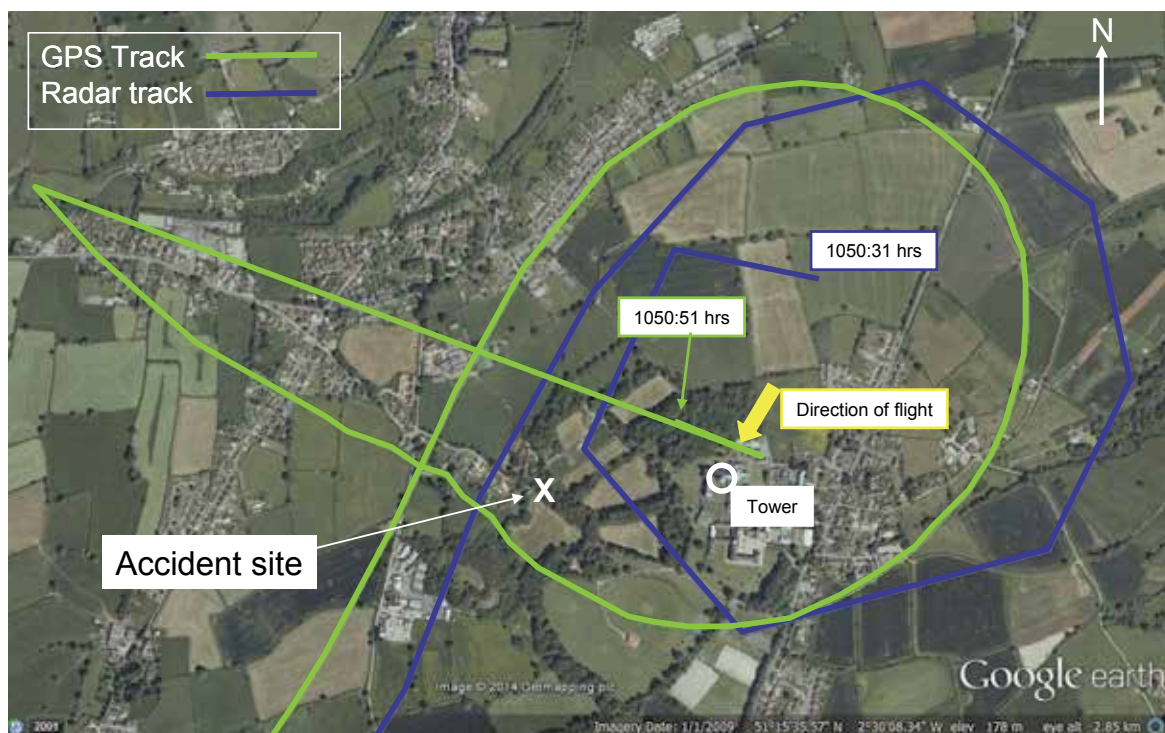
**Figure 3**

Figure 3 shows a combination of the GPS position data and radar derived data. Also shown are the times of the last position points, the direction the aircraft was travelling before it took action to avoid the tower, and the accident site. The discrepancy between the tracks is due to the radar positional accuracy, recording rate and the low level coverage.

The aircraft started a right turn in the accident area, and started to descend. After about 270° of turn, it had descended to about 2,300 ft (about 1,700 ft agl). From this point, the GPS appears to have suffered from signal blanking again, as the recorded position began to deviate from the radar data and became unreasonable. Radar data shows the aircraft continued in its right turn, eventually turning through about 450° before radar returns ceased at 1050:31 hrs, 500 m from the aircraft's last observed position. The GPS data ends with 12 data points which occur at short intervals over a 12 second period, ending at 1050:51 hrs. The positions of these data points are unreliable, but all occur within 170 m of the last position reported by eyewitnesses.

GPS and radar tracks for the final stages of the flight
