ACCIDENT

Aircraft Type and Registration:	Cessna 208B Caravan, G-BZAH	
No & Type of Engines:	1 Pratt & Whitney Canada PT6A-114A turboprop	
Category:	1.2	
Year of Manufacture:	2000	
Date & Time (UTC):	4 November 2004 at 1600 hrs	
Location:	Netheravon Airfield, Wiltshire	
Type of Flight:	Private	
Persons on Board:	Crew - One	Passengers - One
Injuries:	Crew - None	Passengers - None
Nature of Damage:	Damage to lower forward fuselage structure and nose landing gear spring fairing	
Commander's Licence:	Commercial Pilot's Licence	
Commander's Age:	60 years	
Commander's Flying Experience:	10,600 hours (of which 627 were on type) Last 90 days - 91 hours Last 28 days - 35 hours	
Information Source:	AAIB Field Investigation

Synopsis

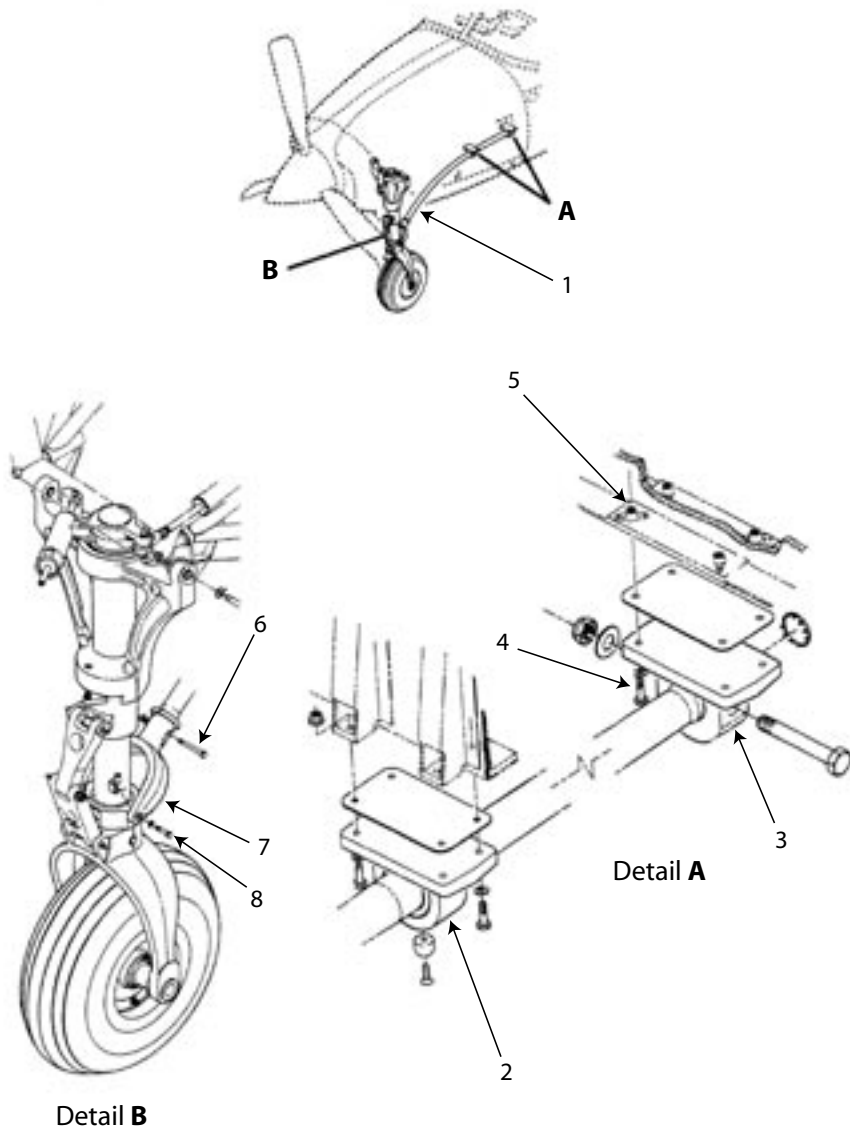
Figure 1

The NLG spring (Figure 1, item 1) is attached to the fuselage by a forward support (Figure 1, item 2) and a rear support (Figure 1, item 3). Each of these spring supports are secured to the fuselage structure by four

attachment bolts that are tightened to 50 foot-pounds torque. The four rear support attachment bolts (Figure 1, item 4) are assembled into self-locking anchor nuts (Figure 1, item 5) mounted within the fuselage structure. One of these four attachment bolts had failed leaving the threaded portion located within the anchor nut. The unthreaded shank section of the bolt was never recovered. The other three attachment bolts were found lying loose within the composite fairing fitted below the forward and rear spring supports.

Diagram of the nose landing gear

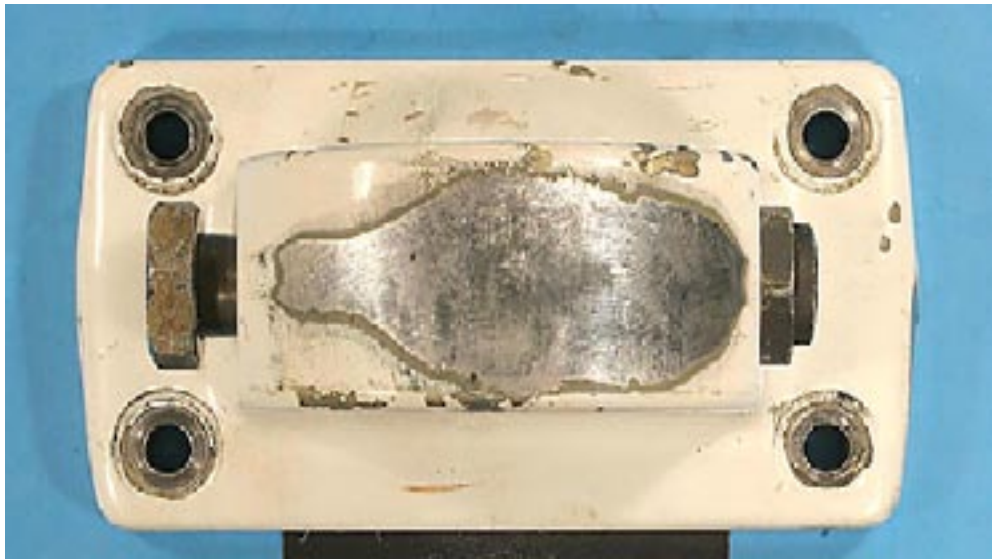
Figure 5

Examination of the lower surface of the NLG rear spring support casting (Figure 1, item 3) showed paint loss

and polishing of the metal (Figure 5). This polishing was in a fore/aft direction. Examination of the inside surface of the composite fairing, which was mounted directly below this support, showed similar rubbing and polishing that had been caused by contact with the lower surface of the support.

Polishing effect on the bottom of the nose landing gear spring rear support

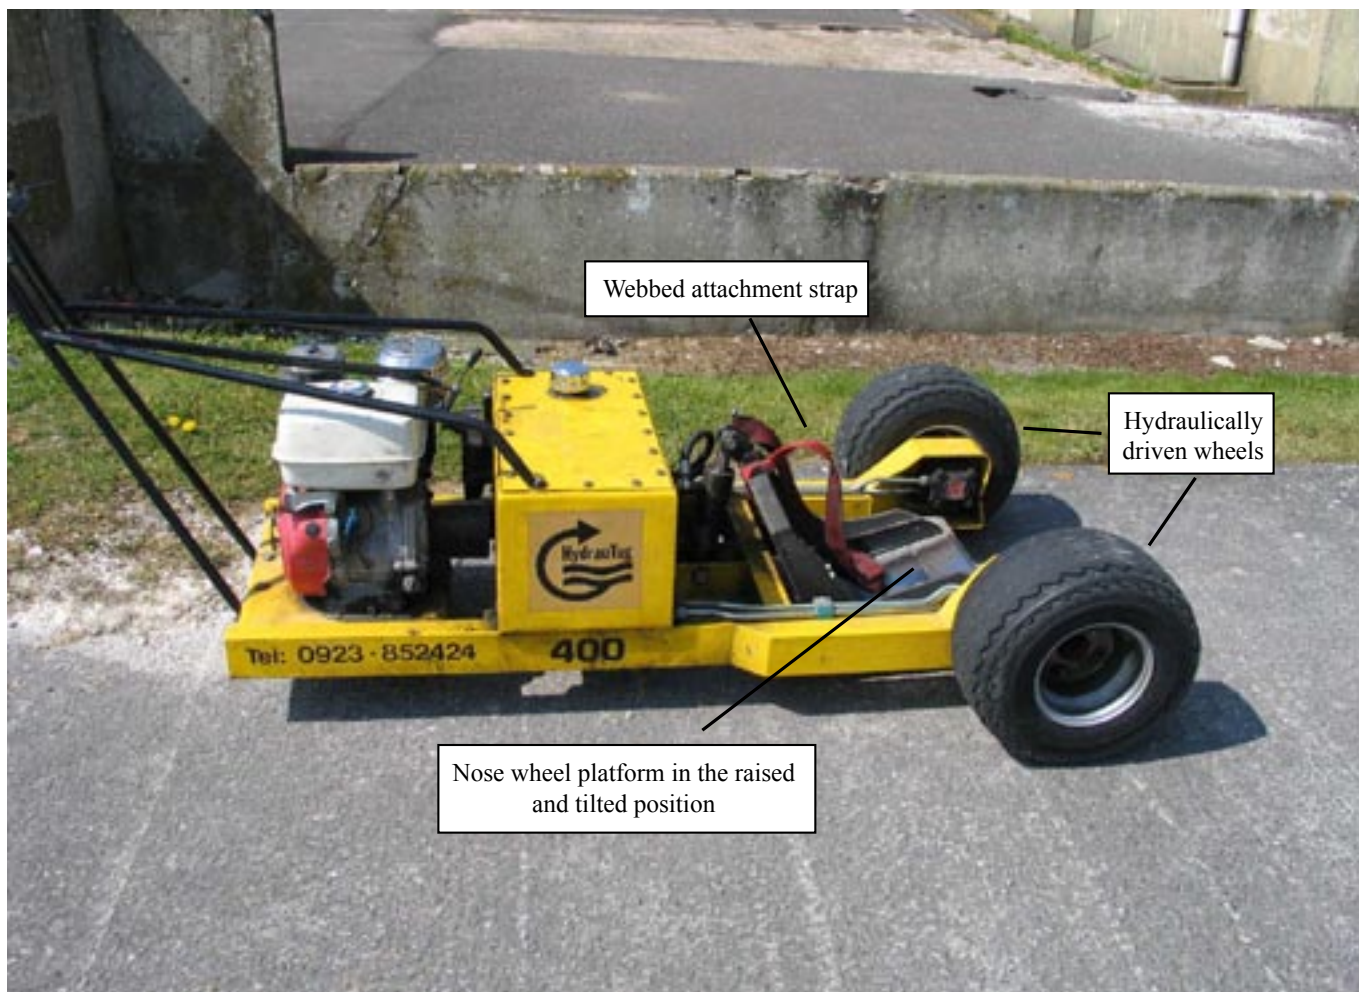
Figure 6

The Hyrau Tug 400

During a visit to the operator's base by the AAIB investigator it was found to be very easy for an inexperienced tug operator to introduce quite a severe 'snatch' when initiating movement of the tug.

It is recommended that the UK Civil Aviation Authority should ensure that all UK aircraft and airport operators utilising powered aircraft towing equipment define and implement towing procedures that ensure the aircraft manufacturer’s published towing load limits are not exceeded.
