INCIDENT

Aircraft Type and Registration:	DHC-8-311, G-WOWA	
No & Type of Engines:	2 Pratt & Whitney Canada PW123 turboprops	
Year of Manufacture:	1992	
Date & Time (UTC):	31 December 2006 at 1250 hrs	
Location:	Newquay (Cornwall) Airport	
Type of Flight:	Commercial Air Transport (Passenger)	
Persons on Board:	Crew - 3	Passengers - 51
Injuries:	Crew - None	Passengers - None
Nature of Damage:	Frangible fairing on 'touched runway' sensor broken, light abrasion damage to underside of rear fuselage	
Commander's Licence:	Air Transport Pilot's Licence	
Commander's Age:	49 years	
Commander's Flying Experience:	7,250 hours (of which 574 were on type) Last 90 days - 48 hours Last 28 days - 21 hours	
Information Source:	Aircraft Accident Report Form submitted by the pilot and Quick Access Recorder information

Synopsis

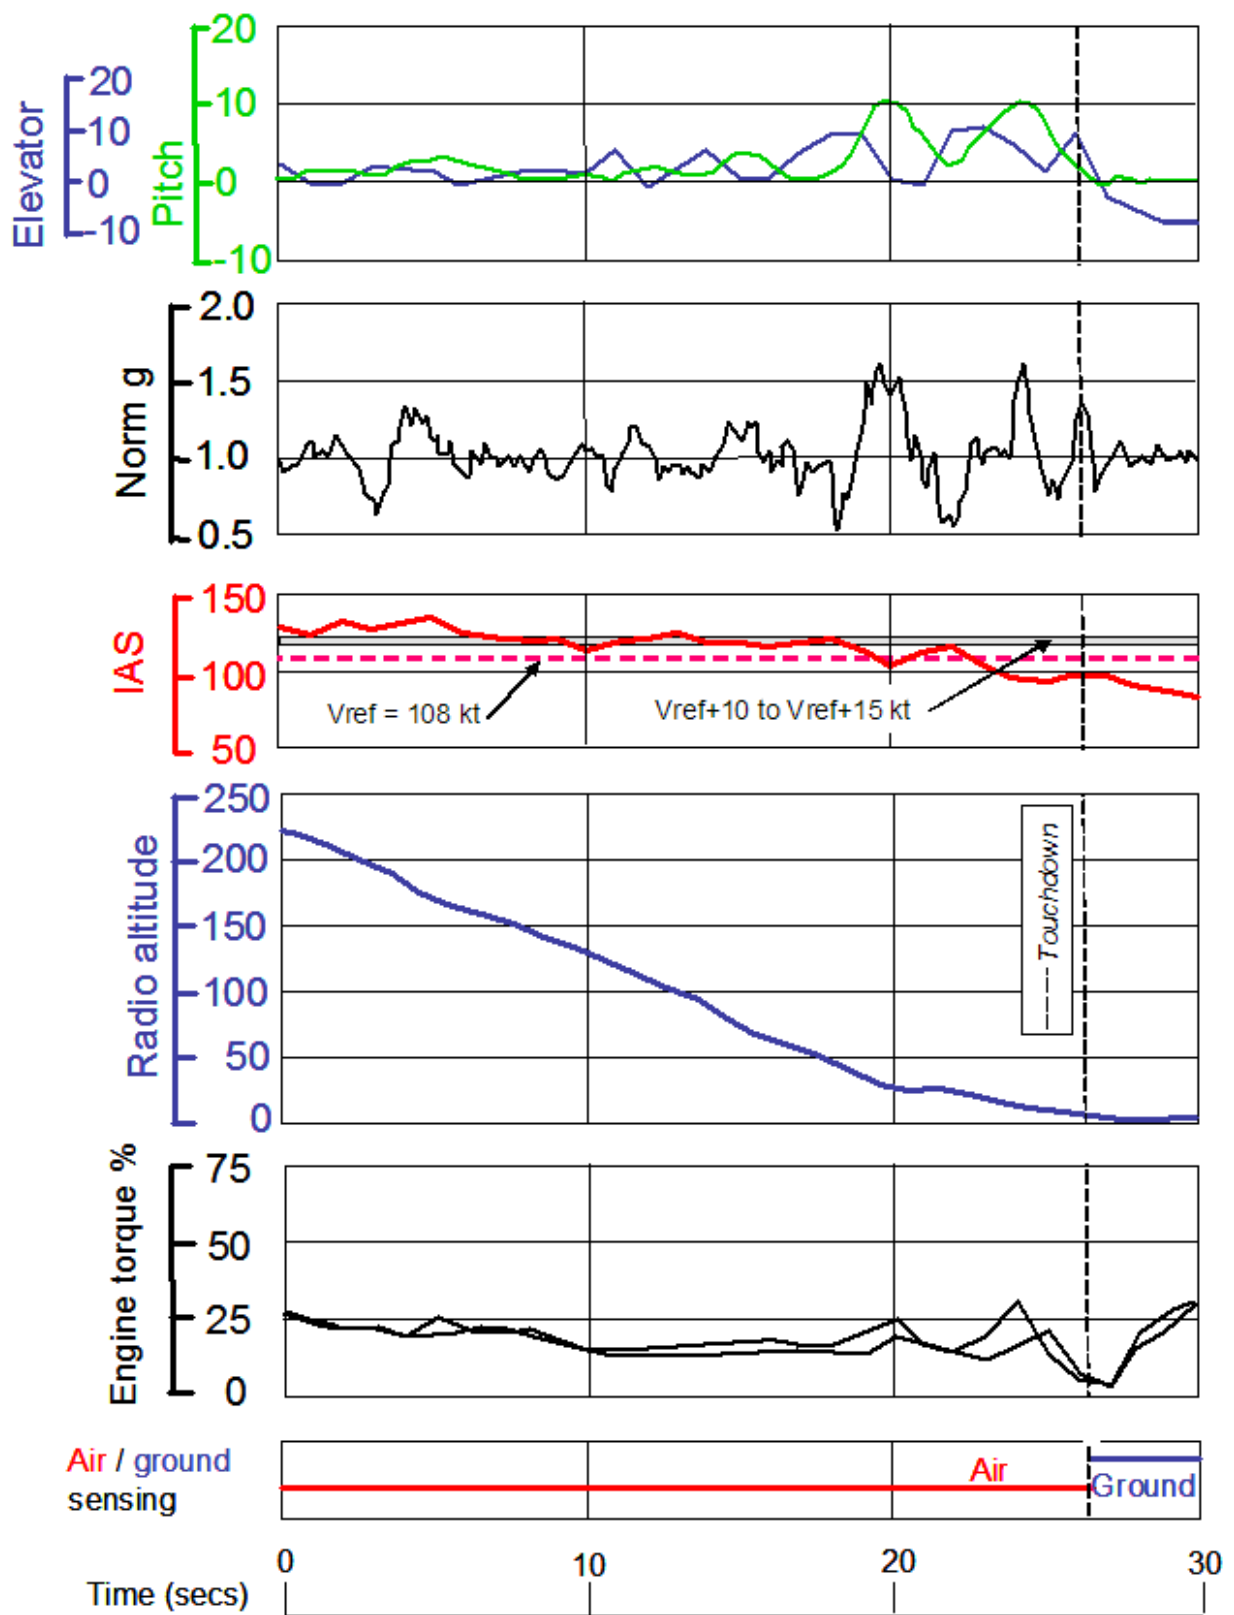
Figure 1
Relevant flight data parameters

The relevant recorded parameters for the latter stages of the approach are shown at Figure 1. As the aircraft descended on final approach, the speed remained at or above the 118 to 123 kt band ($V_{REF}+10$ to $V_{REF}+15$ kt) with a pitch attitude of between 2° and 3°. From about 16 seconds before touchdown, the flight data showed increasing pitch excursions which were countered by elevator input. The recorded pitch and elevator signals became out of phase, and both increased in amplitude as the aircraft continued its descent. This divergence culminated in two significant pitch excursions, at 6 and 2 seconds before touchdown. In the first case, the pitch attitude reached a maximum of 10.5° at a radio altitude of 24 ft, even after a significant corrective nose-down elevator input had been made. The pitch attitude then reduced to between 2° and 3° momentarily, before increasing again to reach 10.6°, at a recorded radio altitude of 11 ft.

During the first significant pitch excursion, the airspeed dropped to 105 kt ($V_{REF} - 3$ kt), before recovering somewhat as the pitch attitude reduced. The airspeed then showed an overall downward trend for the remainder of the landing phase, reducing to 94 kt ($V_{REF} - 14$ kt) at the peak of the second pitch excursion, just prior to the landing. The touchdown itself was recorded with a pitch attitude of 2° to 3° and an airspeed of 98 kt, and the pitch attitude at the point of touchdown was decreasing at a rate of about 5° per second. The peak normal acceleration at touchdown was 1.2 g, which was less than that associated with the two previous pitch excursions (about 1.4 g).

Engine torques remained steady as the aircraft neared the runway, but increased in response to the loss of airspeed associated with each pitch-up event. The maximum torque recorded by either engine below 100 ft was 31.2%. Pitch trim was in use during the approach, varying between 2.7 and 3.8 units of applied trim. During the final 200 ft the pitch trim remained steady at 3.1 units.

The flight data showed that a stable approach was achieved initially, but that this became unstable at a late stage, probably due to a combination of the gusty conditions and the associated large control inputs. During the final stage of the approach the airspeed decayed to 94 kt, significantly below both V_{REF} and the target approach speed.

The significant downdraught reported by the commander below 100 ft is likely to be associated with the observed pitch excursion at about 24 ft, and the consequent loss of airspeed. Although some engine thrust was added to counter the speed loss, this was not effective and, after a brief recovery, the speed continued to decay until touchdown. It was during the second pitch excursion, shortly before main wheel touchdown, that the tail most probably contacted the runway. The flight data supports the commander's recollection that the touchdown itself was not at an exaggerated pitch attitude.
