ACCIDENT

Aircraft Type and Registration:	DA 42 Twin Star, G-SUEA	
No & Type of Engines:	2 Thielert TAE 125-02-99 piston engines	
Year of Manufacture:	2007	
Date & Time (UTC):	20 January 2009 at 1457 hrs	
Location:	Lands End Aerodrome, Cornwall	
Type of Flight:	Private	
Persons on Board:	Crew - 1	Passengers - 2
Injuries:	Crew - 1 (Minor)	Passengers - 2 (Minor)
Nature of Damage:	Substantial damage to forward fuselage and propellers	
Commander's Licence:	Private Pilot's Licence	
Commander's Age:	47 years	
Commander's Flying Experience:	1,315 hours (of which 62 were on type) Last 90 days - 38 hours Last 28 days - 10 hours	
Information Source:	AAIB Field Investigation

Synopsis

The aircraft overturned on soft ground beyond the airfield boundary following a rejected takeoff. The takeoff distance available was less than that required by the aircraft under the prevailing conditions to become safely airborne.

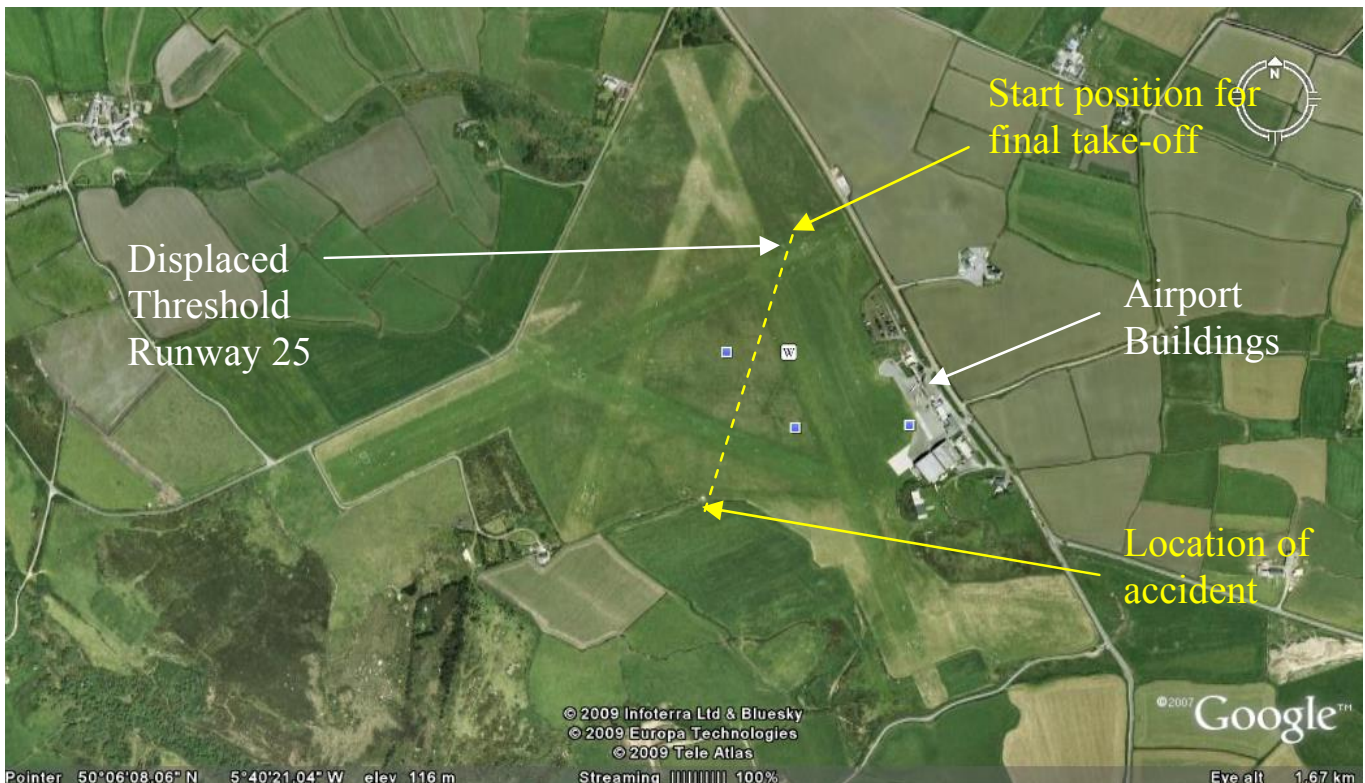
Figure 1
Lands End Airfield

The AFS then towed the aircraft to the right side of Runway 25, adjacent to the normal threshold, Figure 1. The pilot reported that he thought his location was closer to the airport buildings and on the left side of Runway 25. He then attempted to take off. His plan was to track alongside Runway 25, displaced to the left, which he felt was firmer ground than on the runway itself. As power was increased, the aircraft accelerated. The pilot was closely monitoring the airspeed, hoping to reach 70 kt in order to be able to lift off. However, at around 46 kt he reported a “pull to the left” and became aware of the L ECU A FAIL caption being illuminated. He then retarded the throttles and aborted the takeoff.

The wheel marks on the airfield indicated that the aircraft had followed a straight track in a direction of approximately 200° from its start location on the right side of Runway 25. It had covered approximately 350 m when it crossed the airfield boundary and entered a ploughed field. The aircraft immediately nosed over in the very soft ground, coming to rest inverted.

The ground actually traversed by G-SUEA was from the threshold of Runway 25 to its final position beyond the airfield boundary, between the thresholds of Runways 02 and 34. The elevation at the accident location was approximately 384 m, giving a very slight downslope from the threshold elevation of 389 m of Runway 25.
