**AAIB Bulletin No:** 4/95

**Ref:** EW/G95/02/03

**Aircraft Type and Registration:** ARV 1 Super 2, G-BSRK

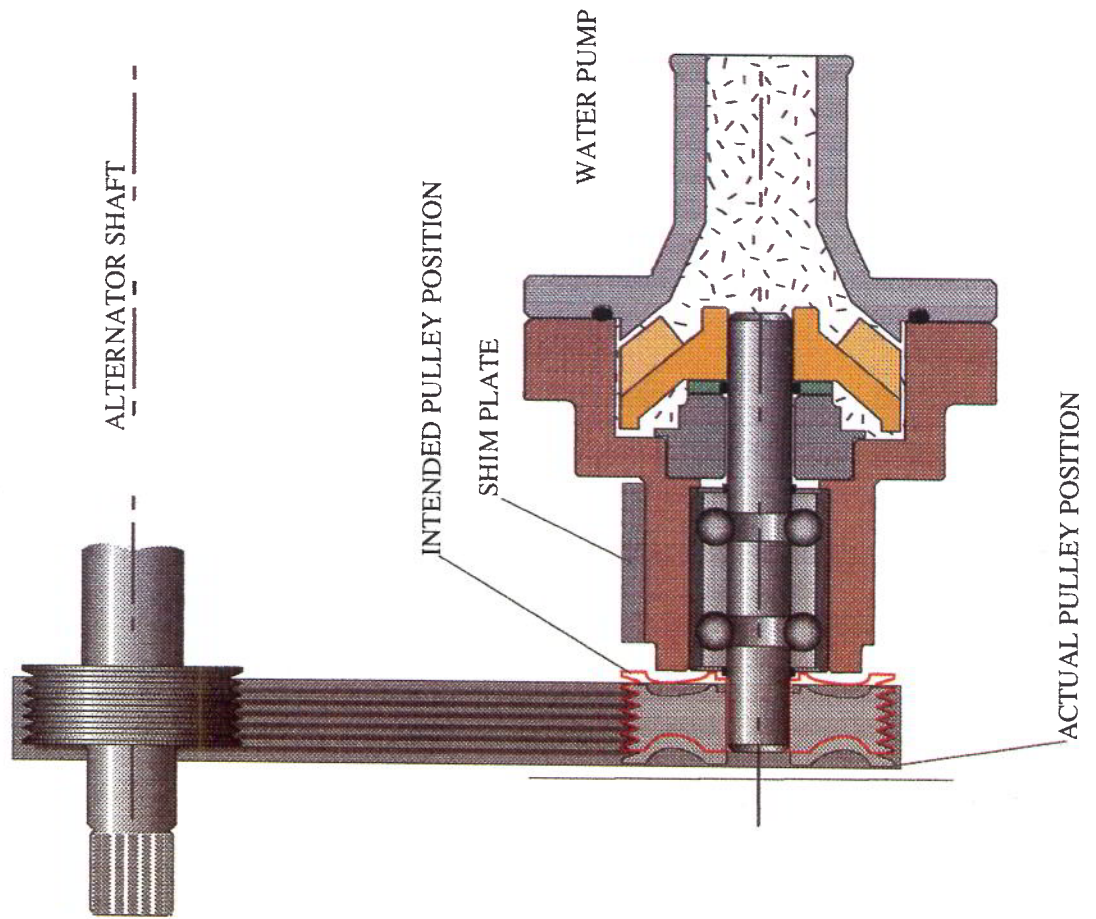
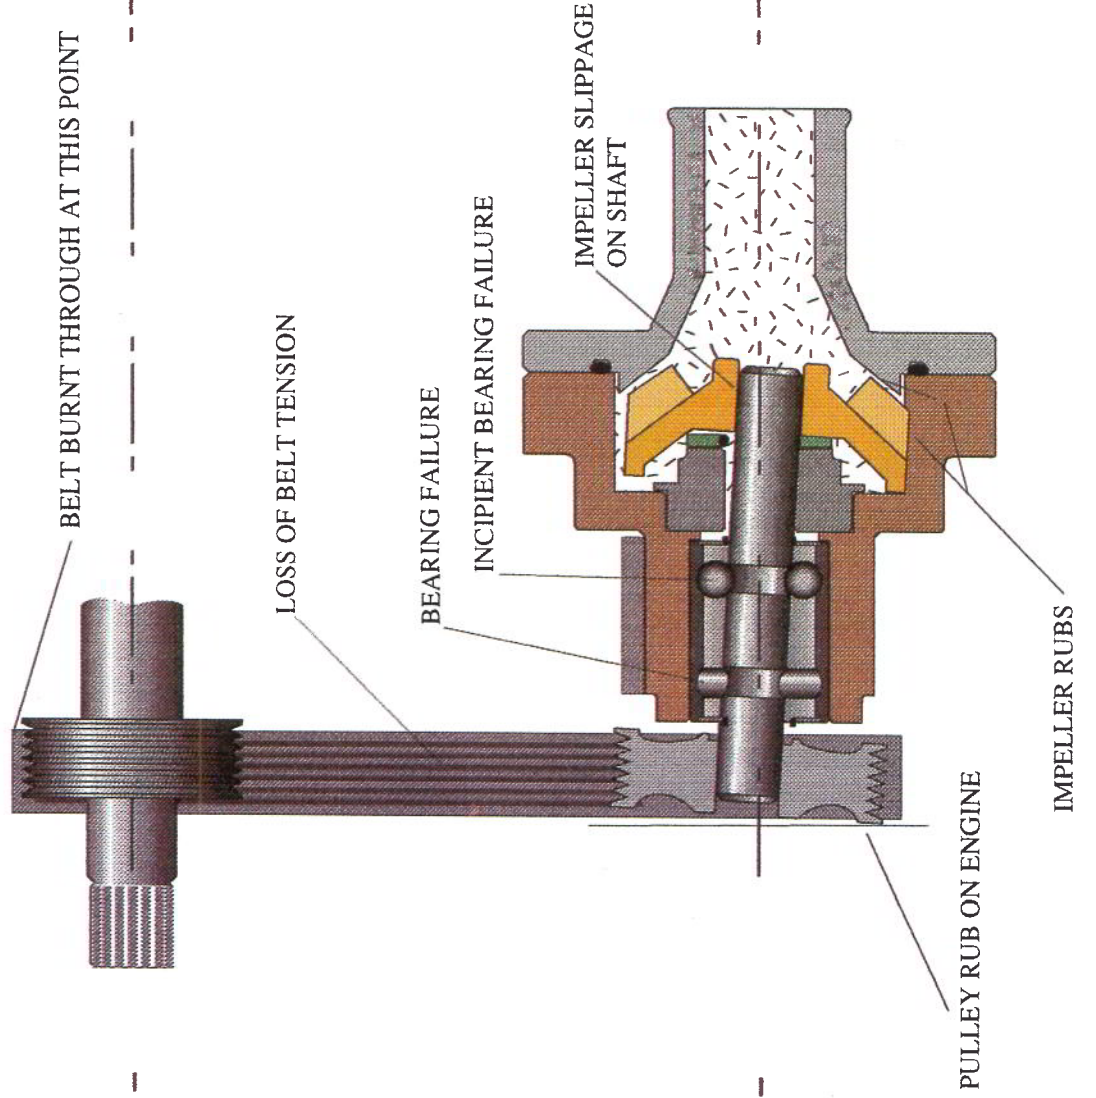
FIGURE 1

When the water pump was examined generally and compared with assembly instructions and drawings, it became apparent that the drive pulley had not been correctly positioned onto the shaft. It was a requirement that the pulley should be flush with the end of the shaft, a position that would place it close to, but not binding against, the pump body and ensure its correct alignment with the drive pulley on the alternator shaft. The pulley is a press fit onto the shaft and, as found, it was apparent

that it had been pressed insufficiently far onto the shaft by approximately 0.2 inch. This had the effect of misaligning the drive belt onto the drive pulley such that it had been running one groove displaced, as indicated in Figure 1. The pulley was tight on the shaft and witness marks indicated that it had never been correctly located. Collapse of the bearing had several effects; to allow the pulley rim to contact and probably jam against the rear of the engine, to permit the impeller to rub against both the housing and water inlet fitting and loss of belt tension due to reduction in pulley centre distance. The belt itself had failed by being burnt through/eroded at one location whilst stationary by the rotating alternator shaft pulley. Evidence of the rubber dust at this location and rubber deposits in five of the six pulley grooves is shown in Figure 3.

AS INSTALLED CONDITION PRIOR TO BEARING FAILURE

EFFECT OF BEARING FAILURE

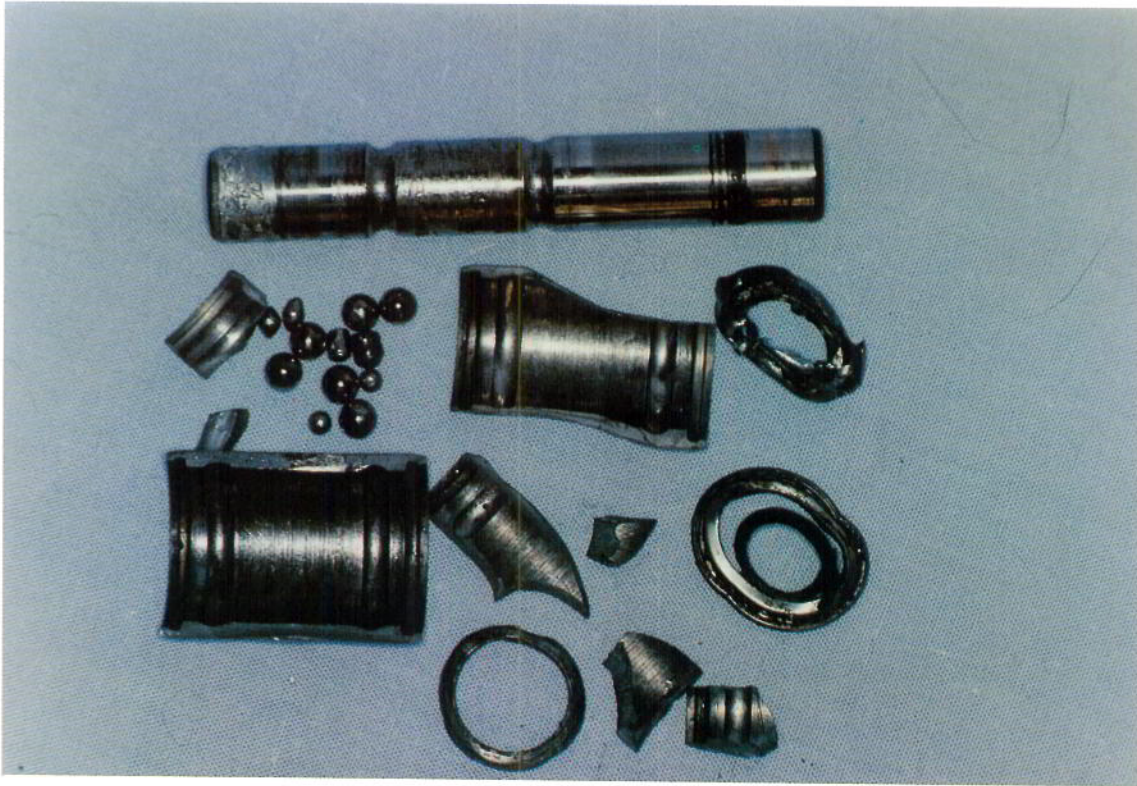
FIGURE 2

Detailed examination of the shaft and outer sleeve showed that they were only lightly greased and that the grease was in reasonable condition. The outer and inner raceways at both ends of the bearing assembly had been damaged by impressed solid particles and wear. The outer raceway at the pulley end had been damaged to the extent that metallic 'burrs' were present around its rim. The balls from the impeller end bearing had all been temper-coloured to a mid straw colour and showed evidence of softening and damage where they had tracked in the raceways. The balls from the pulley end bearing, however, were much more heavily damaged. One of the six was generally temper-coloured to a dark straw shade with very small patches of blue and had been barrelled by softening and wear against the mating raceway. The remainder were excessively worn and distorted. This type of damage appeared an extension of that present on the balls from the impeller end bearing which, together with the condition of the grease and raceways, indicated that the damage had resulted from a local breakdown in lubrication caused by excessive bearing loads, but over a relatively short period of time. A general view of the dismantled bearing assembly is shown in Figure 2.

Bearing and Shaft Assembly. Sleeve broken open during examination.
