AAIB Bulletin No: 4/95

Ref: EW/G95/02/03

Aircraft Type and Registration: ARV 1 Super 2, G-BSRK

Nature of Damage: Damage to propeller, landing gear and forward fuselage

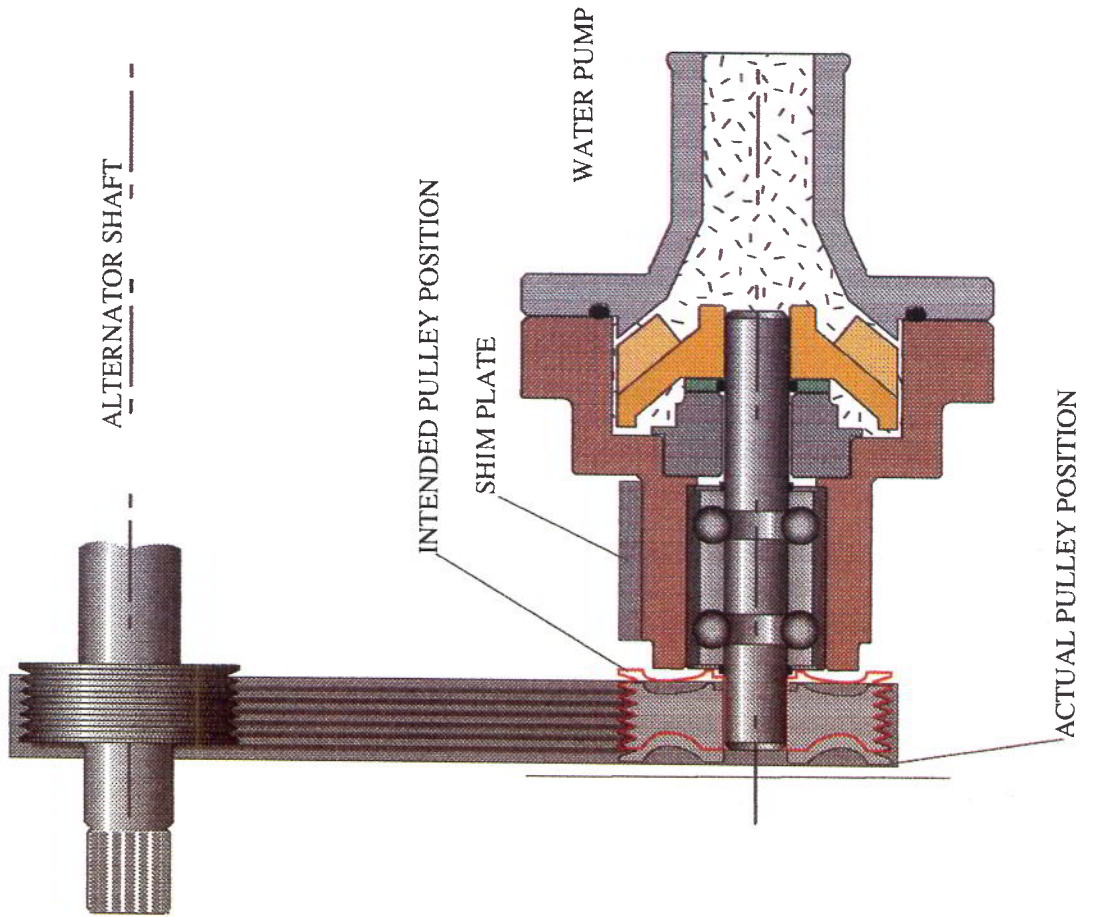
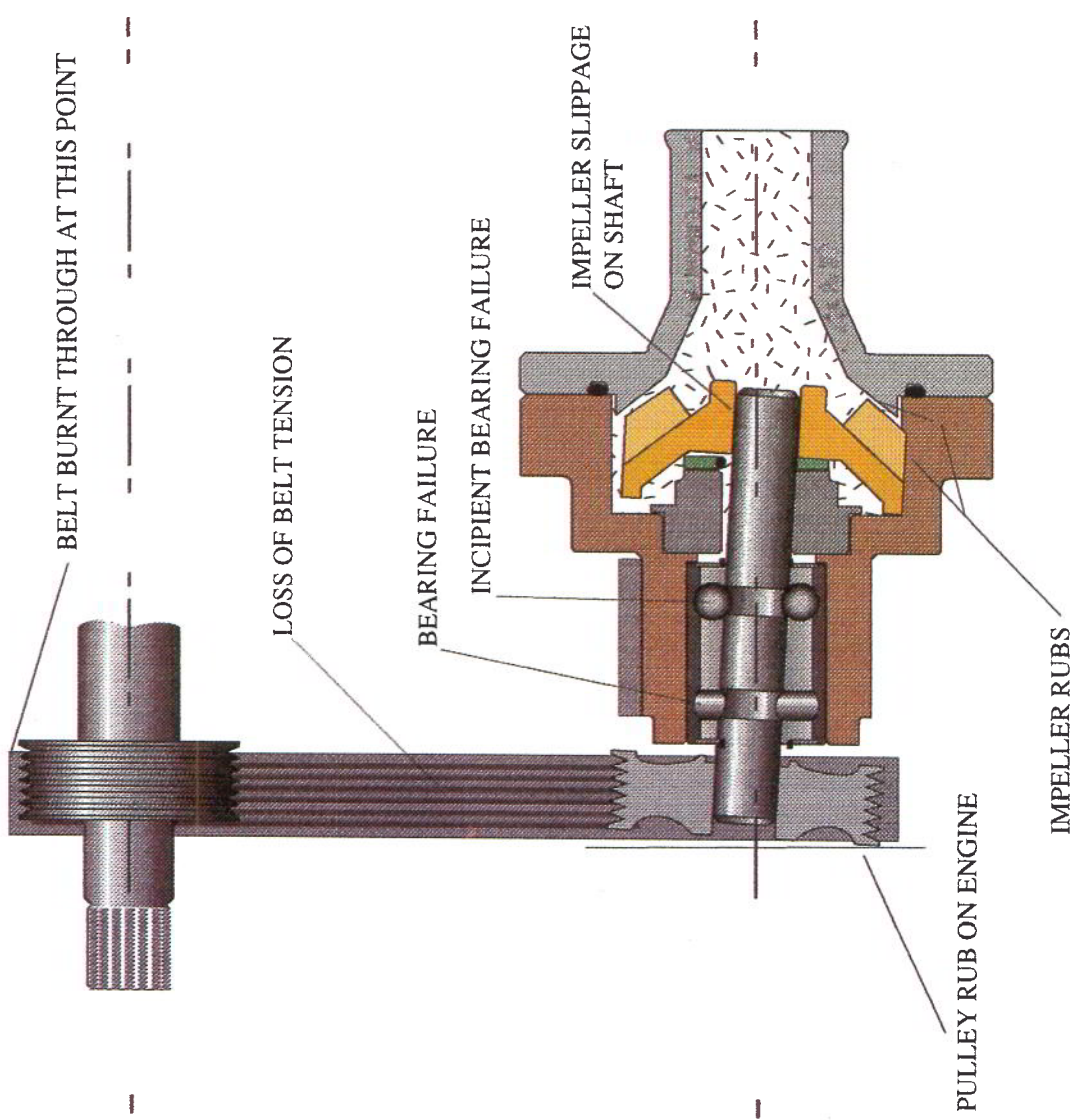
FIGURE 1

When the water pump was examined generally and compared with assembly instructions and drawings, it became apparent that the drive pulley had not been correctly positioned onto the shaft. It was a requirement that the pulley should be flush with the end of the shaft, a position that would place it close to, but not binding against, the pump body and ensure its correct alignment with the drive pulley on the alternator shaft. The pulley is a press fit onto the shaft and, as found, it was apparent

that it had been pressed insufficiently far onto the shaft by approximately 0.2 inch. This had the effect of misaligning the drive belt onto the drive pulley such that it had been running one groove displaced, as indicated in Figure 1. The pulley was tight on the shaft and witness marks indicated that it had never been correctly located. Collapse of the bearing had several effects; to allow the pulley rim to contact and probably jam against the rear of the engine, to permit the impeller to rub against both the housing and water inlet fitting and loss of belt tension due to reduction in pulley centre distance. The belt itself had failed by being burnt through/eroded at one location whilst stationary by the rotating alternator shaft pulley. Evidence of the rubber dust at this location and rubber deposits in five of the six pulley grooves is shown in Figure 3.

ARV SUPER 2 WATER PUMP INSTALLATION SCHEMATIC

AS INSTALLED CONDITION PRIOR TO BEARING FAILURE

EFFECT OF BEARING FAILURE
