No: 10/92

Ref: EW/A92/6/1

Aircraft Type and Registration: Boeing 747-283B, G-VOYG
No & Type of Engines: 4 Pratt and Whitney JT9D-7A turbofan engines
Year of Manufacture: 1971
Date & Time (UTC): 13 June 1992 at 0001 hrs
Location: Newark Airport, New Jersey, USA
Type of Flight: Public Transport (Scheduled passenger)
Persons on Board: Crew - 21 Passengers -245
Injuries: Crew - None Passengers -None
Nature of Damage: Damage to leading edge of inboard left wing
Commander's Licence: Airline Transport Pilot's Licence
Commander's Age: 45 years
Commander's Flying Experience: 10,100 hours (of which 5,000 were on type)
Information Source: AAIB Field Investigation

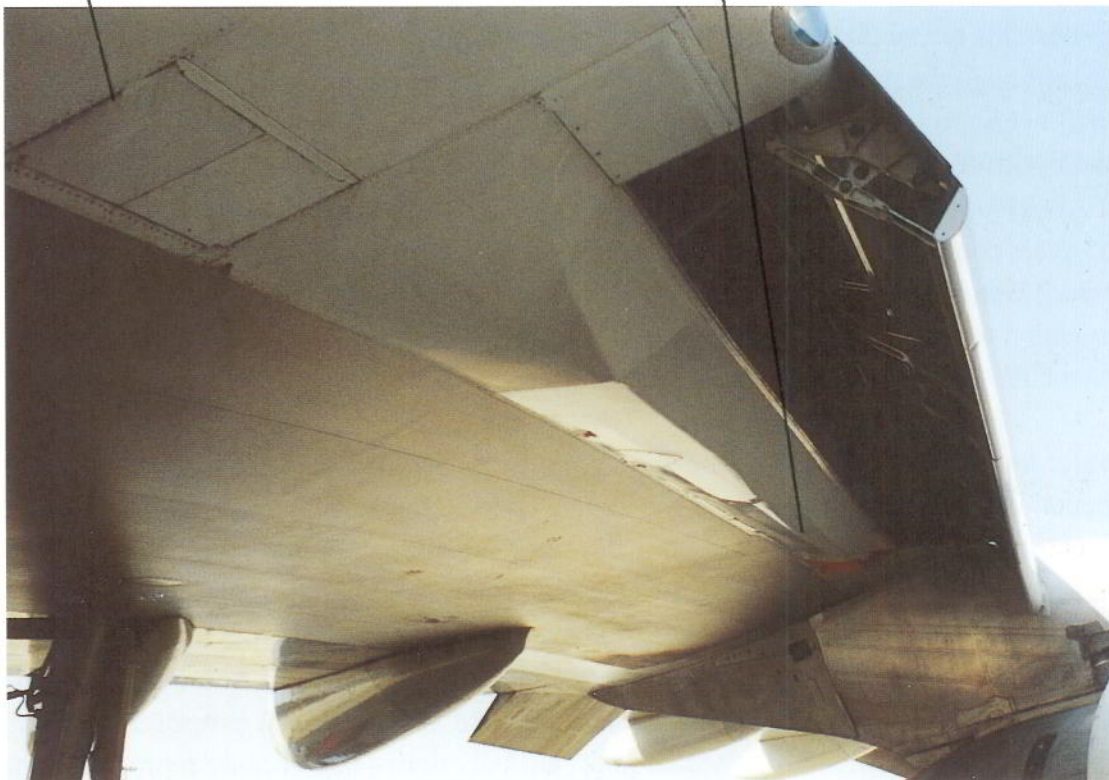
Subsequent examination of the aircraft revealed that the bleed air duct in the left wing, between the No 2 pylon and the fuselage, had failed circumferentially at a weld adjacent to a coupling, in the vicinity of the pylon. Extensive damage had occurred to the leading-edge honeycomb structure on the underside of the wing, and one panel on the upper leading-edge was distorted. The leading-edge structural members were also distorted, but there was no leading-edge flap damage, nor was there any apparent mechanical interference with the flap which might have prevented retraction. The pressure relief panel, which is located at the inboard leading-edge position, had not released (see photographs). The aircraft manufacturer has since advised that this panel is designed to release in the event of a relatively slow leak. Sudden failure of the duct can release volumes of bleed air sufficient to damage the structure before the relief panel can operate. Examination showed that the panel had been assembled using Thiokol, or similar sealant, instead of the specified RTV154 sealant. However the aircraft manufacturer advised that this factor had probably not contributed to the damage in this instance.

Pressure Relief Panel

VIEW ON INBOARD LEADING EDGE SHOWING COLLAPSE OF COMPOSITE PANEL AFT OF KRUGER FLAP

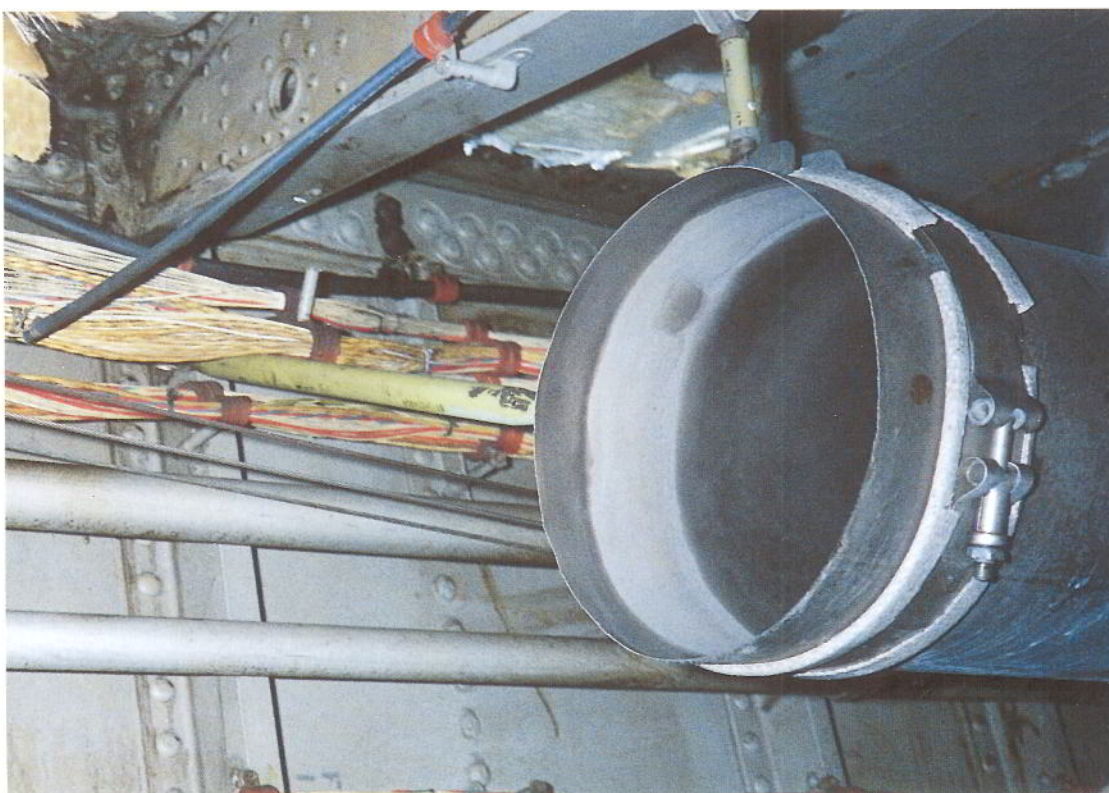
Metallurgical examination of the duct fracture surfaces showed that it had failed due to cracking from multiple origins on the duct inner surface, adjacent to the weld. Hydride formations were present and the metallurgical report concluded that the failure was similar to that described in Boeing Service Bulletin 747-36A2074, issued on 11 February 1988, and Revision 5 of 27 June 1991. This states "At duct operating temperatures of 300 to 350 degrees Fahrenheit, hydrogen in the titanium duct material tends to migrate towards areas of high stress, and then during cooling, hydrides form. These hydrides have an embrittling effect on the duct material and may contribute to crack initiation.....Studies indicate that stress relieving the ducts eliminates the residual stress and local stress concentrations which stops the migration of hydrogen to the circumferential welds." The Service Bulletin calls for dye penetrant inspections, pressure testing and stress relieving of the ducts. The requirements of the Service Bulletin had been made mandatory by FAA Airworthiness Directives 88-17-07 (superseded) and 91-06-08.

Region of duct failure

VIEW OF CIRCUMFERENTIAL FAILURE OF BLEED AIR DUCT AT WELD

- 92-80: The FAA should consider reducing the compliance timescale requirements of Boeing 747 bleed air duct inspection AD 91-06-08, particularly on those aircraft which have low utilisation and/or high life cycles, in order to prevent further duct failures and associated secondary damage.
