**ACCIDENT**

<b>Aircraft Type and Registration:</b>	Gemini Flash 2 Alpha microlight, G-MTJZ	
<b>No &amp; type of Engines:</b>	1 Rotax 503 piston engine	
<b>Year of Manufacture:</b>	1987	
<b>Date &amp; Time (UTC):</b>	11 July 2006 at 1100 hrs	
<b>Location:</b>	Field in Rocester, near Uttoxeter, Staffordshire	
<b>Type of Flight:</b>	Training	
<b>Persons on Board:</b>	Crew - 2	Passengers - None
<b>Injuries:</b>	Crew - None	Passengers - None
<b>Nature of Damage:</b>	Nosewheel collapsed and wing damaged	
<b>Commander's Licence:</b>	Private Pilot's Licence (Microlights) with Instructor Rating	
<b>Commander's Age:</b>	47 years	
<b>Commander's Flying Experience:</b>	670 hours (of which 120 were on type) Last 90 days - 60 hours Last 28 days - 19 hours	
<b>Information Source</b>	Aircraft Accident Report Form submitted by the pilot and further enquiries by the AAIB

**Synopsis**

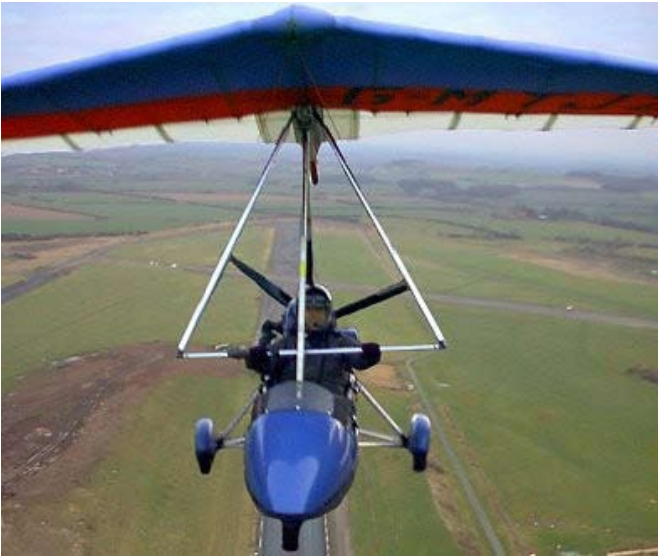
**Figure 1**

Gemini Flash 2 Alpha flexwing microlight
