INCIDENT

| Aircraft Type and Registration: | Boeing 747-4Q8, G-VHOT | |
| Date & Time (UTC): | 7 December 2006 at 1445 hrs | |
| Location: | London Heathrow Airport | |

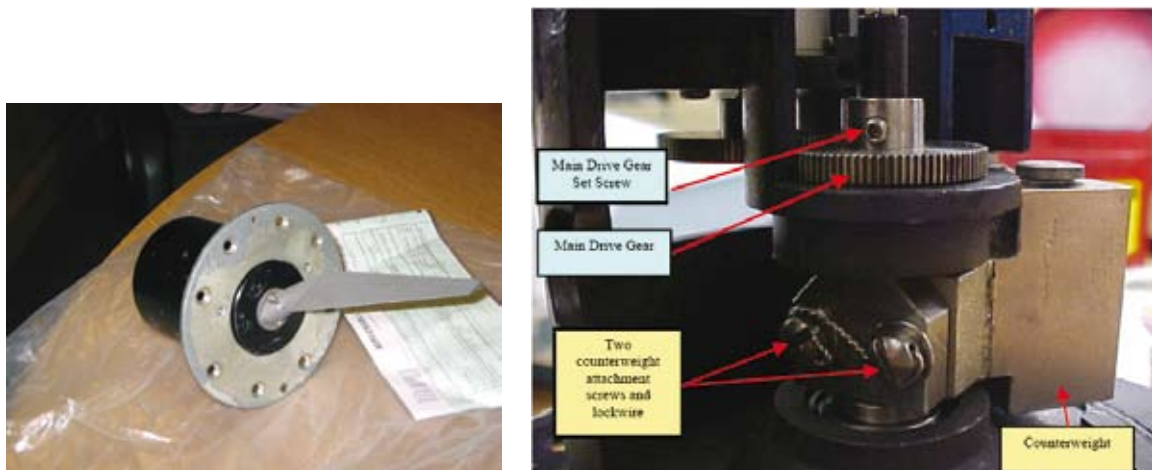
Schematic of AOA sensor

The second AOA sensor, which was from a different manufacturer, was removed from the aircraft on 18 December 2006 and was examined at a UK facility in January 2007 under AAIB supervision. The documentation associated with this component indicated that it had been installed on G-VHOT in October 1994, at the aircraft's entry into service. It had been removed on 9 February 2005 due to recurrent PLF messages of 'aoa vane r fail' and returned to the same repair organisation that overhauled the first unit. It was declared serviceable in December of that year and was installed on G-VHOT on 8 December 2006 following the stick shaker incident. As noted above, it was removed from the aircraft ten days later, following similar PLF messages.

The workshop report from 2005 contained no detail as to the nature of the repair; however, during the AAIB supervised examination, it was apparent, from its pristine condition, that the vane had been renewed. An internal examination revealed that a slight seepage had occurred from an oil-filled damper. When the unit was placed on test, with the resolver outputs being displayed on an oscilloscope and a digital voltmeter, a small calibration error was noted. The vane was rotated over its full range of movement and although the test initially appeared satisfactory, it was found that a slow rate of vane rotation revealed an 'open spot' for resolver No 2 at the approximate 29° position, possibly as a result of a contaminant particle in the brush-type resolver pick-off. In the opinion of the overhaul agent, this feature almost certainly accounted for the intermittent failure

messages. The almost immediate reappearance of the fault messages following its reinstallation on the aircraft on 8 December, suggested that the original defect had not been rectified following its shop visit in 2005.

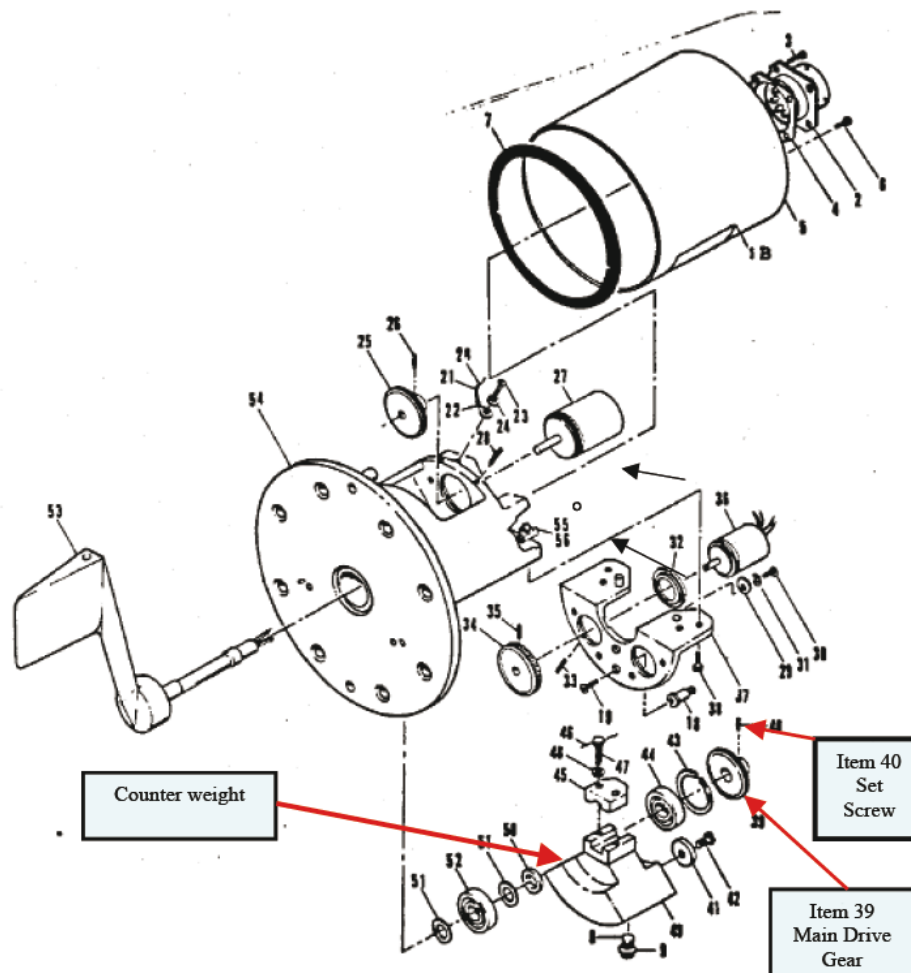
Figure 3
AOA sensor

Following the incident of 7 December 2006 the sensor was sent to its manufacturer's facility in Seattle, USA, where it was examined in the company of representatives of Boeing and the National Transportation Safety Board. When the unit was placed on test, it failed the part of the test schedule where the vane, positioned at discrete points throughout its operating range, should result in specified electrical outputs supplied to the ADCs. These were somewhat random in nature and subsequent disassembly revealed the main drive gear to be loose, being able to rotate freely 360° around the main shaft. The counter-weight was also found to be loose and had a free play of about $\pm 2^\circ$ rotation. Examination of the main gear revealed that the set screw that secured it to the shaft was not fully tightened: the overhaul manual specifies an assembly torque of 4.0 - 4.5 inch-pounds for this item. This was established as the reason for the

random readings of the resolver outputs with respect to vane displacement, which thus resulted in the right ADC receiving erroneous angle of attack data. An exploded view of an AOA sensor, together with photographs of an intact unit and the internal gear train, is shown at Figure 3.

The investigation revealed that the incident was caused by a defective AOA sensor in which an internal gear train became unsecured, resulting in both resolvers generating potentially highly inaccurate outputs to the right hand ADC. There was no way in which the ADC could 'know' that these values were false, which thus led to the stall warning system being activated for what it registered as excessively high angles of attack. In addition, high angles of attack in any aircraft alter the airflow around the static ports and pitot probes, introducing inaccuracies in the IAS and altimeter readings. In this aircraft, the ADC applied the appropriate corrections, thus leading to the discrepancies between the right and (correct) left instrument readings.

The operator reviewed the contract details covering pooled component repairs. Whilst the same overhaul organisation was retained, a quality audit was performed on the repair and overhaul of the AOA sensors.

In the time since the incident to G-VHOT, the aircraft manufacturer, Boeing, has revised the Boeing 747-400 series FIM tasks for '*Capt IAS/Alt Disagree*' to include additional checks of the AOA sensor.
