INCIDENT

Aircraft Type and Registration:	BAe HS125 Series 700, EI-WJN	
No & Type of Engines:	2 Garrett/Honeywell TFE-731-3R1H turbofan engines	
Year of Manufacture:	1979	
Date & Time (UTC):	20 September 2005 at 1006 hrs	
Location:	Prestwick Airport, Ayrshire	
Type of Flight:	Public Transport (Passenger)	
Persons on Board:	Crew - 2	Passengers - 4
Injuries:	Crew - None	Passengers - None
Nature of Damage:	Nos 1 and 2 tyres destroyed. Further damage to No 1 wheel and door linkage	
Commander's Licence:	Airline Transport Pilot's Licence	
Commander's Age:	54 years	
Commander's Flying Experience:	17,400 hours (of which 3,307 were on type) Last 90 days - 72 hours Last 28 days - 19 hours	
Information Source:	Aircraft Accident Report Form submitted by the pilot and further information from ATC and Airport Fire Service

Synopsis

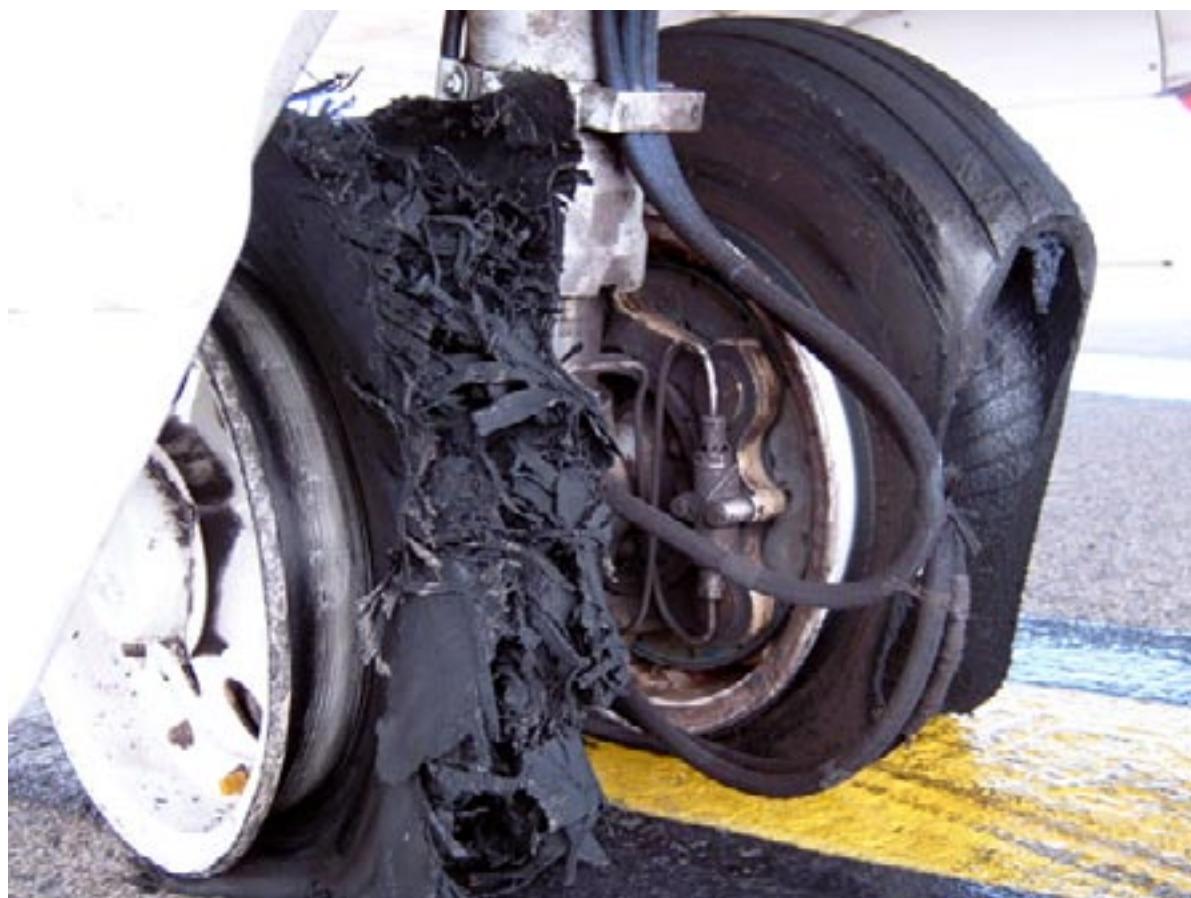
Figure 1

All that remained of the tyre on wheel No 1 were the two beads and some shredded portions of the tyre sidewalls which had remained attached to the beads. The even

pattern of damage to the wheel rim showed that, following the tyre burst, this wheel had been rotating for at least part of the time that the aircraft rolled along and clear of the runway and this damage was not inconsistent with a tyre burst at, or very shortly after, touch-down. By contrast, there was no visible damage to wheel No 2 and its tyre was intact over some 180° of its circumference. The remaining circumference of the tyre showed two very large and distinct areas of 'chamfer' and local heating, where the tyre had slid along the runway surface without rotation. (See Figure 1.)

View looking aft and inboard on the Nos 1 & 2 tyres after landing

pressure, although discussion with the operator indicated that this was unlikely. More probably, the slight angle of bank to the left after the touchdown and tyre burst had resulted in the outboard rim of the No 1 wheel becoming the weight-bearing rolling surface for the left landing gear which had resulted in the No 1 tyre experiencing a different post-burst loading.

The damage to the No 2 tyre was consistent with that to be expected if the wheel had failed to spin up at touchdown. This could occur if some brake pressure were present at the wheel when the wheel touched down which, in turn, would annul the anti-skid function of the braking system, leaving the brake 'locked on'. Since, during the investigation, no significant deficiencies were found in the braking system of the aircraft, it was considered likely that some braking was being applied, inadvertently, on the left side at touchdown.
