ACCIDENT

Aircraft Type and Registration:	SZD-24-4A Foka 4, G-DBZZ	
No & Type of Engines:	N/A	
Year of Manufacture:	1966	
Date & Time (UTC):	8 August 2010 at 1410 hrs	
Location:	Bicester Airfield, Oxfordshire	
Type of Flight:	Private	
Persons on Board:	Crew - 1	Passengers - None
Injuries:	Crew - 1 (Fatal)	Passengers - N/A
Nature of Damage:	Aircraft destroyed	
Commander's Licence:	Gliding Certificate	
Commander's Age:	25 years	
Commander's Flying Experience:	226 hours (of which 2.5 hours were on type) Last 90 days - 3.7 hours Last 28 days - 1.3 hours	
Information Source:	AAIB Field Investigation

Synopsis

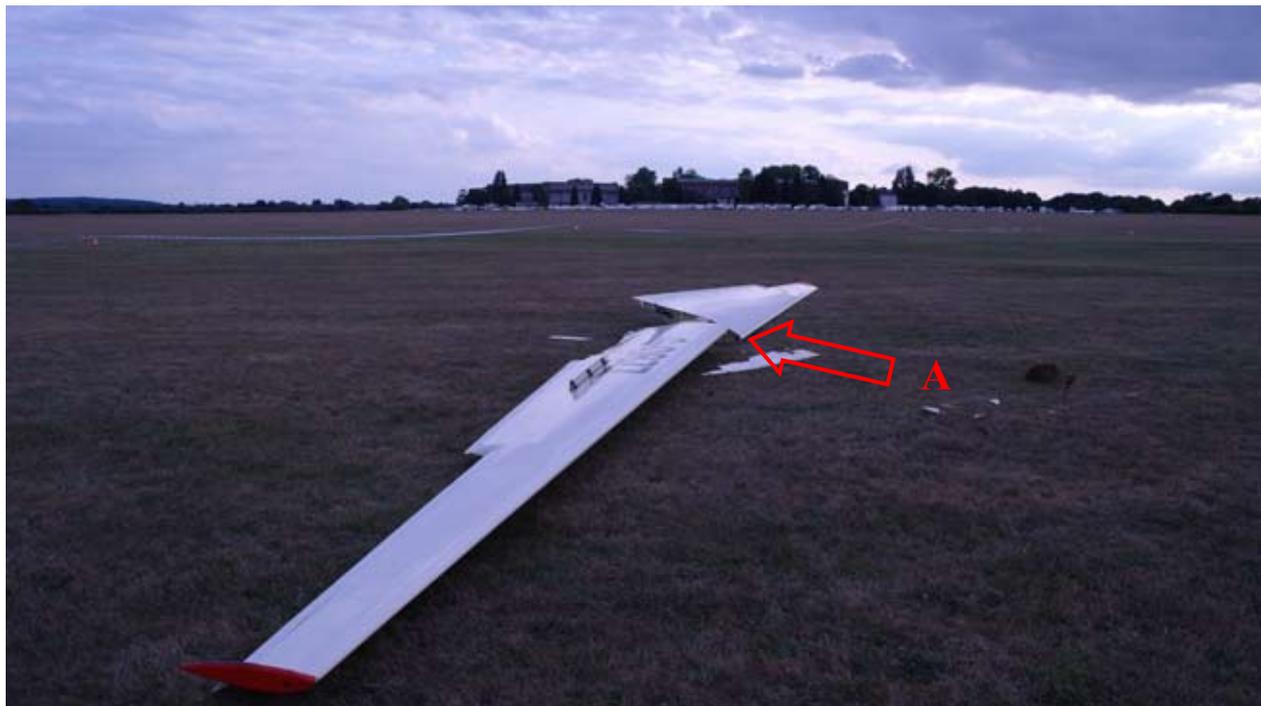
Figure 7
G-DBZZ Wing assembly (inverted)

The wings (Figure 7), which were still attached to each other, were largely intact except for a 2.15 m section of the left wing inboard trailing edge, which had detached on impact with the ground. Examination of the wing root fitting in the as-found inverted position, revealed that the lower bevel bolt was only partially engaged in the lower right wing attachment lugs and the lower left wing attachment lug was disengaged from the lug stack (Figures 8a and 8b).

After turning the wings over into their correct orientation, examination revealed that although the upper attachment lugs of the right wing had splayed apart, the wings had remained connected by the upper lug stack and bevel bolt. The T-wrench was still installed in the internal

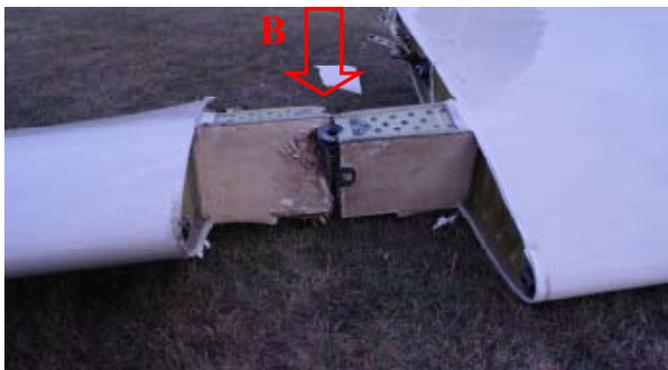
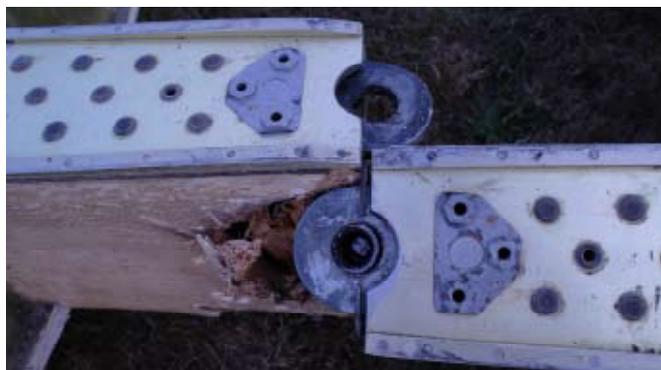
Figure 8 (a)
View on Arrow A from Figure 7

Figure 8 (b)
View on Arrow B from Figure 8 (a)

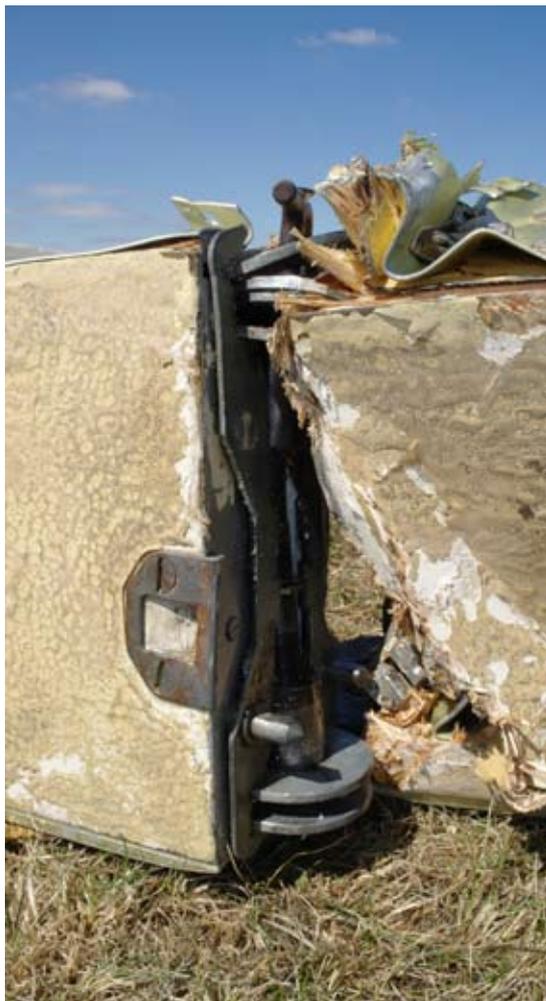
Figure 9

diameter of the threaded screw and locked in position (Figure 9). Both the T-wrench and the threaded screw of the wing main fitting were distorted where they passed through the upper bevel bolt and lug stack.

It was noted that the upper and lower bevel bolts had not expanded symmetrically along the threaded screw and the central collar of the threaded screw had been dislodged from the cut-out in the guide plates.

Wing main fitting in correct orientation

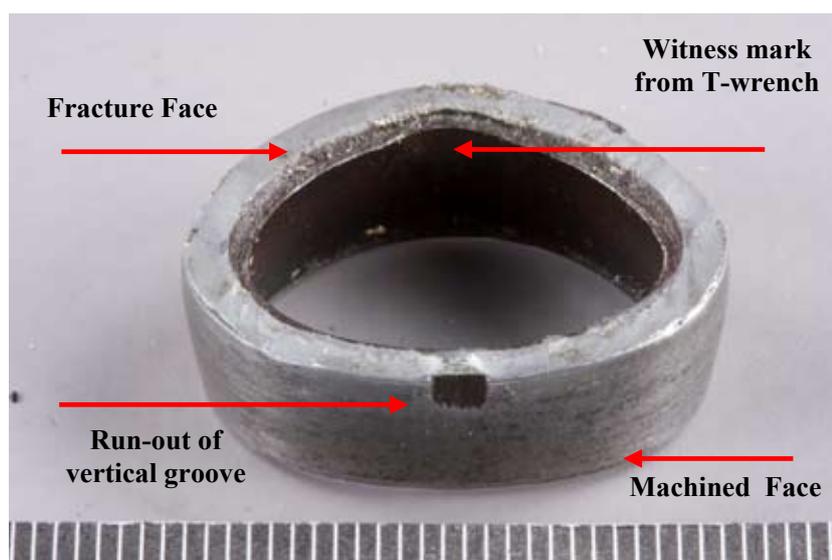
Figure 10

The fractured portion of the lower bevel bolt was approximately 8 mm in length and was observed to be elliptical in shape, having been deformed during the failure. It exhibited a fracture surface on one face and a machined finish on the other indicating that it was the 8 mm tapered lead-in at the bottom of the bolt which had been fractured.

Detailed examination of the fracture surface by a Scanning Electron Microscope (SEM) showed that the majority of the fracture surface exhibited shear dimples, indicating a failure in shear. Some mechanical damage was also evident and was most likely the result of contact with the lugs or contact between the opposing fracture surfaces during the failure. Both the shear dimples and mechanical damage indicated that the direction of failure was across the minor diameter of the ellipse.

It was noted that the inner diameter of the sheared section exhibited an area of mechanical damage (Figure 10), which is consistent with contact with the end of the T-wrench during the failure of the bevel bolt.

Fractured section of lower bevel bolt

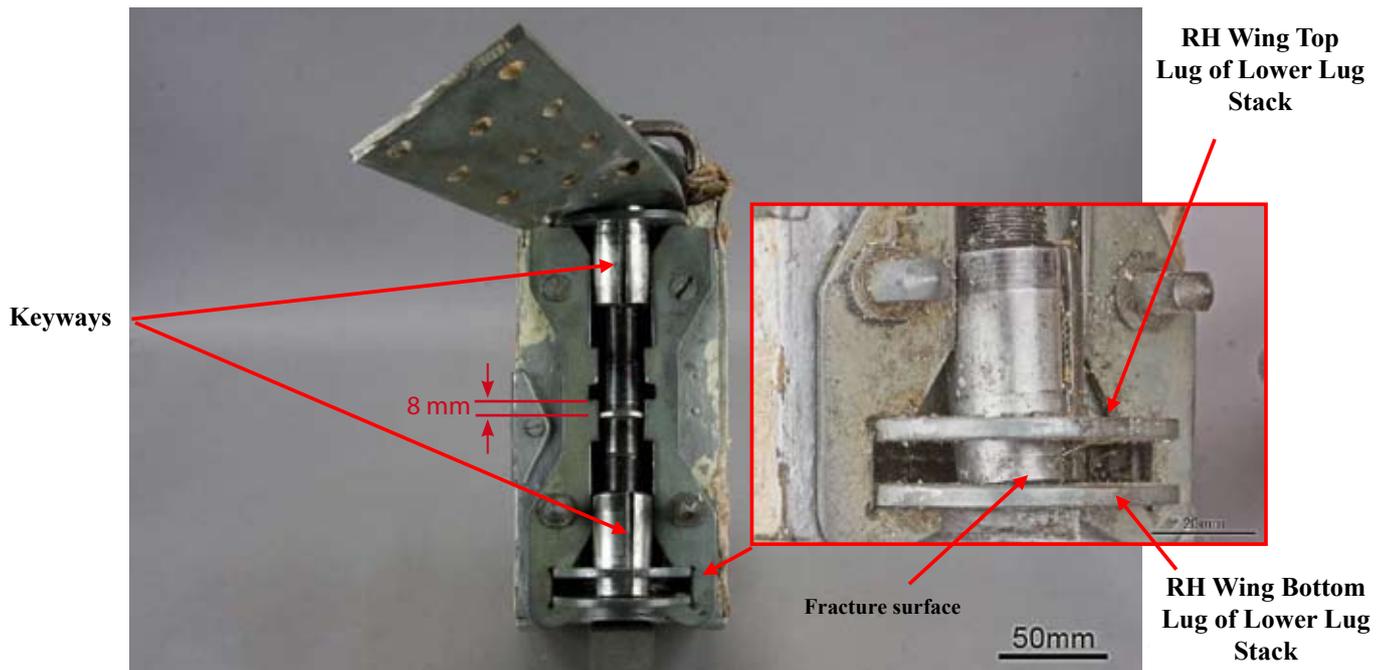
Figure 11
Wing Main Fitting

The fracture surface of the lower bevel bolt (Figure 11) was found to be positioned flush with the top face of the bottom lug in the lower right wing lug stack. In this position, the left wing lower lug could not have disengaged, therefore it was concluded that the threaded screw, and hence both bevel bolts, must have moved downwards by approximately 8 mm after the lower left wing lug separated from the lug stack.

When found after the accident, the fractured end of the bevel bolt was flush with the upper surface of the lower right hand lug. Therefore, it is evident that the whole wing main fitting assembly moved downwards by approximately 8 mm during the wing separation sequence and / or impact with the ground.

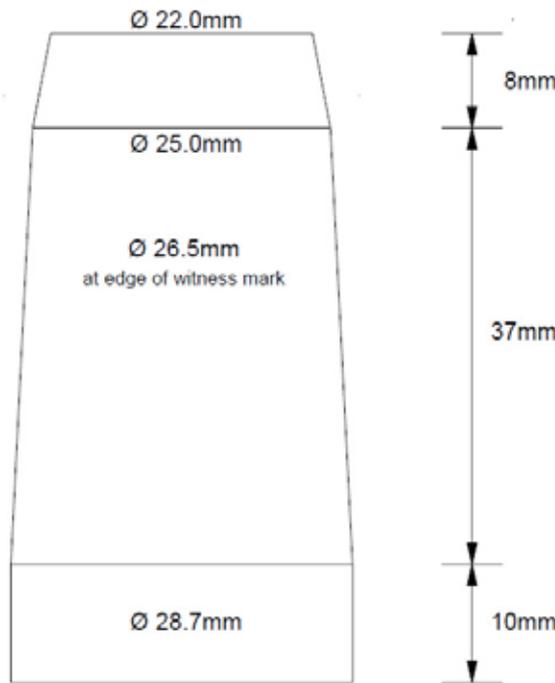
Figure 12

The depth of the keyway on both bolts was measured as 2.3 mm within the cylindrical section, running out to 0.5 mm at the end of the middle taper section. The dimension between the flats of the keyways on the cylindrical section of the bolts was therefore 24.1 mm.

The width between the guide plates was measured between the limits of vertical movement of the upper and lower bevel bolts and noted as varying between 28.1 mm and 29.1 mm in the region of the upper bevel bolt and between 28.9 mm and 28.5 mm in the region of the lower bevel bolt. The guide plate spacing was therefore greater in places than the maximum diameter of the bolts and the distance between the keyways.

Dimensions of the bevel bolts

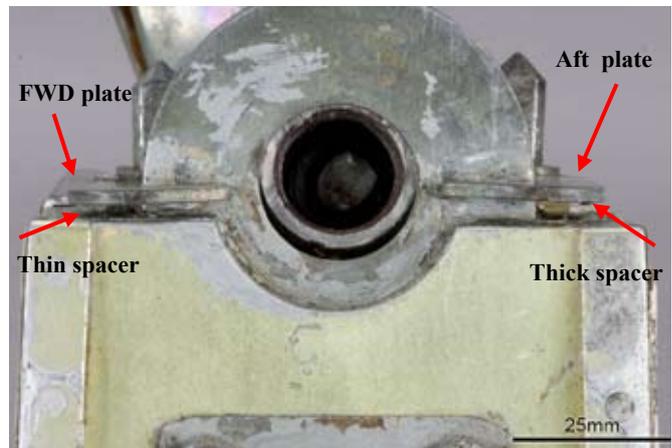
Figure 13

The guide plates are secured to the inboard end of the right wing root spar with two screws (upper attachment point) and two locating spigots (lower attachment point.) Spacer washers are used under the guide plate on each fastener. At the upper fastener position the stand-off was measured as 5.1 mm and 4.8 mm for the forward and aft plates respectively; at the central position 6.7 mm (forward) and 5.9 mm (aft); and at the lower fastener position 4.2 mm (forward) and 6.4 mm (aft).

Difference in stand-off between forward and aft guide plates

After dismantling the guide plates, it was found that different thickness washers had been used on the lower fasteners of the forward (0.55 mm) and aft plates (1.9 mm) (Figure 13).

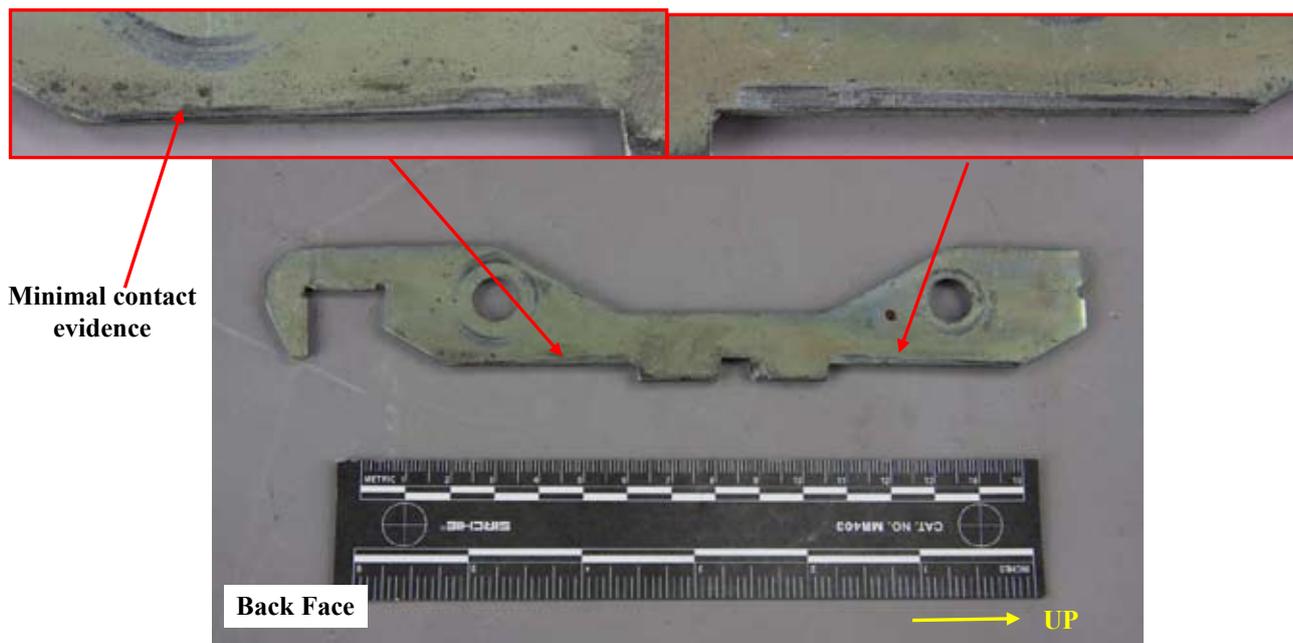
Figure 14

However, there was very little evidence of a witness mark on the lower end of the back face of the aft guide plate, suggesting minimal engagement of the guide plate with the keyway of the lower bevel bolt. There also appeared to be some edge rounding (Figure 14).

Wear marks on back face of aft guide plate

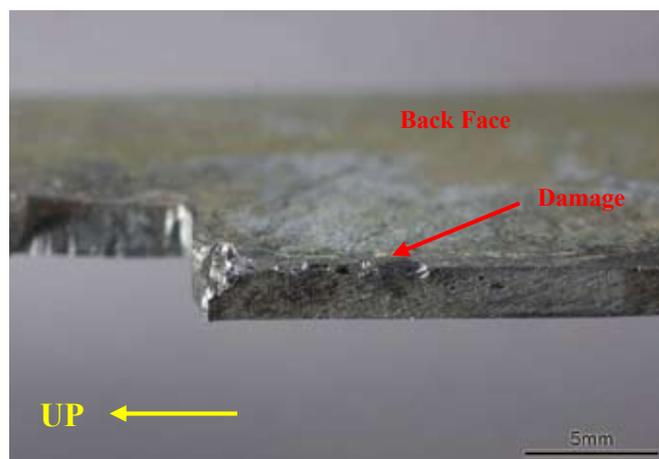
Figure 15

Examination of the guide plates showed that mechanical damage was present on the edge of the back face of the forward and aft guide plates over a length of 8 mm from the lower land of the central recess.

This corresponds to the position in which the central collar of the threaded screw was found. However, the first 1 - 2 mm of damage on both forward and aft plates is consistent with rotational movement of the collar (horizontal scoring) rather than vertical movement of the collar. This indicates that the collar had been damaging the lower edge of the guide plate recess on both forward and aft guide plates while the mechanism was being operated (Figure 15).

Forward guide plate below recess
(Aft guide plate exhibits similar damage)

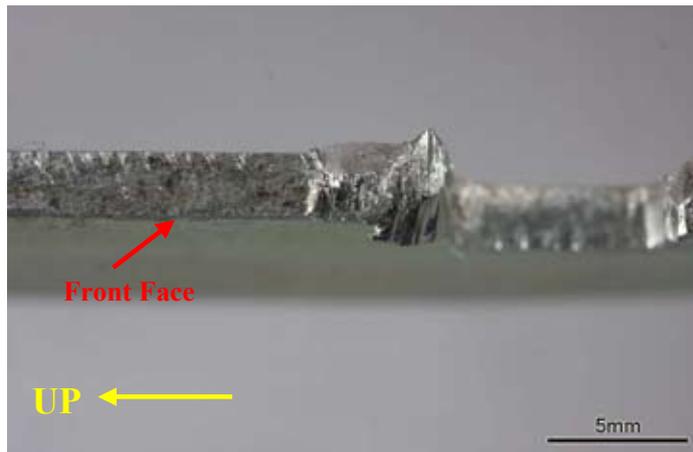
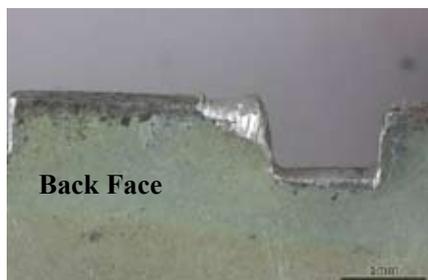
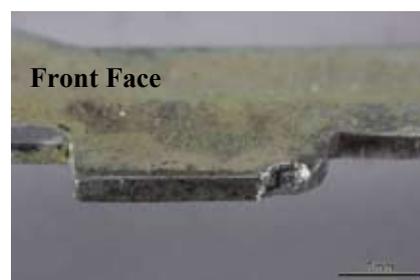
Figure 16

Mechanical damage was also evident above the guide plate recess. Unlike the damage below the recess, which occurred only on the back face edge, the damage above the recess was evident on both the visible and back face edges for a distance of approximately 5 mm from

the upper land of the recess. The mechanical damage resulted in horizontal scoring of the plate, consistent with rubbing against the collar during rotation (Figures 16 and 17). Examination of the collar showed similar horizontal scoring (Figure 18), which is consistent with the collar moving up out of the recess as the T-wrench was turning.

Forward guide plate above recess

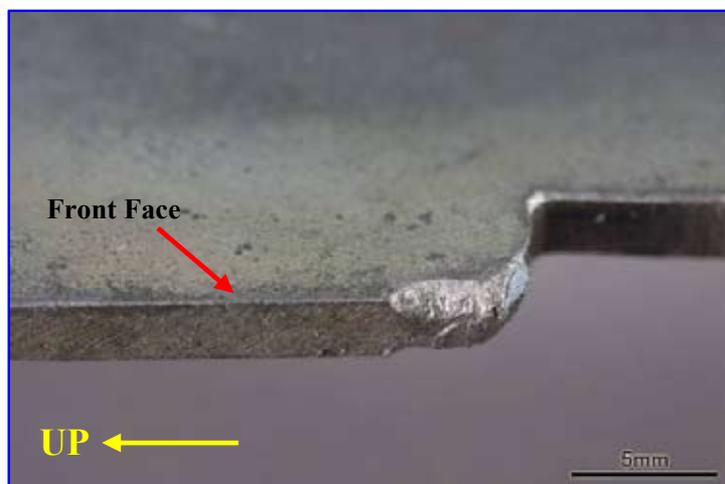
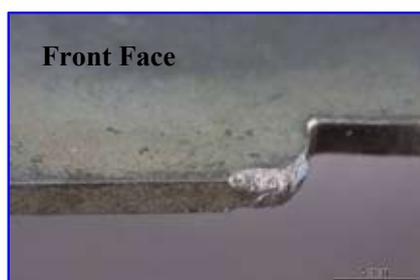
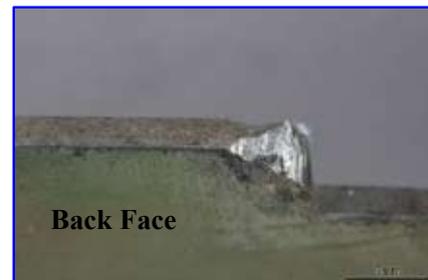
Figure 17

Aft guide plate above recess

As rotational scoring was present above the recess on both the front and back faces of the guide plates, it is considered possible that the direction in which the rigging tool was being turned was reversed (ie in an attempt to retract the bolts) which could have caused the collar to damage the opposite face of the plate.

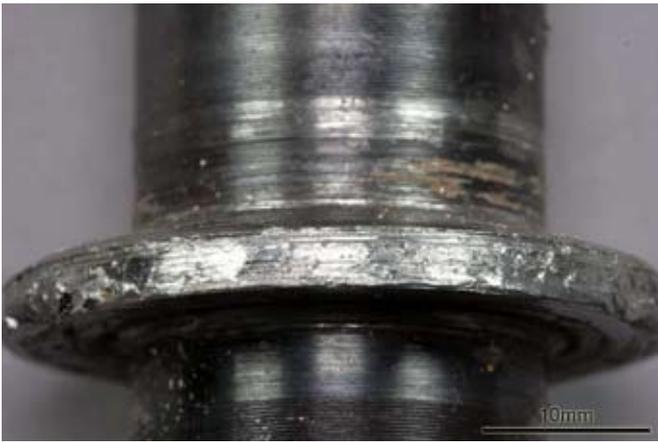
Figure 18

Mechanical damage observed on surface of collar

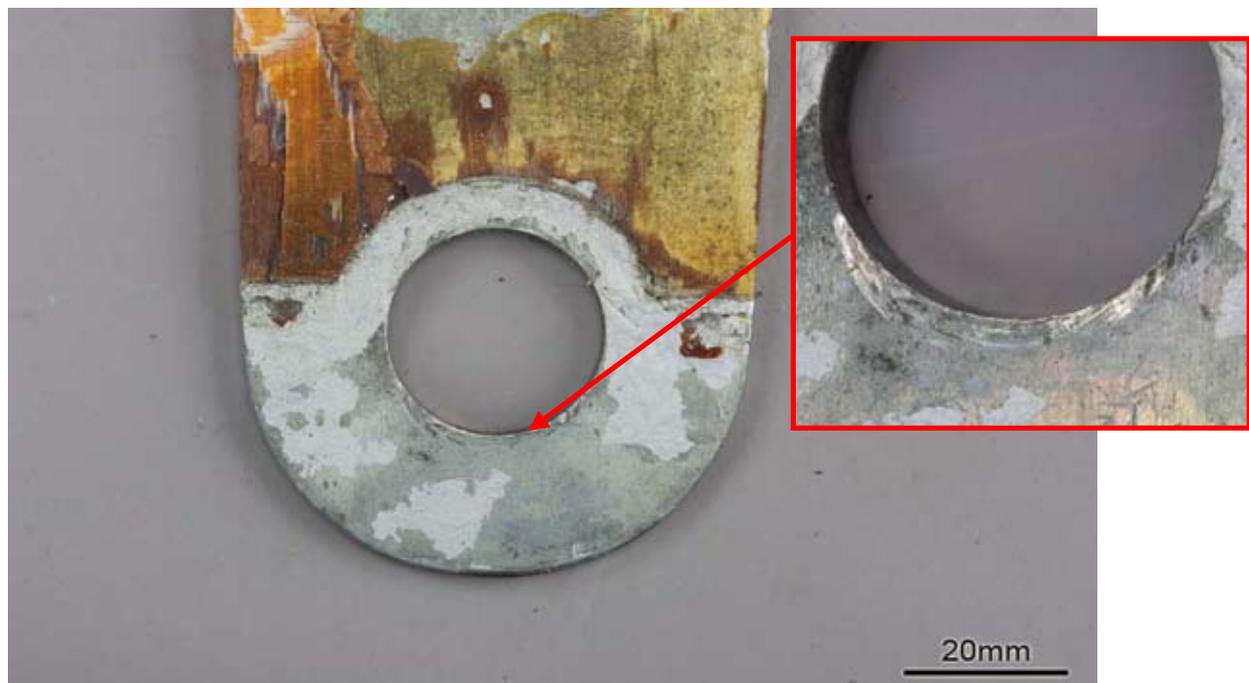
Figure 19

Damage was observed on the upper surface of the upper right hand lug (Figure 19). The damage was circumferential for a width of approximately 2 mm at the edge of the LH side of the hole.

Mechanical damage observed on upper right hand lug

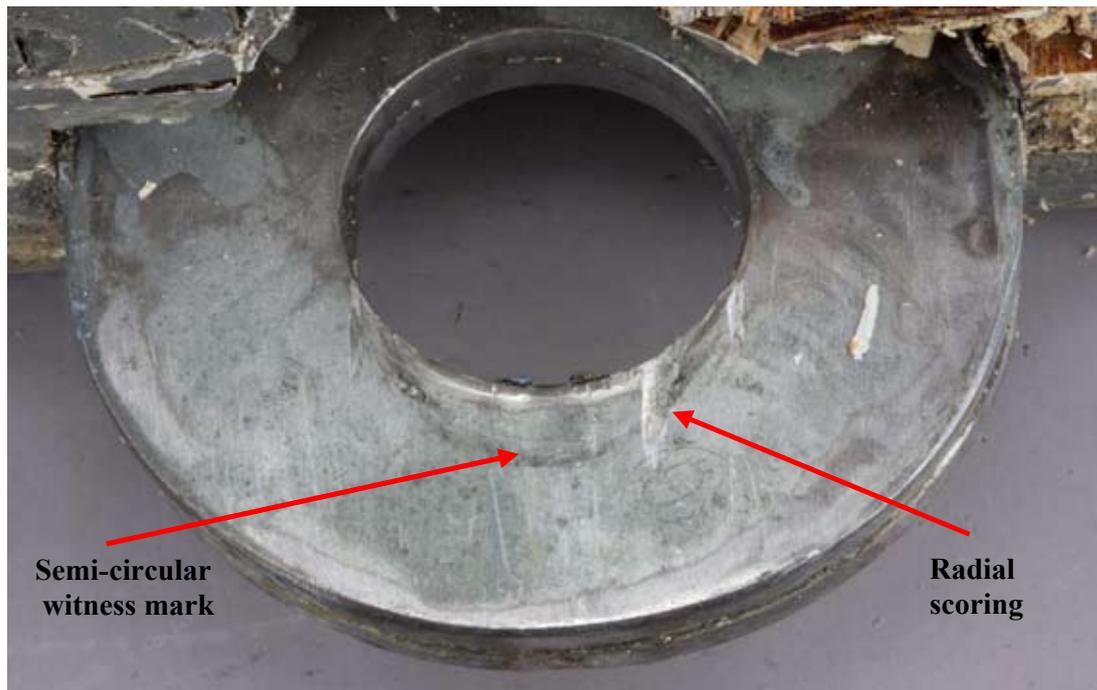
Figure 20

The majority of the damage on the upper and lower right hand lugs was consistent with damage caused as the lower bevel bolt sheared and the left hand lug pulled out of the lug stack. The semi-circular damage on the upper surface of the left hand (centre) lug is consistent with contact with the lower surface of the lower bevel bolt indicating that the bolts were expanded while the left hand lug was not fully aligned in the lug stack.

Mechanical damage on upper surface of the left hand (centre) lug
