Air Accidents Investigation Branch

**Report on the serious incident to
Hawker Siddeley HS 748 Series 2A, registration G-BVOV
at Guernsey Airport, Channel Islands
on 8 March 2006**

Aircraft Accident Report No: 6/2008 (EW/C2006/03/06)

Aircraft Type and Model: Hawker Siddeley HS 748 Series 2A

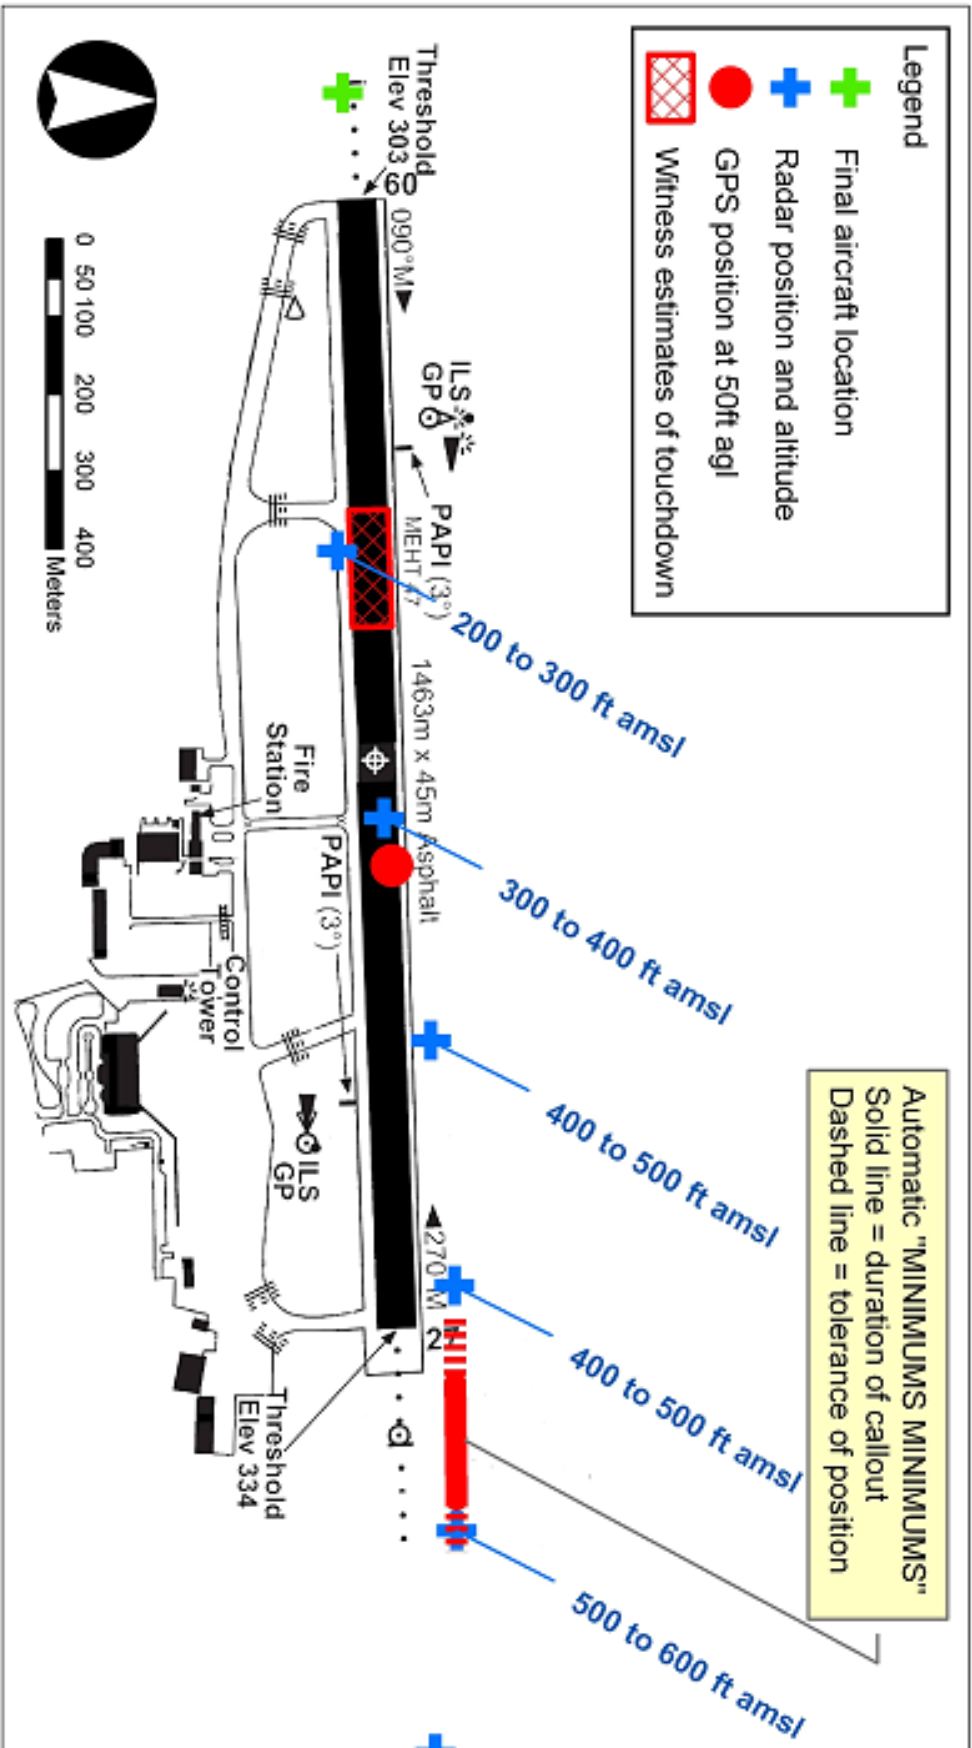
Figure 1

Runway 27 at Guernsey Airport

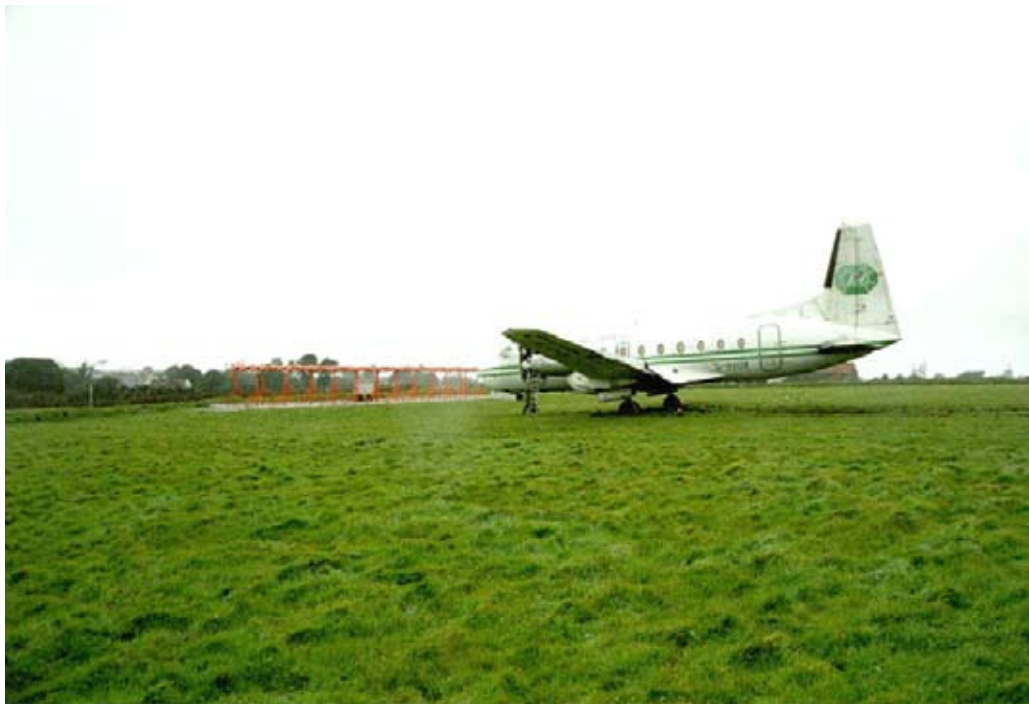
Figure 2

The aircraft departed the end of the paved surface to the left of the centreline and immediately started to slow down. It continued straight ahead and stopped 145 metres beyond the end of the runway, before reaching the approach lighting for Runway 09 (Figure 2). The commander advised ATC of their position and ATC replied that the fire vehicles were on their way. A few seconds later, the crew acknowledged a request from ATC for them to contact the RFFS on 121.6 MHz. Neither of the crew was injured and they carried out the After Landing and Shutdown checks, during which they discovered that the flight fine pitch stops (FFPS) had not been withdrawn. They then disembarked the aircraft, inserted the landing gear safety pins and liaised with the RFFS.

G-BVOV at Guernsey Airport, 8 March 2006

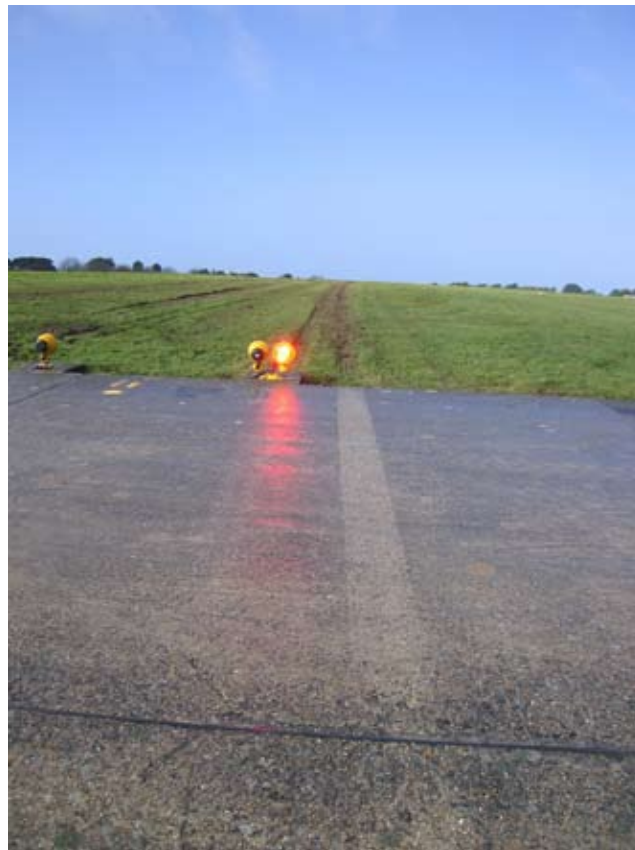
Figure 4

The runway was inspected shortly after the incident, with particular attention being paid to tyre marks. The only notable marks on the runway were at the ‘stop’ end, where the aircraft entered the grassed area, and were made by all six tyres (including the two nosewheel tyres). This area of runway surface is concrete and is where the ‘piano keys’ are located (the rest of the runway being surfaced in asphalt). The amount of white paint on the surface due to the piano keys represents about half the surface area in this region. These tyre marks were light in colour and gave the impression that the runway had been “steam-cleaned”. They stopped at the runway/grass border, at which point tyre tracks in the grass were evident. The runway mark from the No 4 main wheel was prominent, over 5 m in length, very noticeable on the concrete surface (see Figure 4).

Marks at ‘stop’ end of Runway 27 from No 4 tyre

The tyre marks at the end of the runway and the flattened ‘heated’ area on the No 4 tyre did appear to be consistent with a locked wheel on a wet runway, a condition associated with aquaplaning. After the incident to G-BVOV, the Maxaret unit fitted to the No 4 wheel was replaced as ‘*possibly not functioning correctly*’, although in the subsequent bench test it was found to function satisfactorily.

The marks at the end of the runway surface, and the condition of the tyre, suggest that some aquaplaning may have occurred on the No 4 tyre. This may have been due to the local conditions on the concrete part of the runway, including the presence of significant areas of paint for the ‘piano key’ threshold markings, and, possibly, due to marginal performance from the Maxaret on the No 4 wheel and aggressive braking as the aircraft left the runway. However, all the tyres, including those fitted to the nosewheels (which are not braked), made some ‘steam cleaning’ marks on this part of the runway and there was no evidence of aquaplaning elsewhere on the runway or on other tyres. It is, therefore, reasonable to conclude that any aquaplaning would have had a marginal effect and that it was not a factor in the aircraft overrunning the runway.

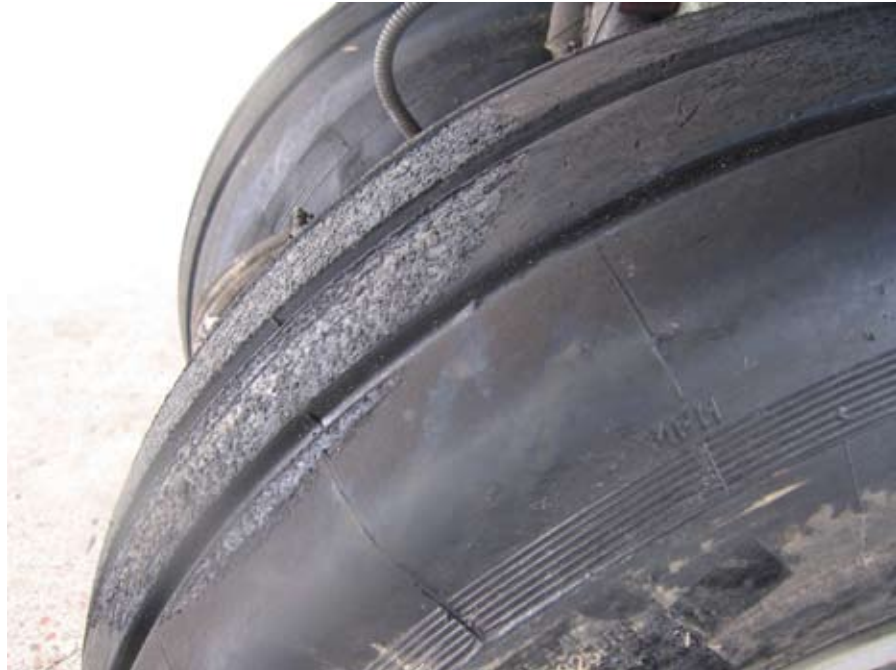
Figure 5

Whilst mud and grass had been thrown up onto the aircraft there was no aircraft damage other than the deep cuts on the No 1 and No 3 tyres, which were subsequently replaced. On the No 4 wheel there was a shallow, 20 cm diameter scorch mark on the tyre treads, (Figure 5) however this was inspected and passed as serviceable. This scorched area was consistent with the marks found on the runway (section 1.10.4 and Figure 4) and were consistent with heating as a result of local aquaplaning; hence the ‘steam-cleaned’ appearance on the runway.

Marks on No 4 tyre

On the HS 748 each main gear wheel has a Maxaret unit to provide anti-skid to the brake system, and these were tested on-aircraft shortly after the incident. Due to the lack of the correct test equipment the tests were not conclusive, but the Maxaret units from the No 1 and No 4 wheels were removed and replaced as *'possibly not functioning correctly'*.
