BOARD OF TRADE

## CIVIL AIRCRAFT ACCIDENT

Report of the German Federal Office of Aviation  
relating to the re-opened Inquiry into the Accident  
to BEA Ambassador (Elizabethan) Aircraft G - ALZU  
on 6th February 1958 at Munich Riem Airport  
and

Royal Aircraft Establishment, Farnborough,  
memorandum on "Application of the Results of  
Slush Drag Tests on the Ambassador to the Accident  
at Munich" submitted as evidence to the Inquiry

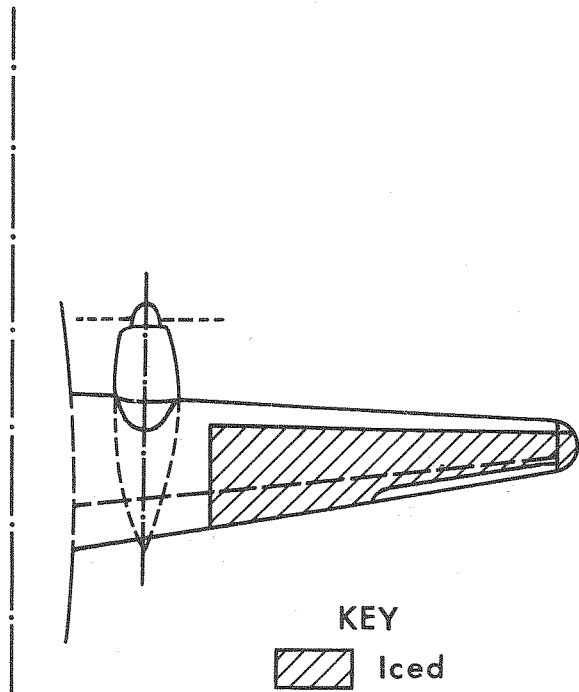
**FIG.1**  
**ICING OF THE LIFTING SURFACES**

Lower surface of wing free of ice,  
about 45% of the wing upper surface  
iced.

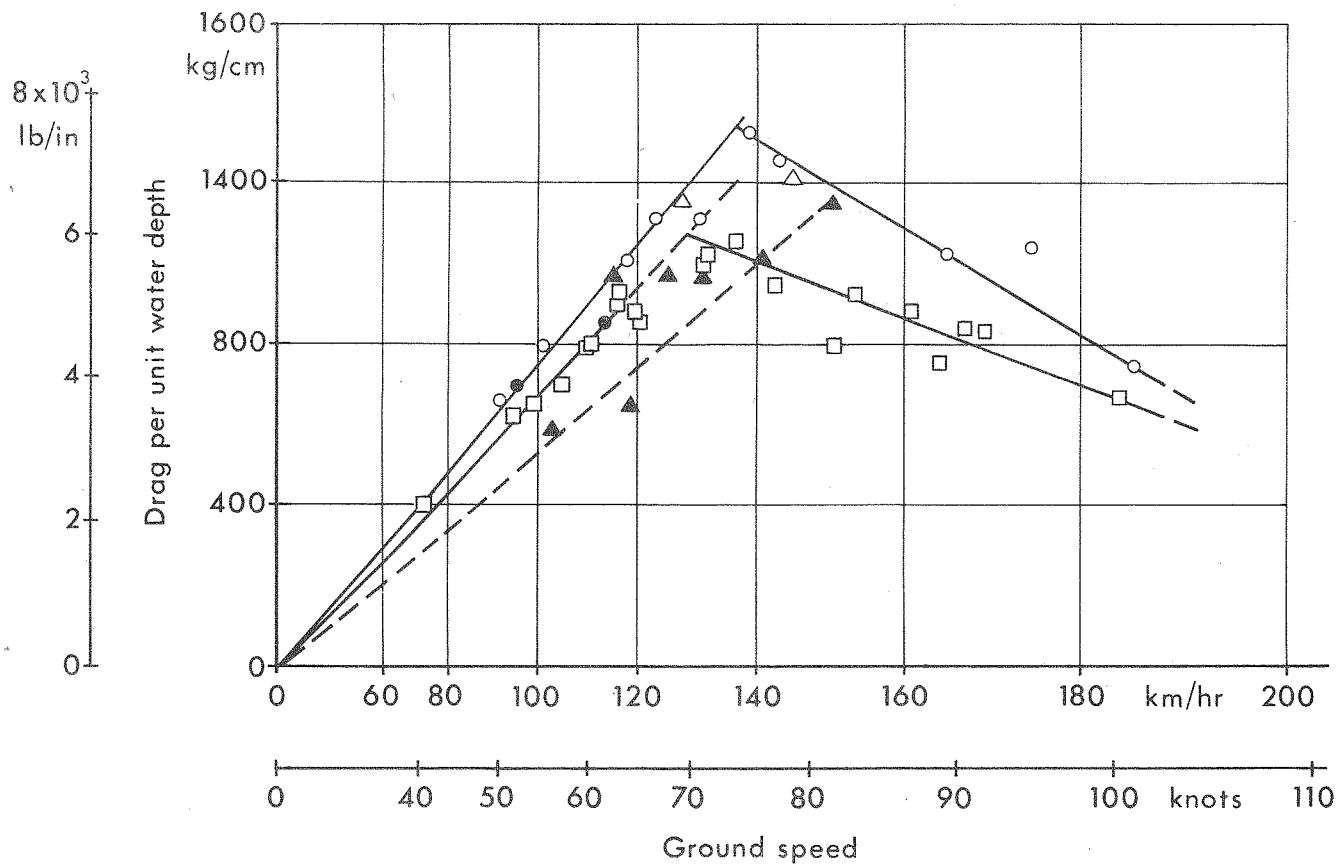
FIG.14

Variation of the drag of the Elizabethan with depth of water & speed

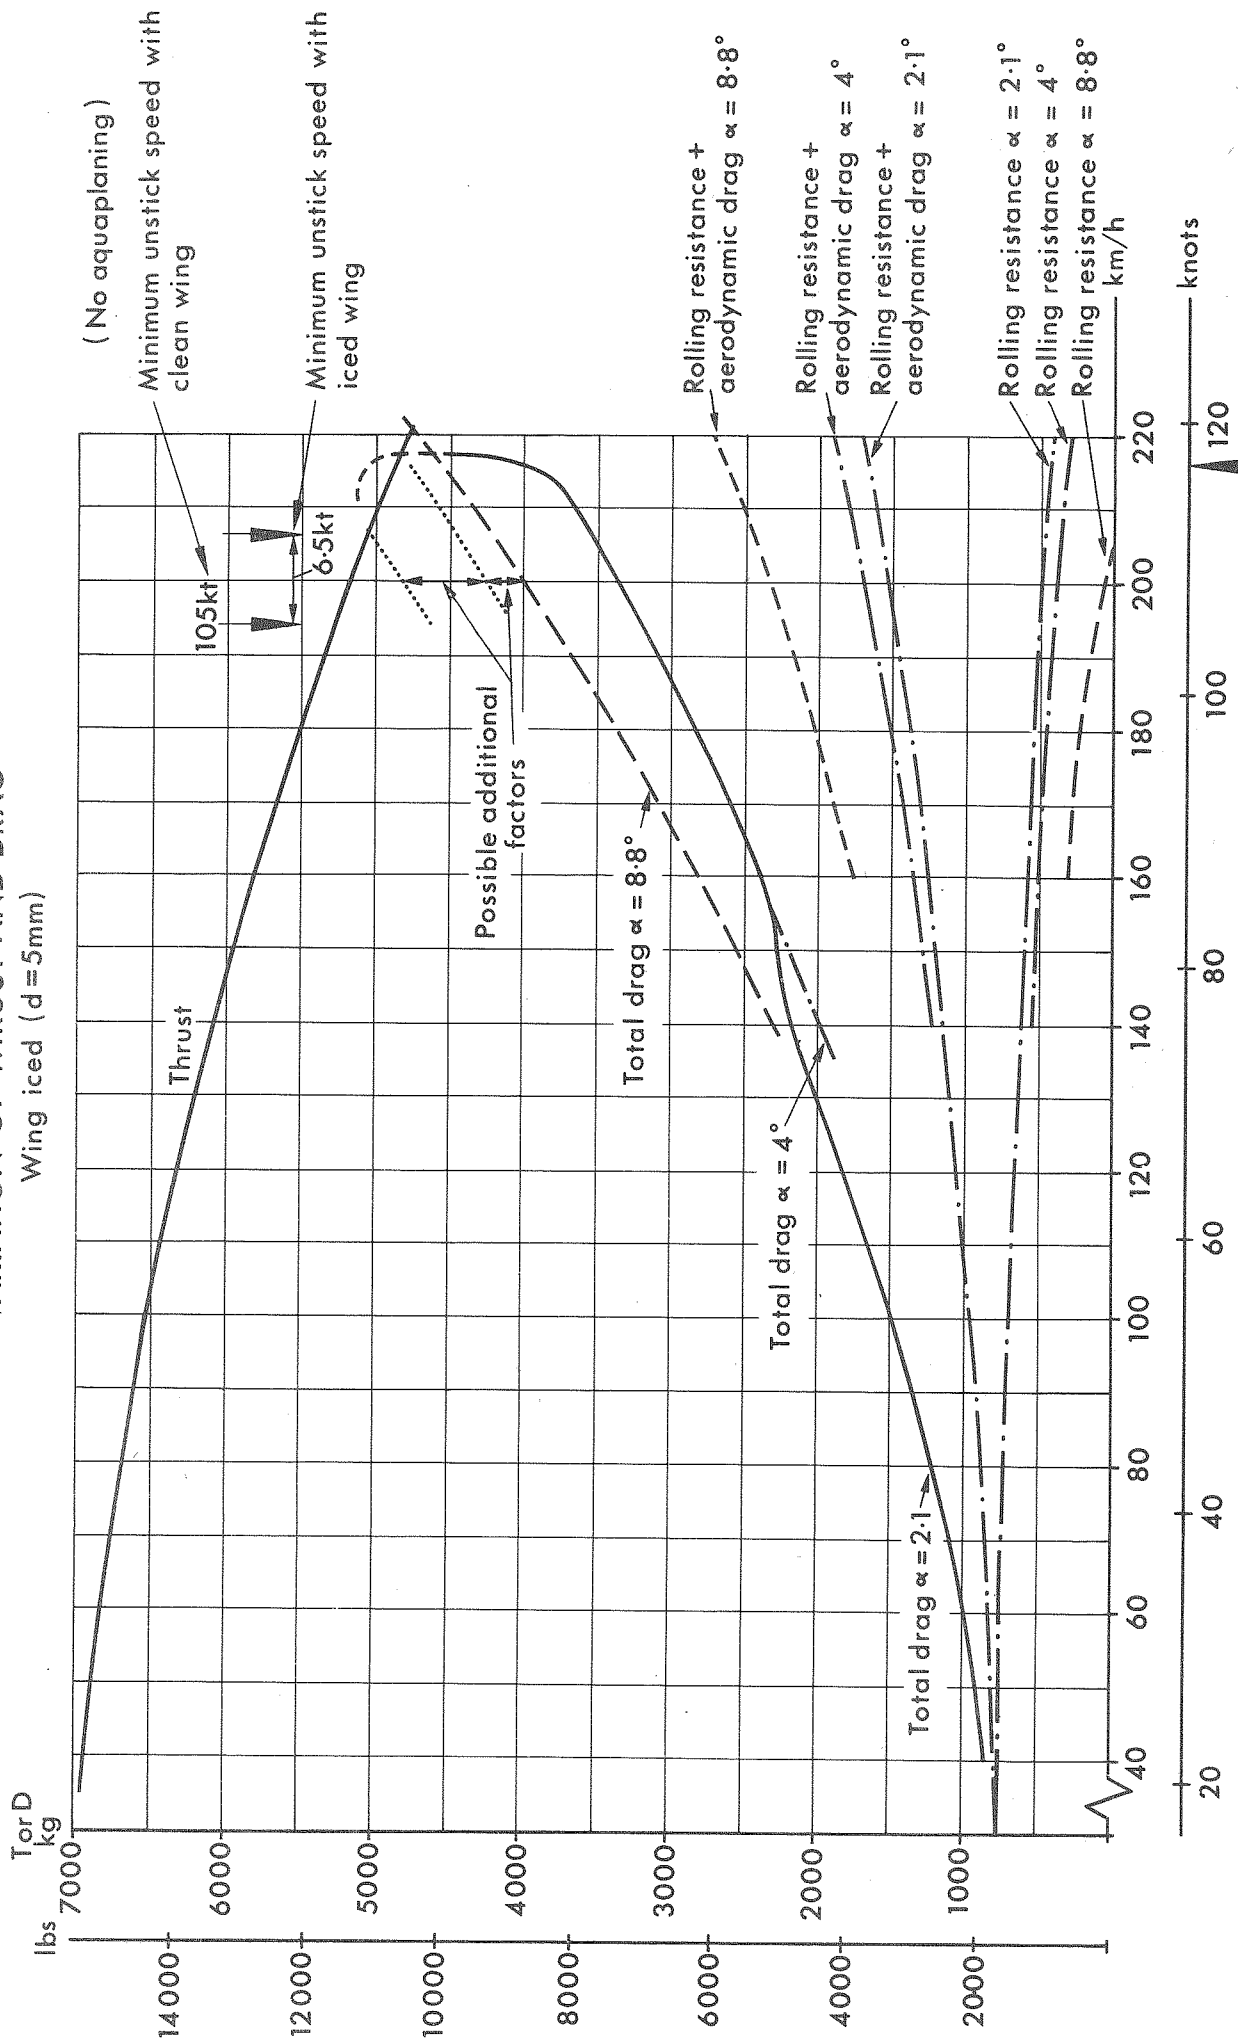
**FIG.21**  
**VARIATION OF THRUST AND DRAG**  
 Wing iced (d=5mm)

In Figure 21 it is assumed that, approximately in accordance with BEA take-off procedures, the aircraft first rolled with its nose wheel on the ground at an angle of incidence of 2.1 degrees, that from a speed of approximately 150 km/h. (81 kt) the nose wheel was raised, and that the aircraft then continued the rolling process at an angle of incidence of 4 degrees. The slush drag decreased after the nose wheel was raised since the drag caused by the nose wheel had ceased. Finally it is assumed that at a speed of 117 kt an angle of incidence of 8.8 degrees was attained. If we take into account the effect of icing on this high angle of incidence, then we have an increase in the total drag which could have resulted in a reduction of the margin of performance and hence to a reduction in the acceleration of the aircraft.

\*Discussion with the Commission established that Figure 21 was not intended to be their reconstruction of the actual course of events. This is put forward on pp 5-9 of this translation. Figure 21 does not show, for example, the drop in speed to 105 knots which the Commission accepts, and the aircraft would in any case lift off before reaching 8.8 degrees incidence at 117 knots even with the (iced) lift curve of Fig. 9. The figure was intended to show that although a considerable reduction in acceleration would be caused by the amount of slush which the Commission concluded was present on the runway it would not by itself be sufficient to prevent take-off. Equally the reduction in performance and lift due to icing would not by itself prevent the aircraft taking off. However the two together, while again not preventing take-off, would reduce the acceleration to such an extent that some other undetermined factor, which by itself would not have been significant, in fact made the accident inevitable. The Commission's statement that icing was an essential cause of the accident was founded on the view that slush plus the undetermined third factor would not have caused the accident in the absence of icing.

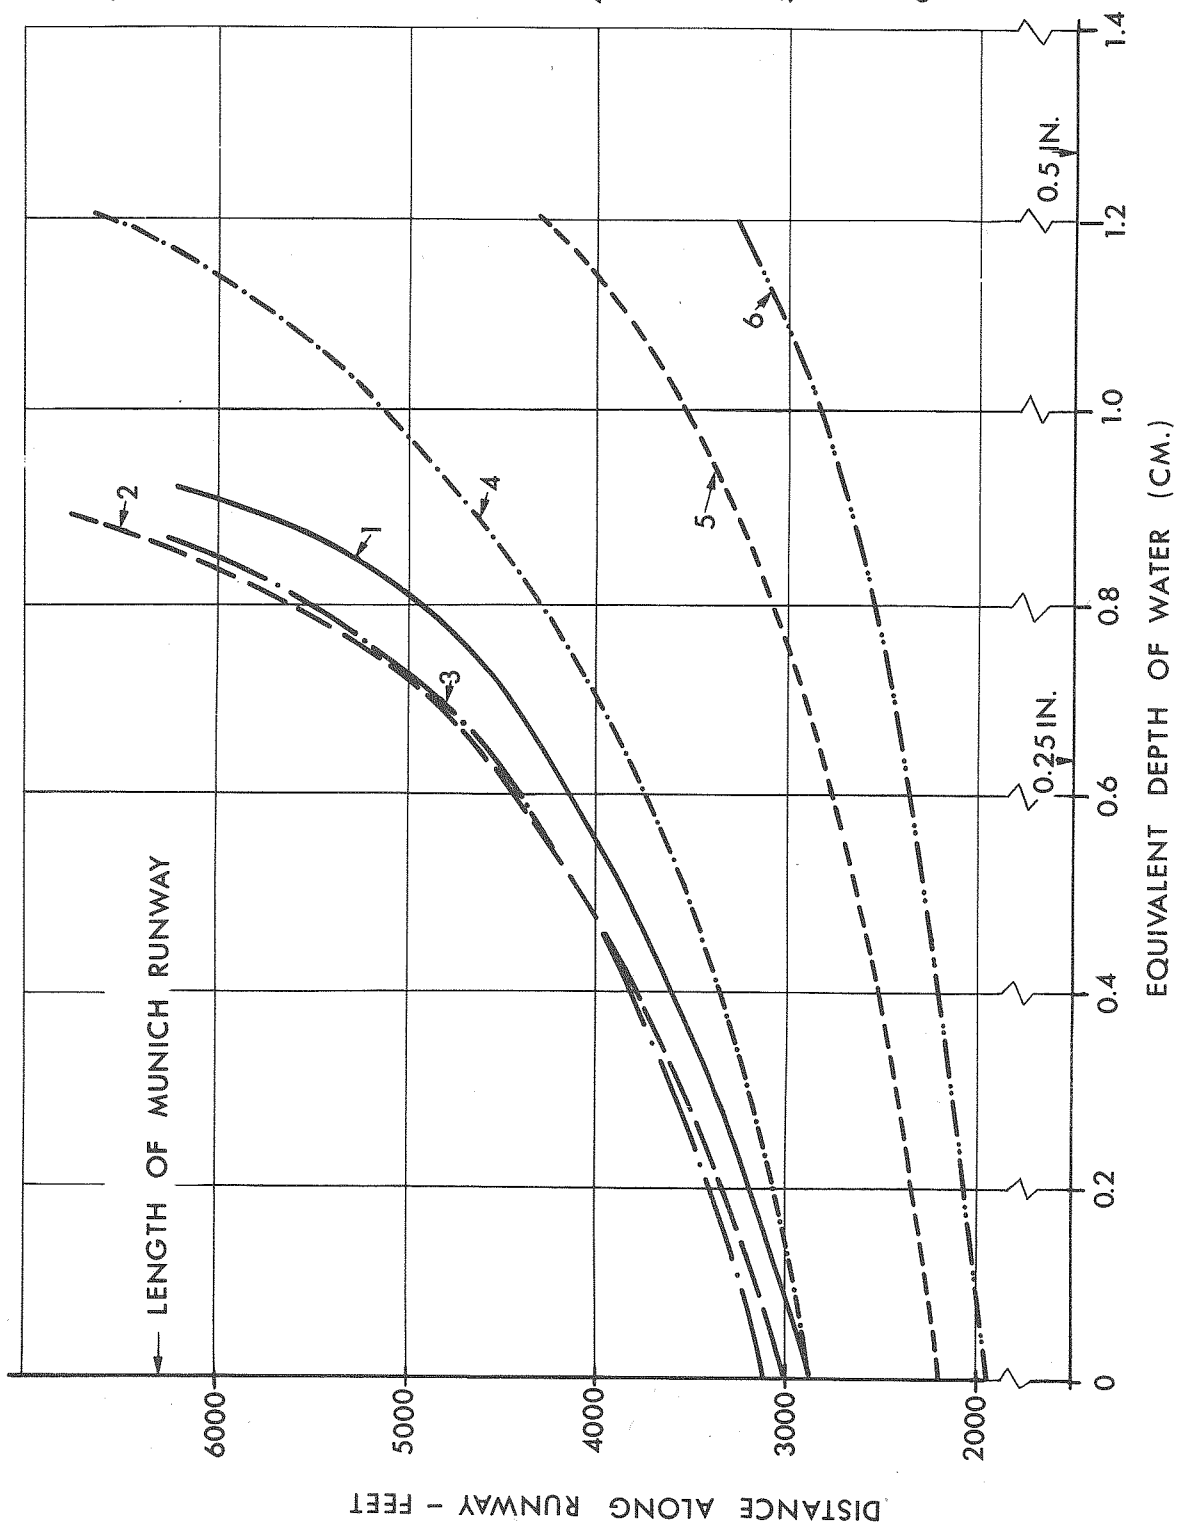
It should be observed that even on this hypothesis slush would be the principal cause of the failure to lift off. The aircraft would still have lifted off at  $V_2$  (119 knots) if rotated to the maximum possible extent, and Fig.1 shows the slush to be the major cause of the lengthened run and therefore of the failure to reach  $V_2$ . Ref.1 suggested that the aircraft reached  $V_1$  after about 1,500 metres and maintained or exceeded this speed at least to the 1,800 metre mark. To prevent acceleration above  $V_1$  would require slush equivalent to about 1.1 or 1.2 cm of water, and an actual depth of about 2.3 cm, over this portion of the runway. The times taken for such a run would be slightly less than those given above and would therefore also be low.
