Pegasus XL-Q Microlight, G-MWOX

AAIB Bulletin No: 3/2004	Ref: EW/C2003/05/01	Category: 1.4
Aircraft Type and Registration:	Pegasus XL-Q Microlight, G-MWOX	
No & Type of Engines:	1 Rotax 462 piston engine	
Year of Manufacture:	1991	
Date & Time (UTC):	7 May 2003 at 1710 hrs	
Location:	Fristling Hall Farm, Stock, Essex	
Type of Flight:	Private	
Persons on Board:	Crew - 1	Passengers - None
Injuries:	Crew - 1 (Fatal)	Passengers - N/A
Nature of Damage:	Aircraft destroyed	
Commander's Licence:	Private Pilot's Licence	
Commander's Age:	67 years	
Commander's Flying Experience:	168 hours (of which 22 were on type)	
	Last 90 days - 0 hours	
	Last 28 days - 0 hours	
Information Source:	AAIB Field Investigation

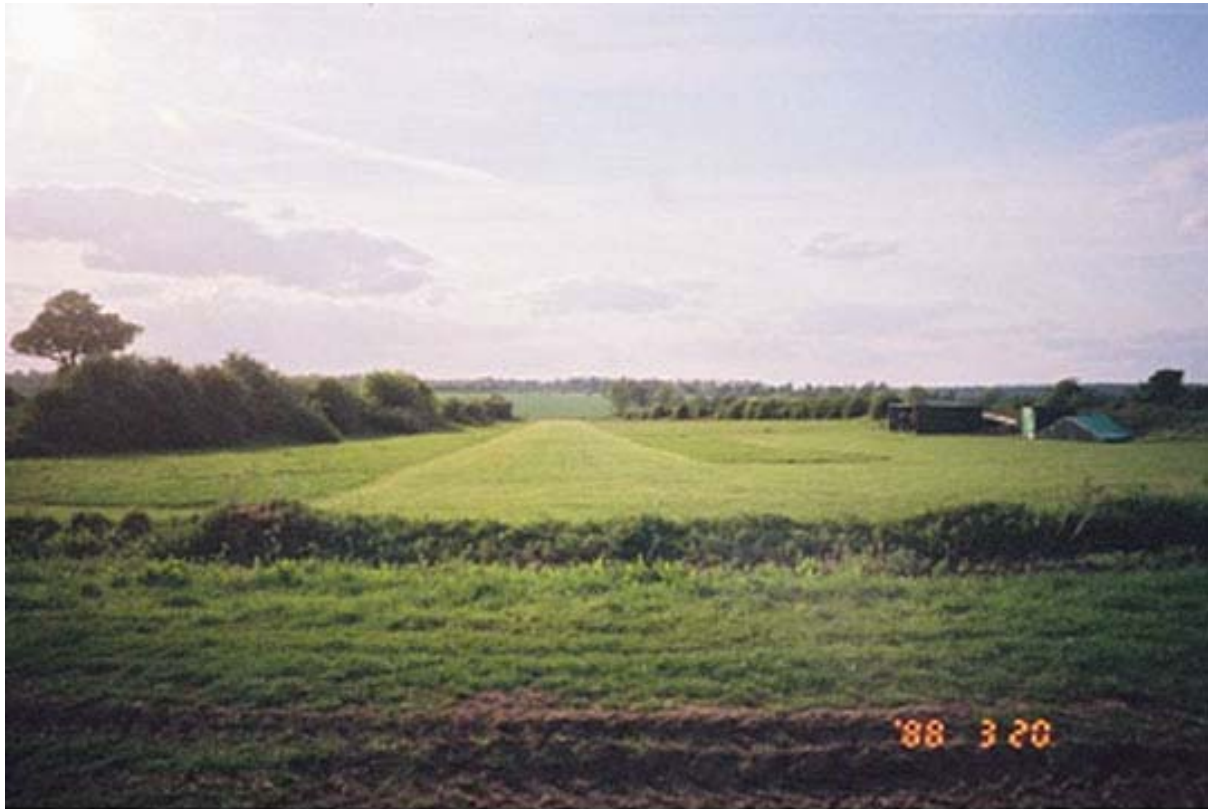
Figure 2

In 2001 the pilot joined a syndicate of pilots operating from the airstrip at Fristling Hall Farm (see Figure 2). Landing or departing aircraft from this strip are presented with more obstacles than at London Colney. The pilot flew his XL-R from this airstrip on three occasions in 2001.

Runway 31 at Fristling Hall Farm Strip

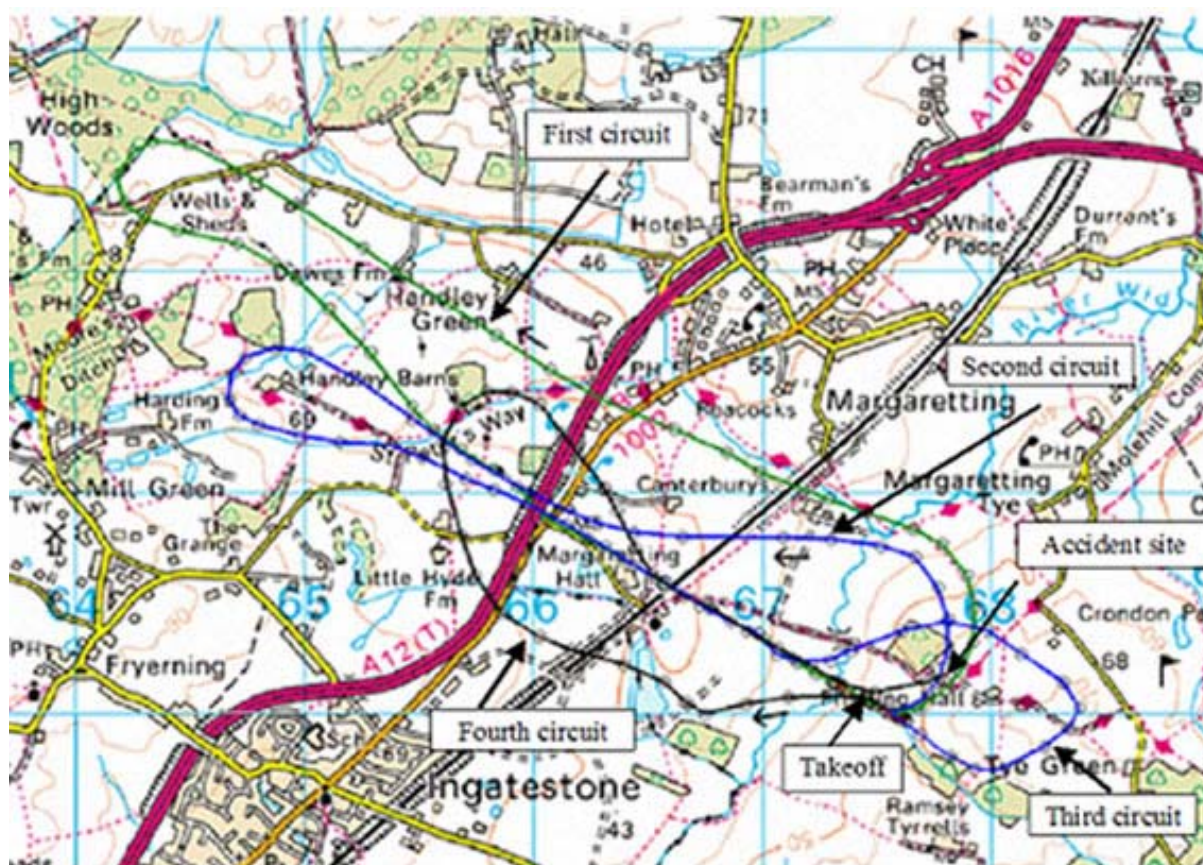
Figure 3

Aircraft's track

(First circuit - green track; second circuit - blue track; final track - black track)

The recorded data ties in the aircraft's movements with those witnessed by the observers at the airstrip. Examination of the final go-around track shows that the aircraft turned approximately 30° to the left as it approached a position abeam the mid-point of the runway. There then followed a small turn to the left just before it struck the tree.
