INCIDENT

Aircraft Type and Registration:	Boeing 757-2T7, G-MONE	
No & Type of Engines:	2 Rolls-Royce RB211-535E4-37 turbofan engines	
Year of Manufacture:	1985	
Date & Time (UTC):	17 March 2006 at 1945 hrs	
Location:	On approach to Gibraltar Airport	
Type of Flight:	Public Transport (Passenger)	
Persons on Board:	Crew - 8	Passengers - 186
Injuries:	Crew - None	Passengers - None
Nature of Damage:	None	
Commander's Licence:	Airline Transport Pilot's Licence	
Commander's Age:	45 years	
Commander's Flying Experience:	11,772 hours (of which 8,381 were on type) Last 90 days - 112 hours Last 28 days - 47 hours	
Information Source:	AAIB Field Investigation

Synopsis

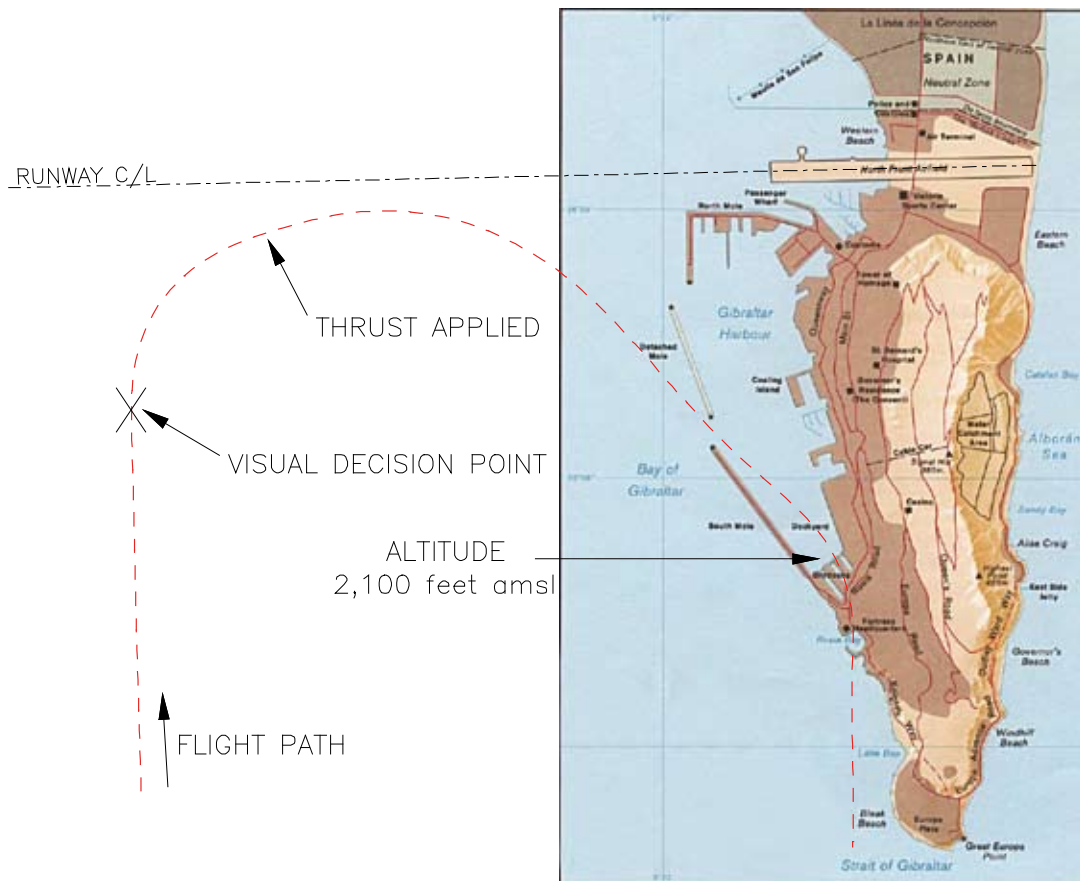
Figure 1

The flight path of the aircraft during the incident period was constructed from data recorded on the QAR. This flight path is presented in Figure 1. It commences as G-MONE tracked north on 001°M towards the VDP. At the VDP, the aircraft was at an altitude of approximately 1,000 ft, at a computed airspeed of 133 kt, and was descending at just under 900 ft/min. G-MONE then entered a descending turn to the right, achieving a maximum recorded bank angle of just over 26°.

Thirty seconds after the aircraft commenced the turn, the engine thrust increased for the 'Go-Around'. At this point G-MONE was descending through 650 ft at 134 kt, with a bank angle of 8° to the right and turning through a heading of 077°M. The aircraft descended a further 100 ft to 550 ft before it entered a climb. It then achieved a climb rate of about 3,000 ft/min whilst turning onto a heading of 140°M. It remained on this heading for 12 seconds before turning left onto a heading of 134°M for a further 12 seconds, followed by a turn to the right onto a heading of 180°M. As G-MONE turned onto the heading of 180°M, it was overland and climbing through 2,100 ft.

Reconstructed flight path of G-MONE
