AAIB Bulletin No: 12/94

Aircraft Type and Registration: Piper PA-23-250 Aztec, G-BBCC

Date & Time (UTC): 3 September 1994 at 1245 hrs

Location: Sywell Airfield, Northamptonshire

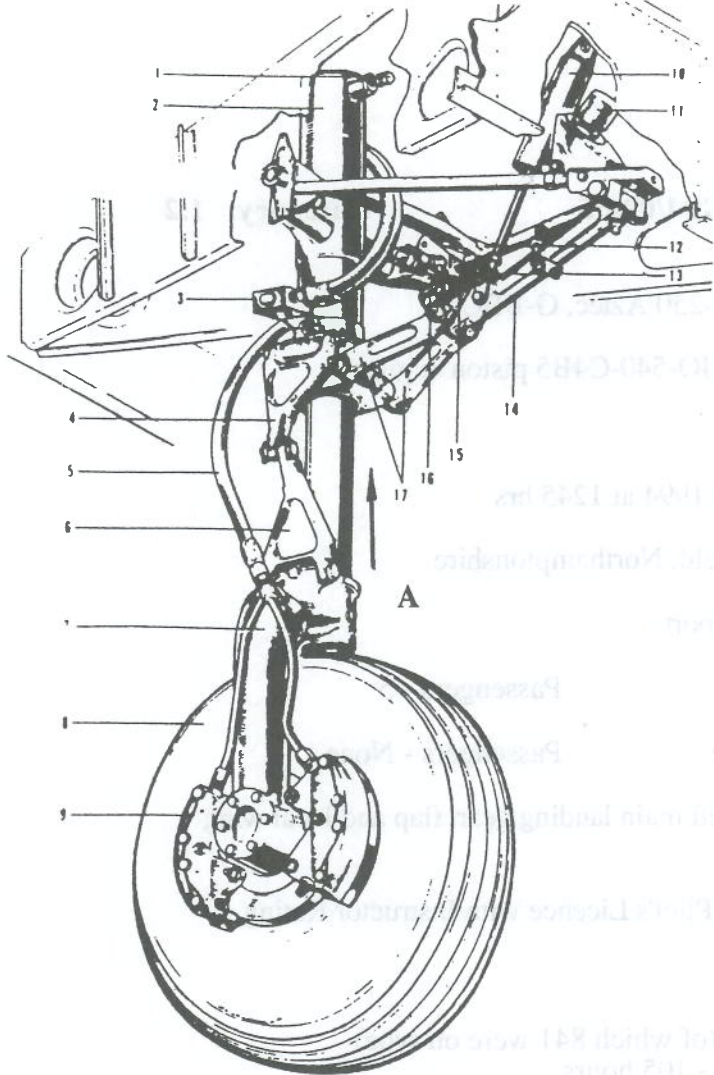
With reference to Figure 1, preliminary inspection of the aircraft showed the landing gear oleo casing to have failed at the drag link attachment point and that this had allowed the leg to pivot rearwards and collapse. Metallurgical examination of the associated fracture showed that it had occurred as a result of overload, but there was insufficient evidence to determine whether the attachment point had been overstressed, for example, during a previous takeoff/landing. Maintenance personnel who examined the aircraft reported that several of the bolts associated with the drag link pivots, when extracted, appeared to be distorted, but that this was unlikely to have occurred as a result of the gear collapse.

1. AIRCHARGE VALVE
2. GEAR STRUT HOUSING
3. ANTI-RETRACTION VALVE
4. TORQUE LINK, UPPER
5. BRAKE LINE
6. TORQUE LINK, LOWER
7. FORK ASSEMBLY
8. TIRE
9. BRAKE HOUSING
10. GEAR ACTUATING CYLINDER
11. TIME DELAY VALVE
12. RETRACTION ROD
13. LATCH ASSEMBLY
14. DRAG LINK, UPPER
15. SPRINGS
16. INDICATING SWITCH
17. DRAG LINK, LOWER

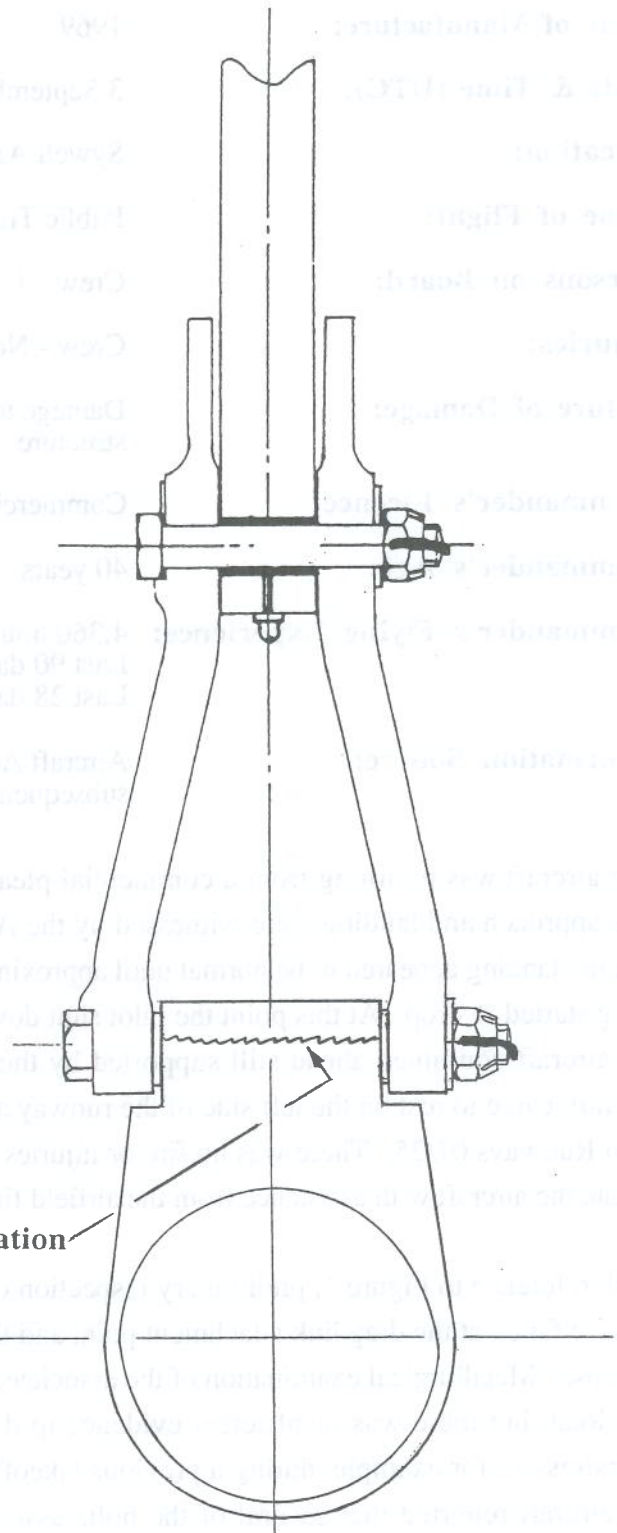
Fracture location

View in direction of arrow A
