<b>Aircraft Type and Registration:</b>	ASK13 Glider, FWN
<b>No &amp; Type of Engines:</b>	N/A
<b>Year of Manufacture:</b>	1969
<b>Date &amp; Time (UTC):</b>	6 August 2004 at 1645 hrs
<b>Location:</b>	Booker, Wycombe Air Park, Buckinghamshire
<b>Type of Flight:</b>	Trial lesson
<b>Persons on Board:</b>	Instructor - 1                  Student - 1
<b>Injuries:</b>	Instructor - 1 (Minor)   Student - 1 (Serious)
<b>Nature of Damage:</b>	Aircraft destroyed
<b>Commander's Licence:</b>	British Gliding Association Pilot's Certificate with Instructor Rating
<b>Commander's Age:</b>	58 years
<b>Commander's Flying Experience:</b>	577 hours (of which 85 were on type) Last 90 days - 74 hours Last 28 days - 25 hours
<b>Information Source:</b>	AAIB Field Investigation

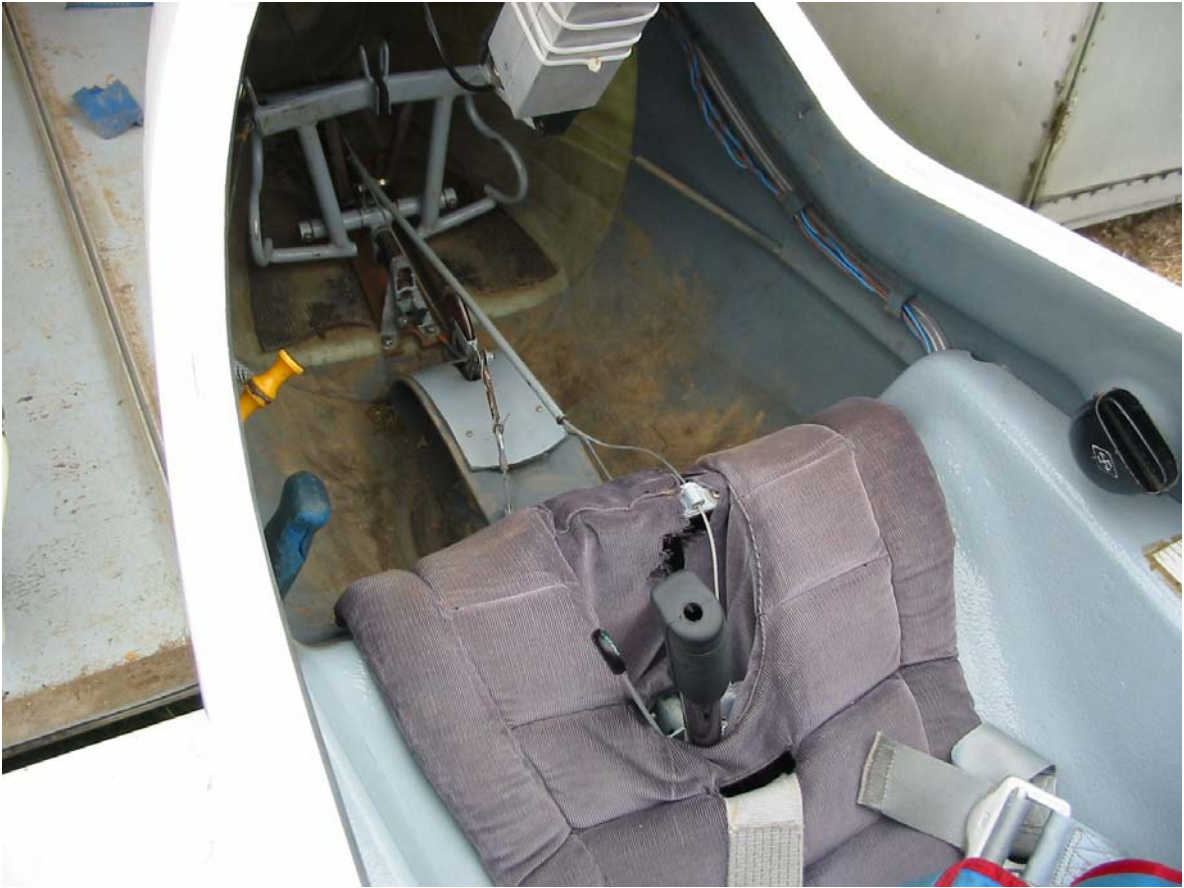
**Figure 1**

the same instructor in the same glider. The first student had taken a camera with him but did not recall being briefed specifically on what to do with it. The design of his glider's cockpit probably encouraged him to hold the camera in his hands (see Figure 1). There was then a pause of about three quarters of an hour before the third student was paired up with another instructor who had just completed a solo 3½ hour cross country flight. This instructor had not been nominated as an instructor for the day's instructional programme but was asked to assist because the instructor who was due to carry out the flight was feeling tired. Apparently it was not unusual for an instructor who had not been rostered to be asked to step in at short notice. However, this instructor could not remember conducting many instructional flights at short notice after a lengthy solo cross country flight. He subsequently commented that he had conducted at least 174 trial lessons.

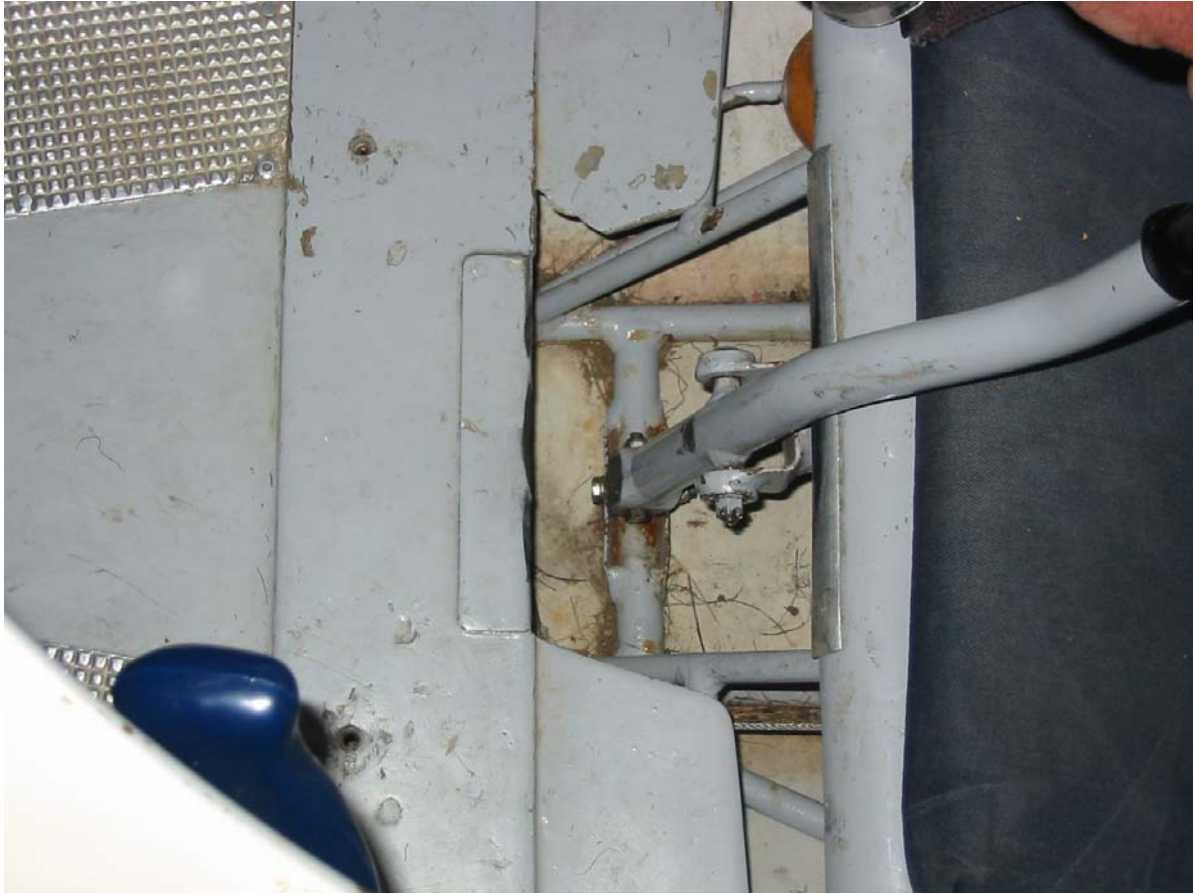
**Figure 2**

An examination of the glider revealed that, in the accident, the student's camera had been damaged. Initial indications suggested that the camera might have become lodged in the aperture for the front seat control column, between the column and its forward control stop; this is located at the aft end of the cockpit floor. This was possible because the space behind the floor around the control column, which allowed the control to be moved through its full range, was unguarded (see example in Figure 2). Further examination revealed that there was a small piece of black material in the edge of the floor in front of the control column, which looked similar to the material on the camera case (see Figure 3). Also the dents in the camera and witness marks on the camera case appeared to be consistent with the camera being jammed between the floor edge and control column at this point. Consequently, the material that was wedged in the edge of the floor and the camera case were sent for analysis.

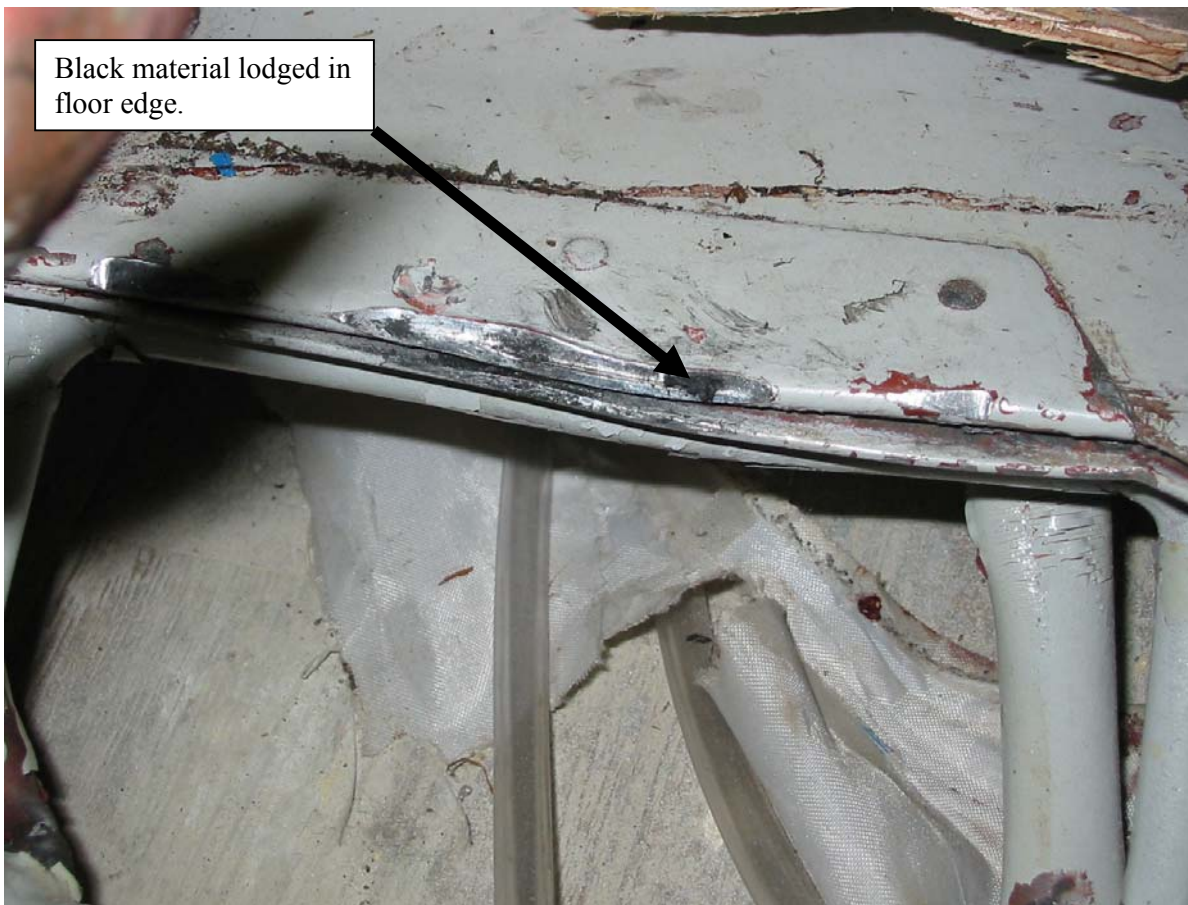
**Figure 3**

The results of that analysis indicated that there were no discernable visual or chemical differences between the two materials and it was concluded that it was likely that the fragment extracted from the edge of the floor came from the camera case.

Black material lodged in floor edge.
