## ADDENDUM

Ref: EW/G91/03/10

### INCIDENT TO BOEING 747-136, G-AWNL ON 19 MARCH 1991 AT LONDON HEATHROW AIRPORT

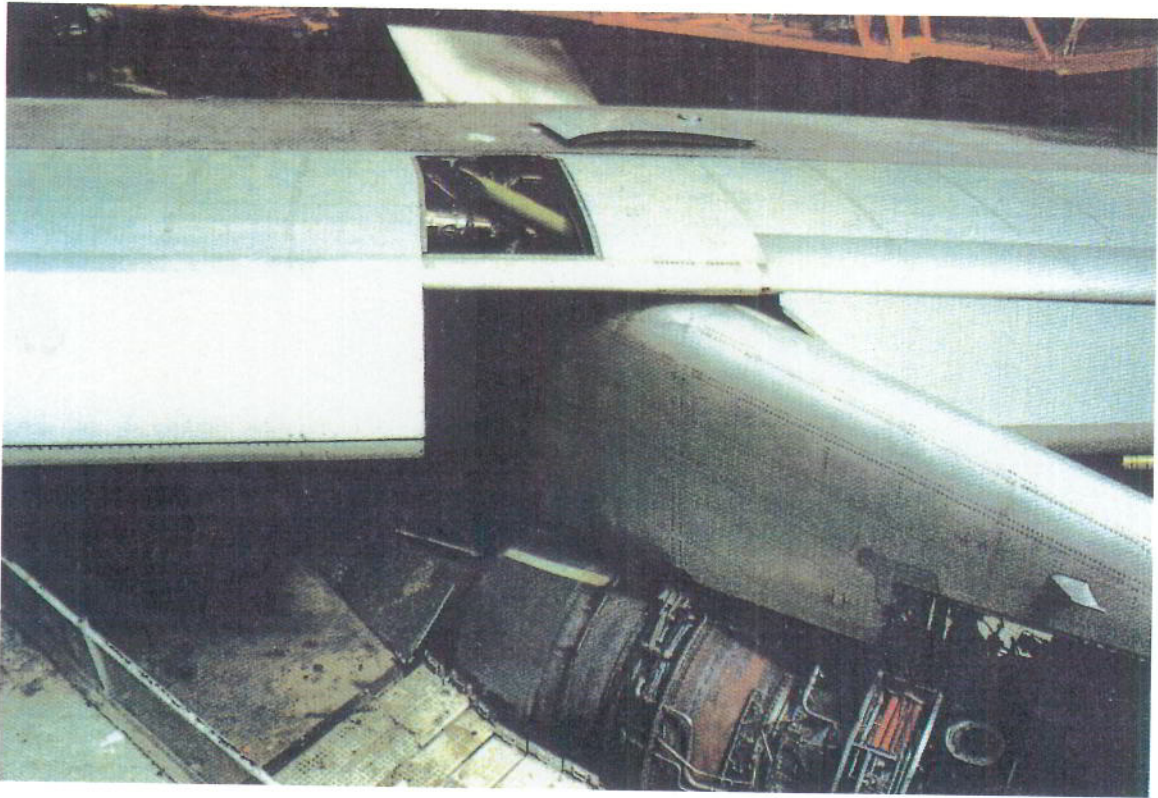
Examination of the aircraft showed that a bleed air duct failure had occurred in the right wing leading edge, adjacent the No. 3 pylon. The duct had separated due to the failure of a clamp securing the 'tee' junction where the engine bleed duct joined the inter-engine duct. The duct clamp had failed with sufficient force to damage the No. 4 engine parameter sensor cables and sever the No. 4 generator feeder cables. This clamp failure had also caused impact damage to the aluminium alloy fuel pipe which supplied the No. 3 engine, and a large diameter aluminium alloy hydraulic (return) pipe. This zone, on an aircraft similar to NL, is shown in Figure 1 with the relative locations of the air duct, adjacent loom and aluminium alloy fuel pipe indicated in Figure 2.

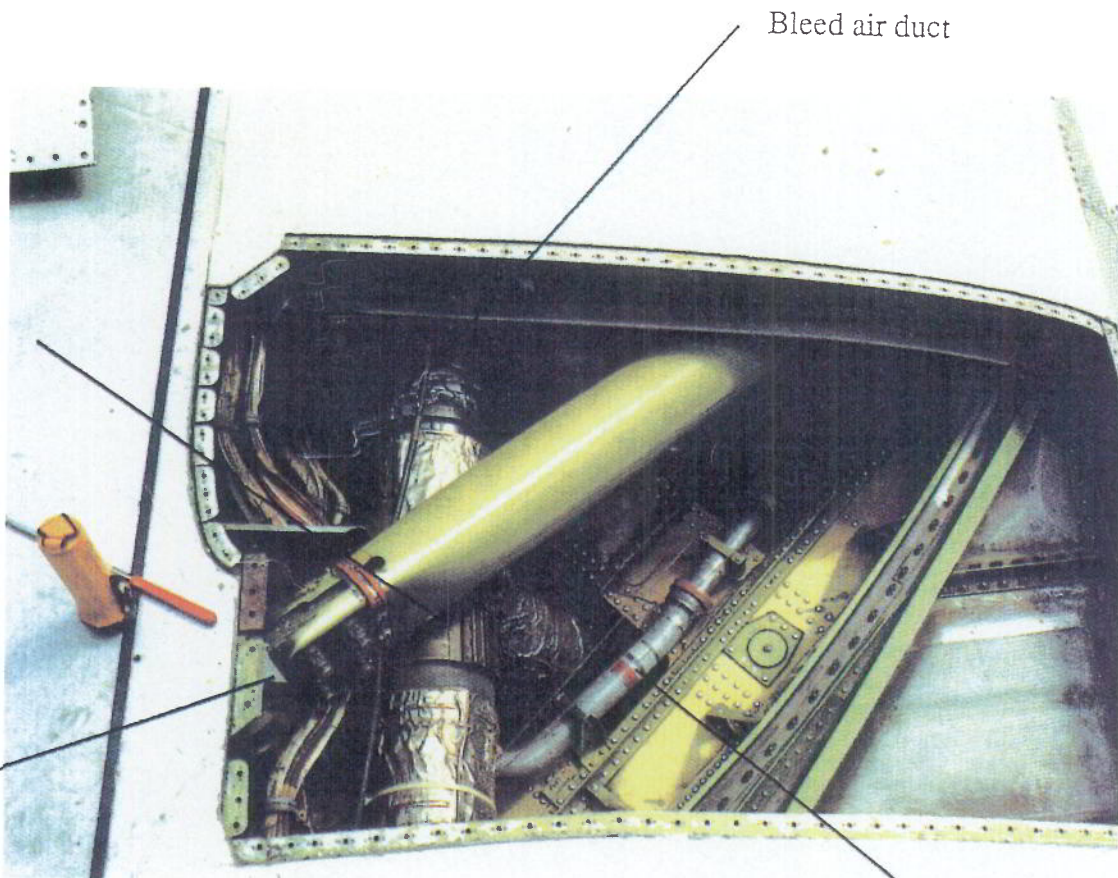
Figure 2

Fuel pipe

- 92-17** The CAA, in consultation with the FAA and the aircraft manufacturer, should require that the aluminium alloy fuel and hydraulic pipes in the four wing leading-edge/pylon zones of the Boeing 747 type be replaced by pipes constructed from materials which meet the fire resistance requirements applicable to designated Fire Zones. The material specification and dimensions of the pipes should be such as will enhance the ability of these pipes to withstand external mechanical impact and abrasion.
