INCIDENT

Aircraft Type and Registration:	Dornier 328-100, G-BWIR	
No & Type of Engines:	2 Pratt & Whitney PW119B turboprop engines	
Year of Manufacture:	1995	
Date & Time (UTC):	20 February 2005 at 1536 hrs	
Location:	London City Airport, London	
Type of Flight:	Public Transport (Passenger)	
Persons on Board:	Crew - 3	Passengers - 26
Injuries:	Crew - None	Passengers - None
Nature of Damage:	None	
Commander's Licence:	Airline Transport Pilot's Licence	
Commander's Age:	38 years	
Commander's Flying Experience:	3,520 hours (of which 3,130 were on type) Last 90 days - 180 hours Last 28 days - 57 hours	
Information Source:	AAIB Field Investigation

Synopsis

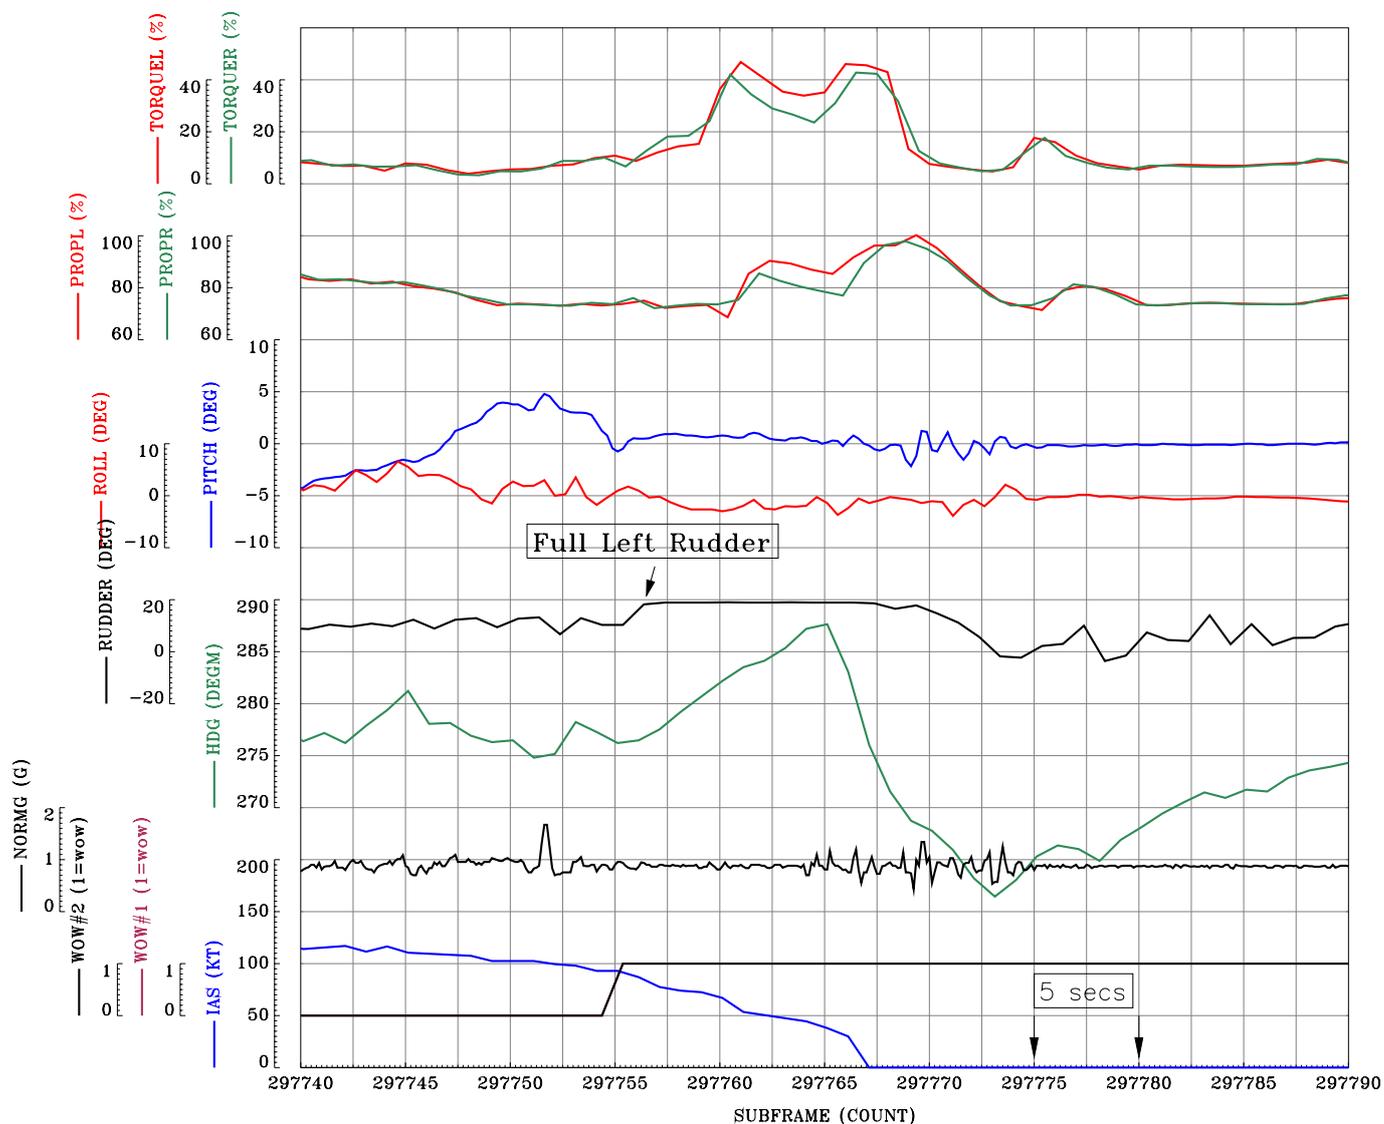
A time history of relevant flight data parameters for the landing at LCY is shown in Figure 1. The weight-on-mainwheels discrettes (there was no weight-on wheels discrete for the nose wheel) were activated when the

airspeed was about 93 kt, although it is possible that the aircraft may have touched down momentarily 4 seconds earlier, when there was a large increment in normal acceleration at an airspeed of about 102 kt.

There was a difference in engine torque of the order of 2% (right torque greater than left torque) just after touch-down. As soon as the aircraft touched down, the aircraft started to diverge to the right at a calculated rate of about 1°/sec. Despite the application of full left rudder 1 second after touch-down, the aircraft continued to diverge to the right. It is inferred from the normal acceleration and pitch attitude data that the aircraft left the paved runway about 9 seconds after touch-down. The airspeed at this time was about 48 kt. About 1 second later the turn to the right was arrested and the aircraft started to turn to the left. It is inferred, again from the normal acceleration and the pitch attitude data, that the aircraft regained the paved runway about 18 seconds after touch-down.

It can be seen from Figure 1 that, at about 5 seconds after touch-down, the difference in torque between the left and right engines was reversed (left torque greater than right torque). This difference was of the order of 4% and lasted for about 9 seconds. This is consistent with the crew attempting to control the yawing motion with differential propeller settings. Also, it can be seen that the pitch attitude remained at about 1° nose up during this part of the landing run and that the elevators remained slightly in the nose up sense until the turn to the right was arrested.

Salient Flight Data Parameters
Serious Incident to Dornier 328, G-BWIR, at London City Airport on 20 February 2005

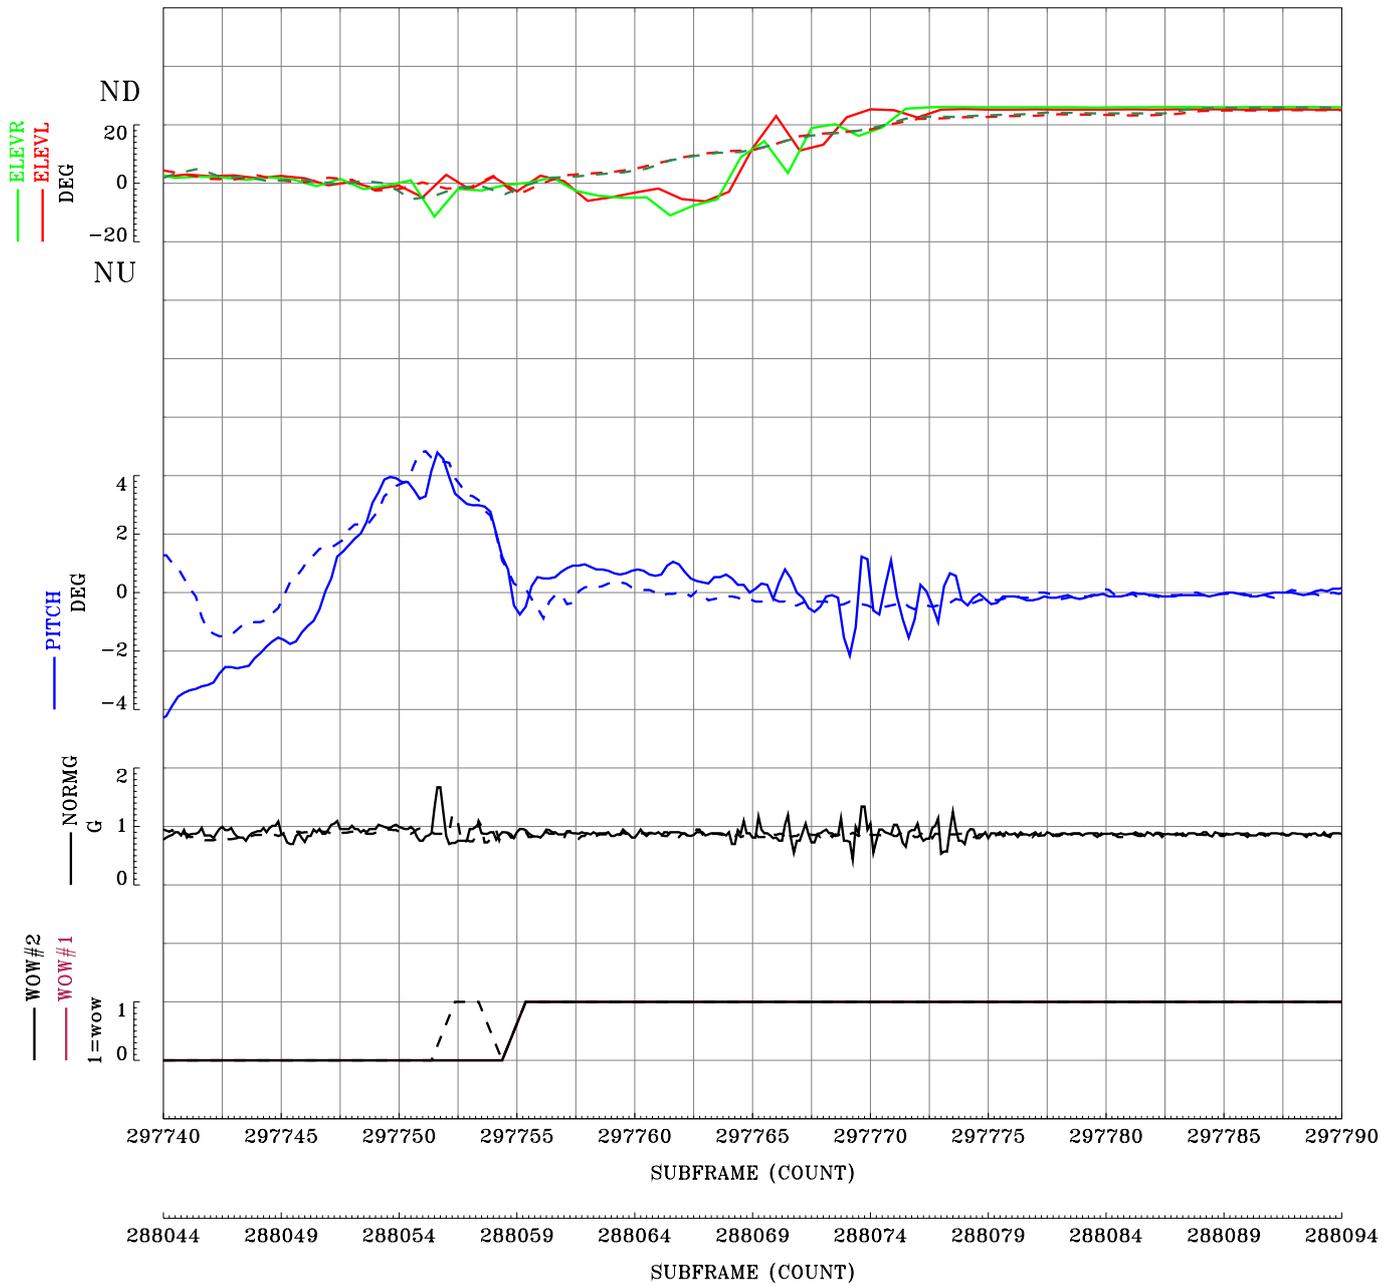
Figure 2

A comparison of the pitch parameters during the incident and during the previous landing is shown in Figure 2. It can be seen that the pitch attitude is about 0° during the previous landing and this was also the case for the other previous recorded landings.

Comparison of Accident Pitch Parameters (solid) with Previous Landing (dotted) Accident to Dornier 328, G-BWIR, at London City Airport on 20 February 2005
