No: 4/92

Ref: EW/G92/01/12

Aircraft Type and Registration: Britten-Norman Islander, BN2A, G-BDWG

Location: Prestwick Airport, Strathclyde

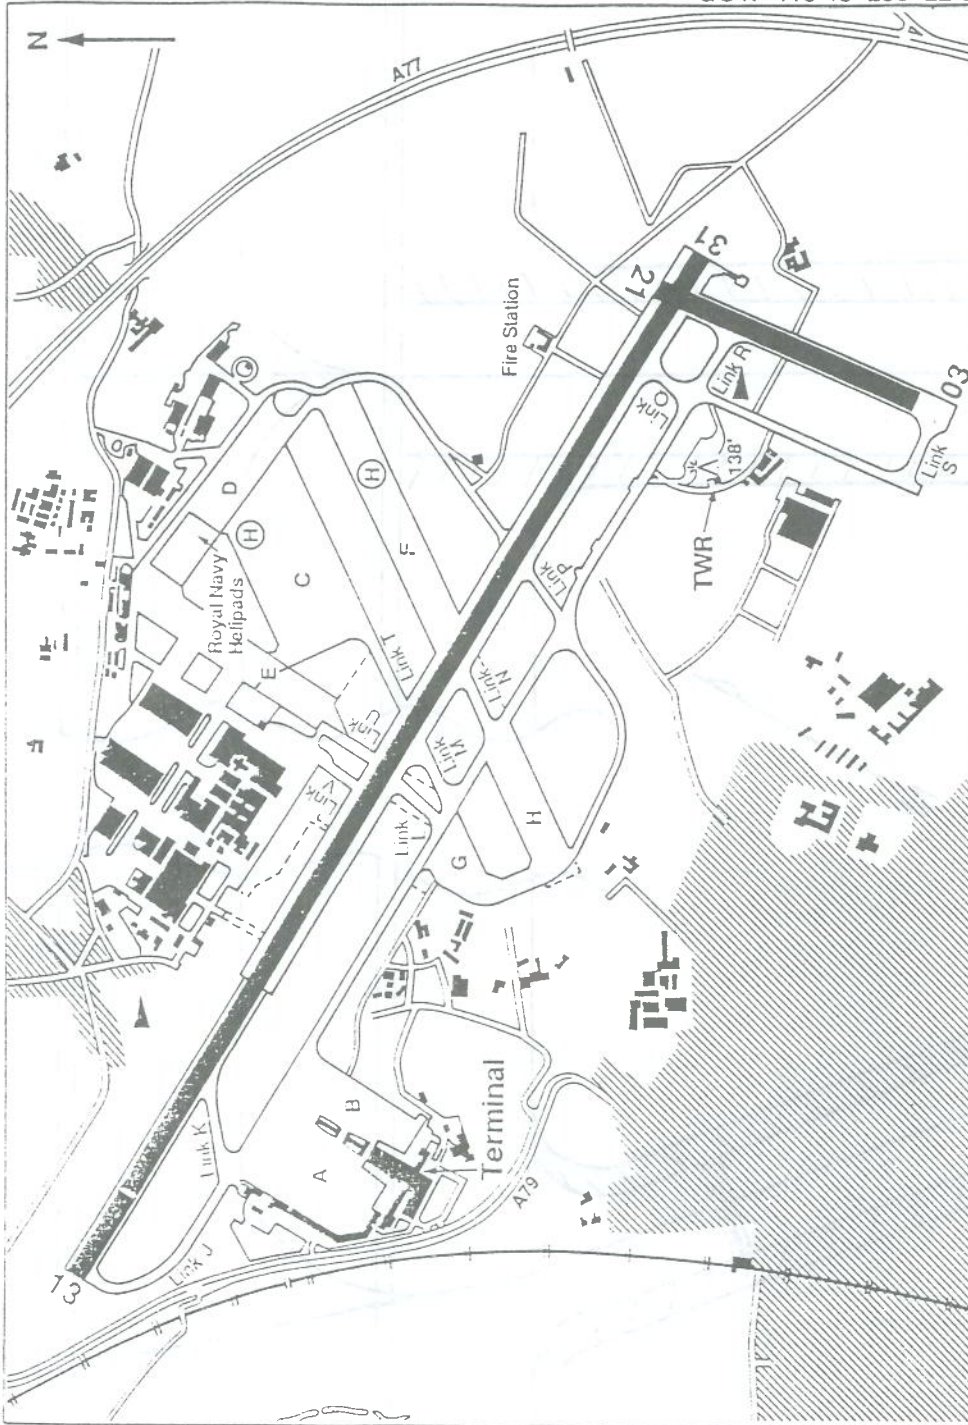
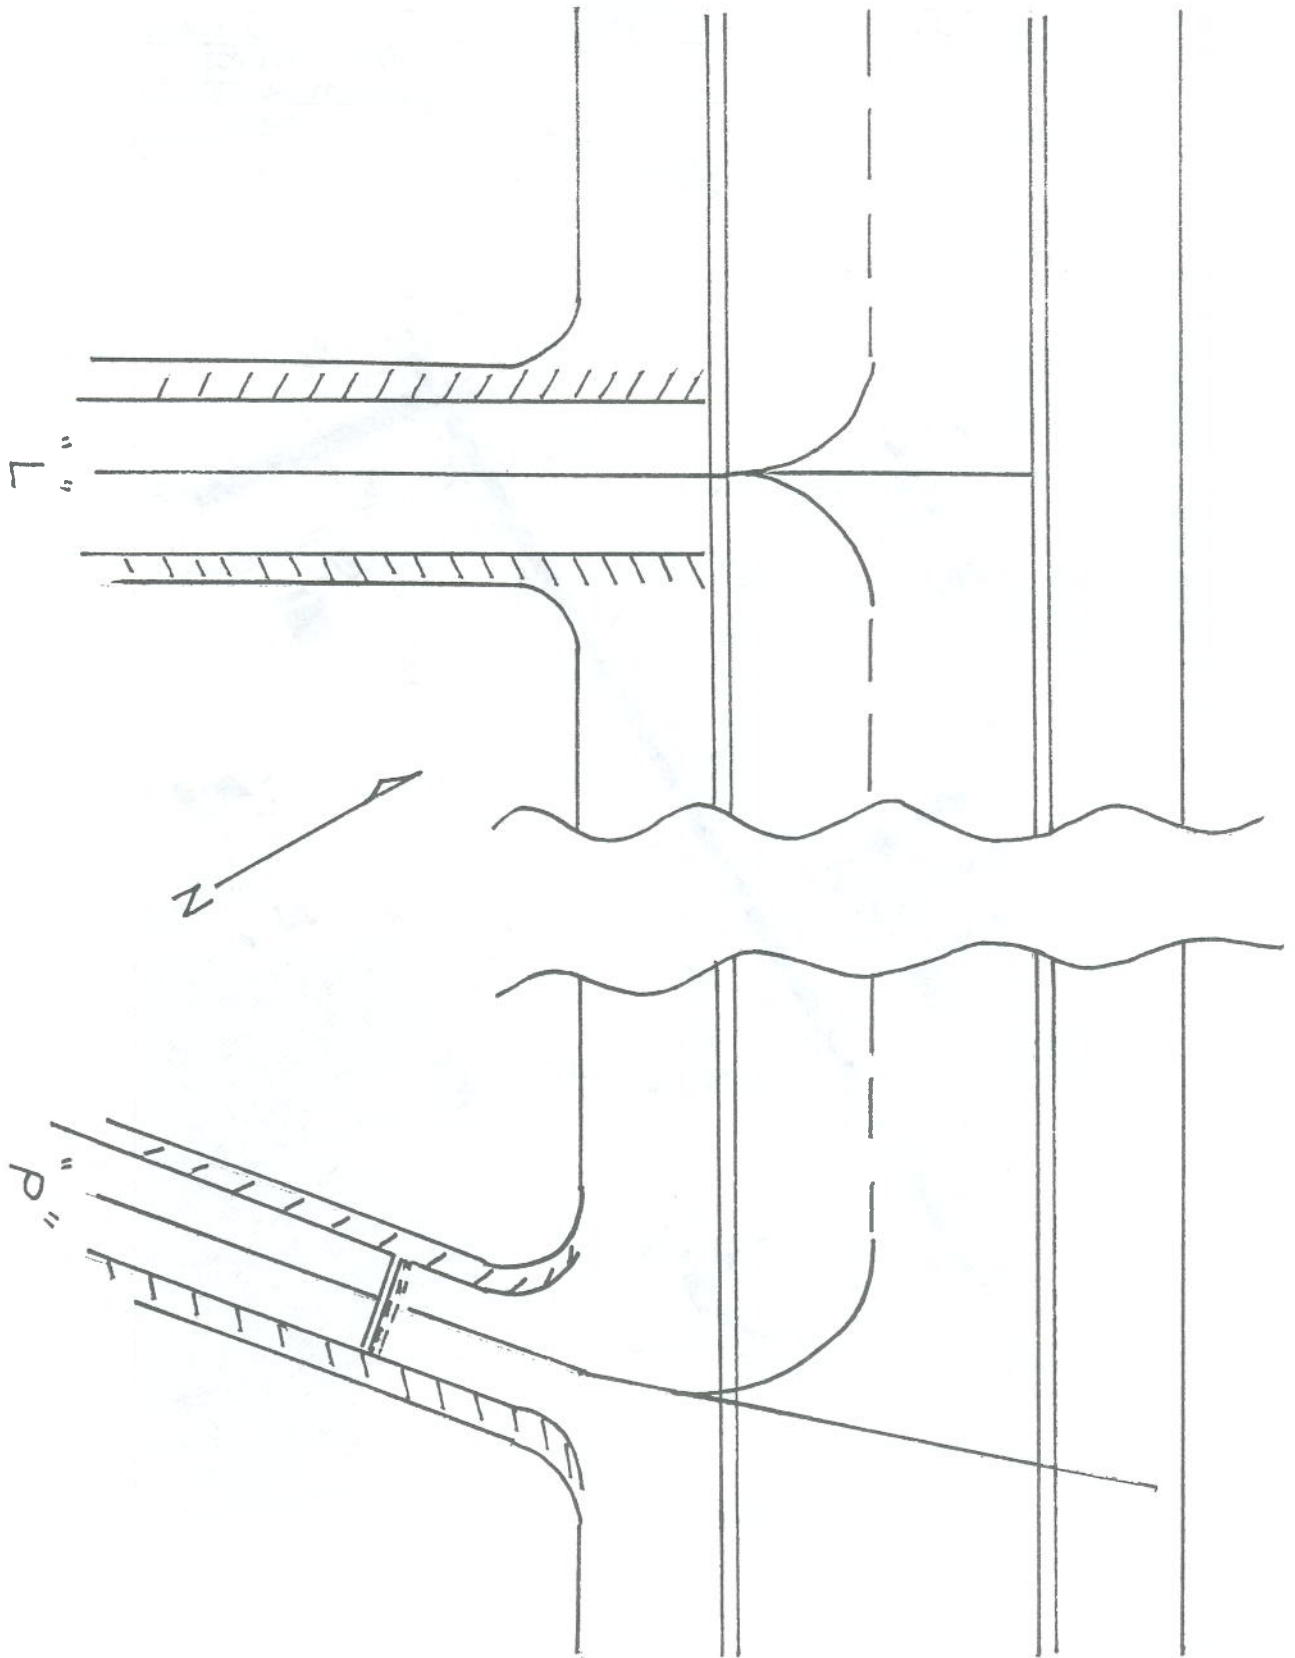
The pilot reported that as he taxied onto the runway he must have mistaken the taxiway edge lines for the centre line. These edge lines curve towards the grass edges adjacent to the hard shoulders where the taxiway meets the runway. As they curve they become worn and indistinct. The yellow painted taxiway centre line, which crosses the runway and leads into the runway centre line, had also become worn and faded in the area of the hard shoulder.

In his report the pilot stated that his entrance onto the runway was from link 'L' (see attached airfield plans). However, inspection of the runway lights at Prestwick revealed damage to one runway edge light in block adjacent to the link 'P' entrance. If the aircraft had commenced its take-off roll from link 'L' this light would have been behind it. The taxiway markings on link 'L' also differ from those described by the pilot in that the taxiway edge lines extend across the runway hard shoulders to meet the runway edge lines and lights. Markings on the link 'P' entrance match those described in the pilot's report. When these anomalies were brought to the pilot's attention he stated that, on reflection, he was unsure of which taxiway link had been used.

It has been recommended that the CAA should carry out an audit of those airfields, where the paved surface extends beyond the runway width, in order to standardise the surface markings at taxiway / runway junctions designed to lead aircraft onto the centreline. Furthermore, it has been recommended that where taxiway guidance is by painted marks alone and possible confusion exists, consideration should be given to restricting the use of these taxiway / runway junctions to daylight hours only.
