Cessna 421C Golden Eagle, G-SAIR

AAIB Bulletin No: 4/2004	Ref: EW/C2003/03/02	Category: 1.2
Aircraft Type and Registration:	Cessna 421C Golden Eagle, G-SAIR	
No & Type of Engines:	2 Continental Motors GTSIO-520-L piston engines	
Year of Manufacture:	1978	
Date & Time (UTC):	29 March 2003 at 1229 hrs	
Location:	Humberside International Airport, North Lincolnshire	
Type of Flight:	Private	
Persons on Board:	Crew - 3	Passengers - None
Injuries:	Crew -	Passengers - N/A
	1 (Fatal)	
	1 (Serious)	
	1 (Minor)	
Nature of Damage:	Aircraft destroyed	
Commander's Licence:	See Report Text	
Commander's Age:	See Report Text	
Commander's Flying Experience:	See Report Text	
Information Source:	AAIB Field Investigation

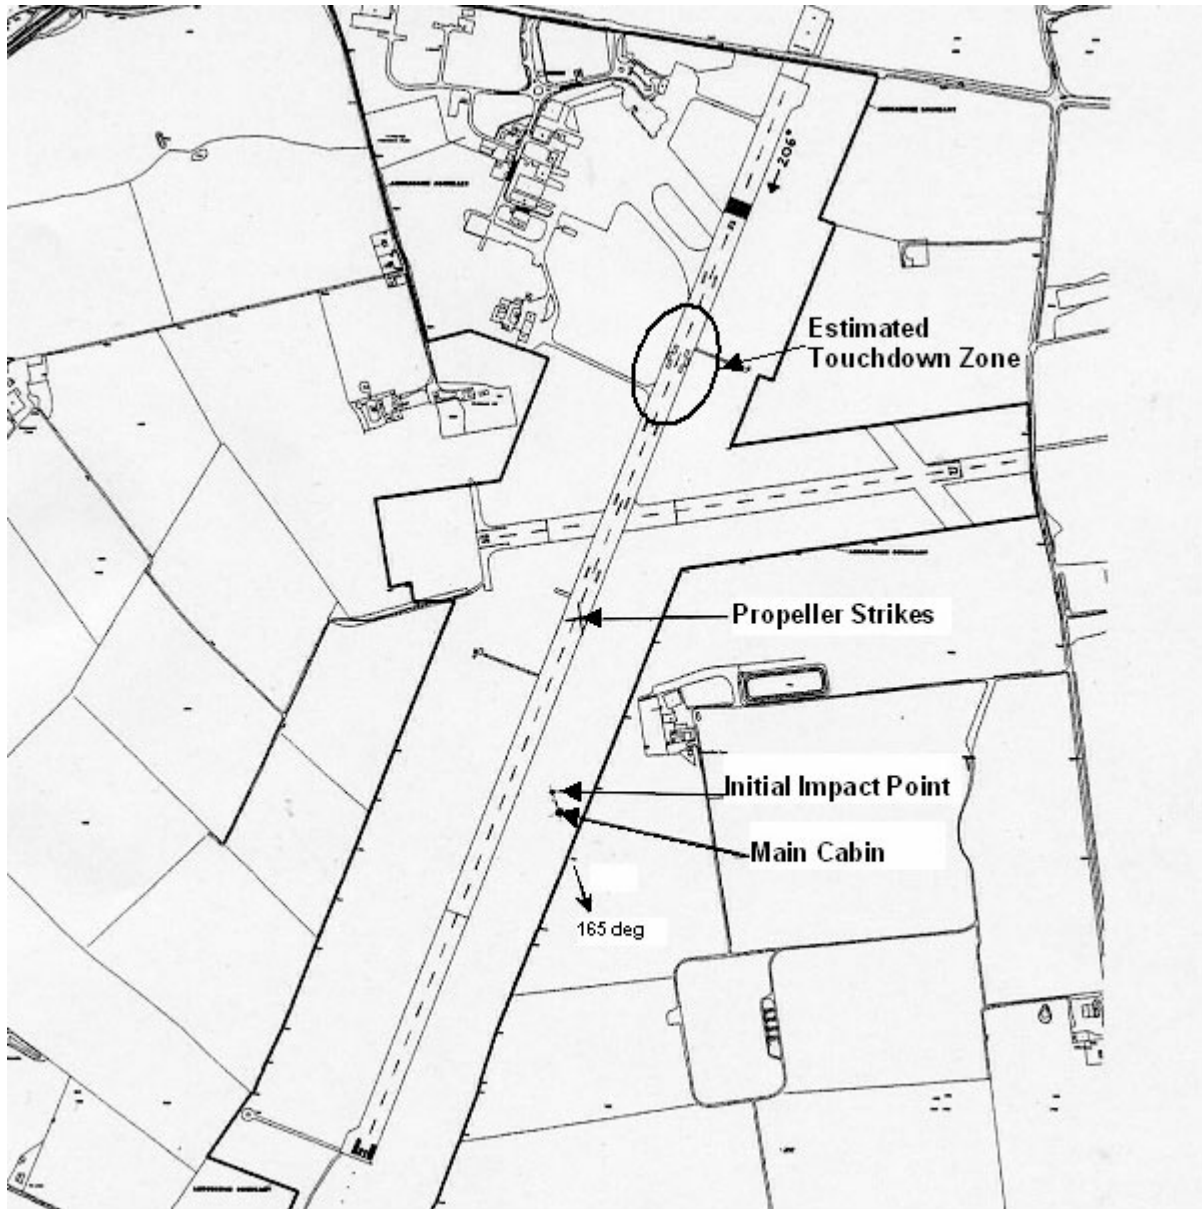
Figure 1 - Accident Site Location

The initial impact point was located in the grass area 75 metres to the left (east) of the Runway 21 centreline, abeam a position approximately 1,170 metres (3,825 feet) along the length of Runway 21 (see Figure 1). Following initial impact on a track of 165°(M), the main cabin had travelled a distance of 42 metres before coming to rest facing opposite to the direction of travel. The aircraft and surrounding area had been engulfed in fire. The wreckage trail was strewn with items from the nose section baggage compartment. The left wing had separated from the aircraft and lay inverted near the main cabin. A fragment of the left wing tip strobe light was found close to the initial impact mark. The nose gear and nose gear strut lay in the wreckage trail leading to the main cabin. All three propeller tips from the right powerplant and two propeller tips from the left powerplant were bent backwards. One propeller tip from the left powerplant was bent forwards.

A number of propeller strike marks were found on the runway approximately 330 metres from the initial impact point (see Figure 1).

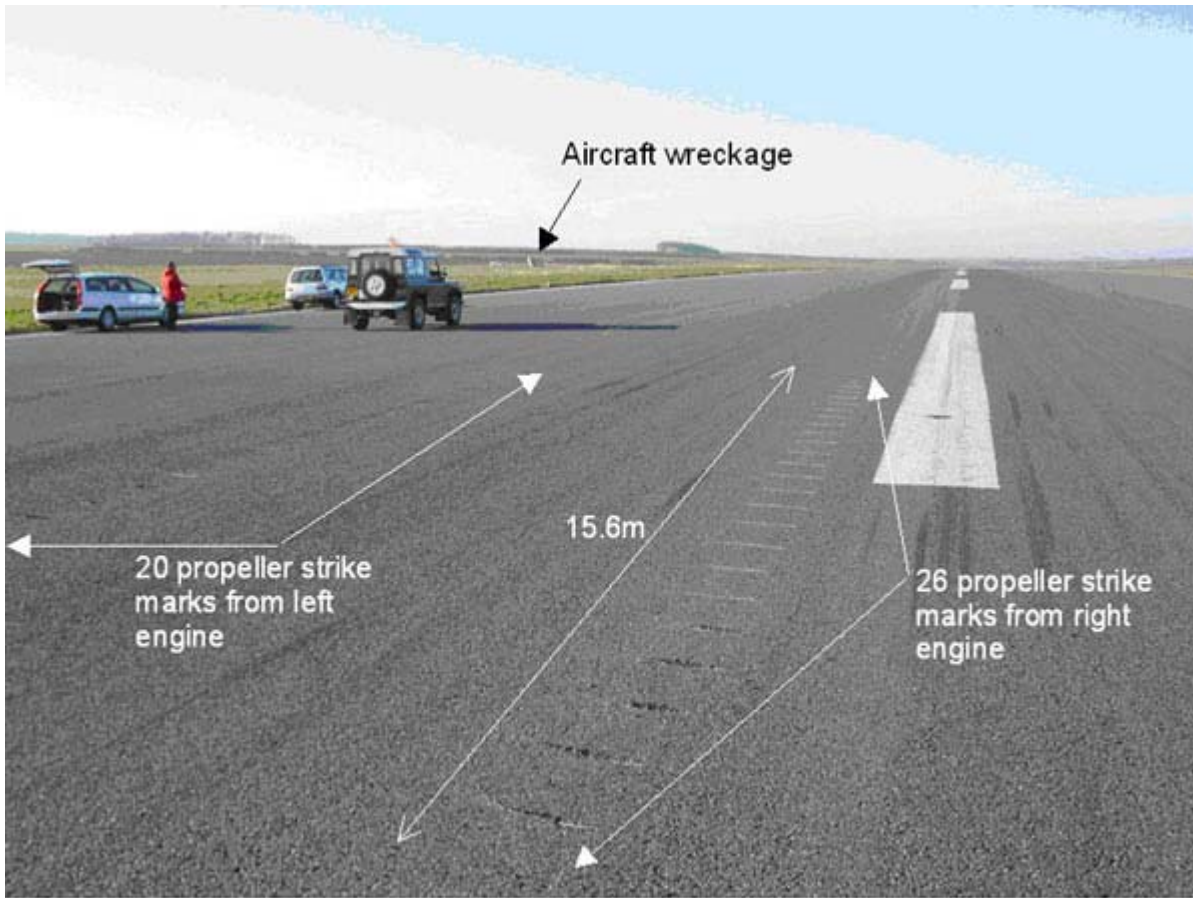
Figure 2 - Propeller strike marks on runway

There were two sets of propeller strike marks running parallel to each other slightly offset to the left of the runway centreline (see Figure 2) indicating that the aircraft was in a near wings-level attitude when the strikes occurred. The right propeller had produced a set of 26 propeller strikes with an initial minimum spacing of 54 cm and a final maximum spacing of 68 cm. The left propeller had produced a set of 20 propeller strikes with an initial minimum spacing of 56 cm and a final maximum spacing of 87 cm. The left propeller strikes started 2.8 metres further along the runway than the strikes on the right but ended in approximately the same abeam location. The first six strikes on each side caused deep gouges in the runway surface while subsequent strikes caused lighter marks.

If the propellers were operating at their maximum RPM for takeoff (2,235 RPM) when the right propeller struck, then based on the spacing of the runway strikes, the aircraft's ground speed was approximately 116 ± 4 kt. With a reported tailwind of 3 kt the aircraft's airspeed was approximately 113 ± 4 KIAS (pilot's normal rotation speed was 111 KIAS). The increasing spacing of the propeller strikes indicated that the propellers were slowing down as a result of the strikes. Assuming a constant ground speed of 116 kt during the strikes, the final RPM on the right propeller when the strikes ended was approximately 1,750 and the final RPM on the left propeller was approximately 1,350. The total time duration of the propeller strikes was approximately 0.26 seconds. Given the short duration of the strikes, it is reasonable to assume that the aircraft's ground speed remained approximately constant during that period. Alternatively, if the propellers had been left at the cruise/landing setting of 1,900 RPM then the aircraft's ground speed when the propellers struck would have been approximately 100 ± 4 kt (97 ± 4 KIAS).

The angle of each propeller strike mark - apart from one - was approximately the same: between 10° and 17° relative to a line perpendicular to the direction of travel. However, the sixth strike on the left side left a deep gouge at an angle of 26° .

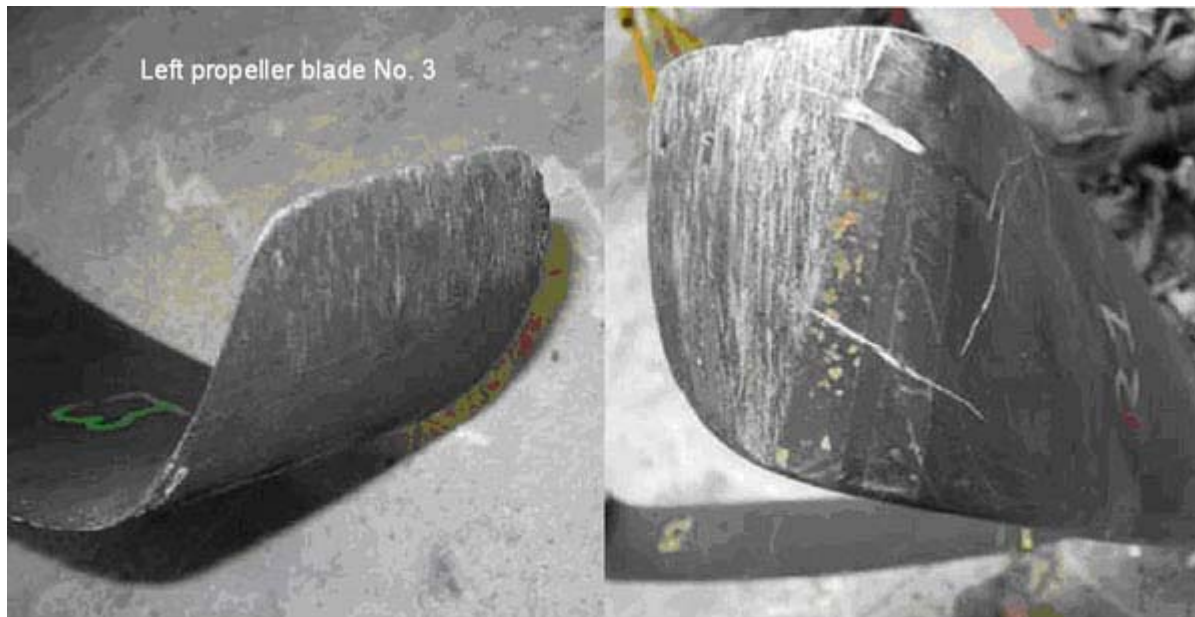
Figure 3 - Spanwise scratches propeller blade (left) versus chordwise scratches (right)

one blade of the left propeller (blade No 3) had been bent forwards with spanwise scratches (see Figure 3).

Internal inspection of the left propeller hub revealed that the actuating pin on the blade root of the No 3 blade had disconnected from the pitch change link allowing it to rotate freely to any pitch angle. Due to the counterweights on the propeller blade roots, the inertial forces due to rotation would cause a disconnected blade to rotate towards the feathered position. This would explain why the No 3 left propeller blade appears to have struck in a near-feathered position creating the spanwise scratches. It is also probable that the left No 3 blade created the unusual left propeller strike mark with an angle of 26°.

Examination of the witness marks inside and outside the propeller hub revealed that both propellers were operating in the fine pitch range when the initial runway strikes occurred but the exact amount of power being produced could not be determined. The damage to the blade tips on the right propeller would have reduced the thrust being produced but no data existed for determining the degree of thrust reduction. The damage to the left propeller would have had a more significant effect on the thrust being produced. The disconnected No 3 blade, in a coarse near-feather position, would have produced significant drag and slowed the rotation of the left engine. As the rotation slowed, the other two propeller blades would have rotated to a finer position (in an attempt by the governor to re-establish the set RPM) thus reducing the thrust being produced by those two blades. The net effect on thrust could not be quantified but it is possible that the left engine slowed sufficiently to a point where it was producing little thrust or perhaps, due to disturbed airflow created by the No 3 blade, no thrust and only drag.

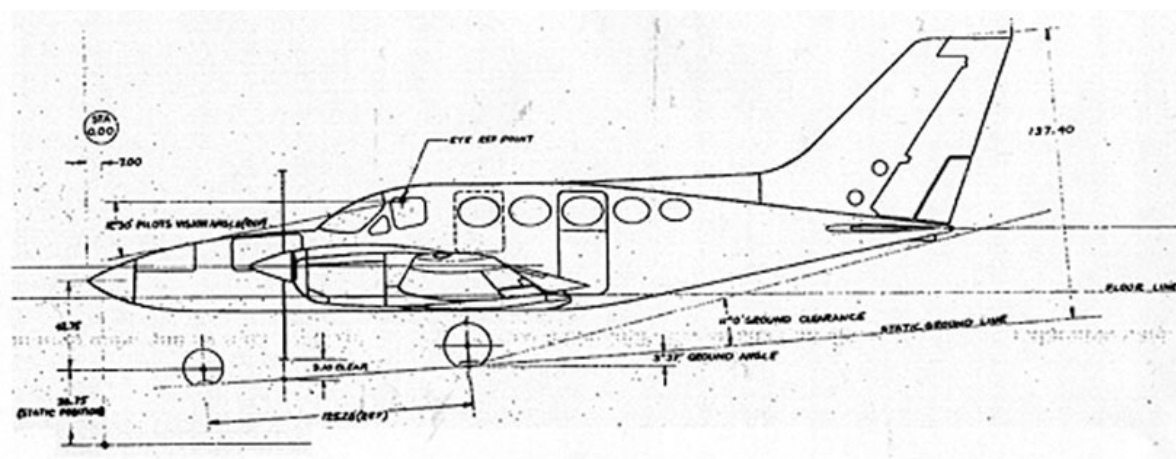
Figure 4 - Cessna 421C geometry

Study of the aircraft's geometry (see Figure 4), and advice given by the manufacturer, indicate that there are only four means by which both propellers can strike the ground simultaneously: (1) collapse of the nose gear, (2) collapse of both main gear, (3) collapse of all the landing gear, or (4) retraction of all the landing gear.

(1) Collapse of the nose gear would result in the aircraft pitching nose down but the owner recalled that the aircraft was in a "slightly nose up attitude" when the propellers struck. No fault was found with the nose gear downlock mechanism and there were physical indications that the nose gear was up and locked at impact. Furthermore it seems improbable that the nose gear would have collapsed 8-10 seconds after the initial touchdown.

(2) Collapse of both main gear would have resulted in a large nose up attitude before the propeller tips could have struck. No such pitch up was observed or reported. A main gear collapse would also probably have resulted in the aircraft's rear fuselage striking the ground before the propeller tips and no evidence of a fuselage strike was found on the runway.

(3) Collapse of all the landing gear caused by a heavy landing appears unlikely because the aircraft rolled along the runway normally for 8-10 seconds after the initial touchdown. Neither the eyewitnesses nor the instructor thought that the landing was unsafe, and no physical evidence was found to indicate a failure of the landing gear. A simultaneous collapse of all the landing gear therefore seems improbable.

(4) Retraction of the landing gear remains a possibility. The landing gear selector was found in the 'UP' position and the physical evidence was consistent with both the main landing gear
