REPORT ON: Re-evaluation of hub failure - Reference: A-Lab report #93-090805.

SAMPLE IDENTIFICATION: Fracture surfaces of Aluminum Hub
from PA 31-325 G-BMGH.

STRESS ANALYSIS OF PROPELLER HUB FOR FAILED PIPER ENGINE

During a flight on 7th June 1993, a Piper Navajo G-BMGH plane suffered the loss of one of the three propeller blades from the starboard engine. The blade loss was caused by a fracture through the hub at the root of the blade. The crack emanated by fatigue from the inner end of a grease nipple hole. A stress analysis of the hub containing this hole has been made assuming the predominant loading to be the centrifugal loading of the propeller blade. A high stress concentration is seen to exist at the crack propagation site. Another analysis is made when the grease nipple hole lies in the thicker flange region of the hub. There, a reduction in the stress concentration is observed. The results are obtained by three dimensional finite element analysis, from which stresses may be obtained at all locations in the hub. Thus, stresses away from stress raisers like the hole may be compared.

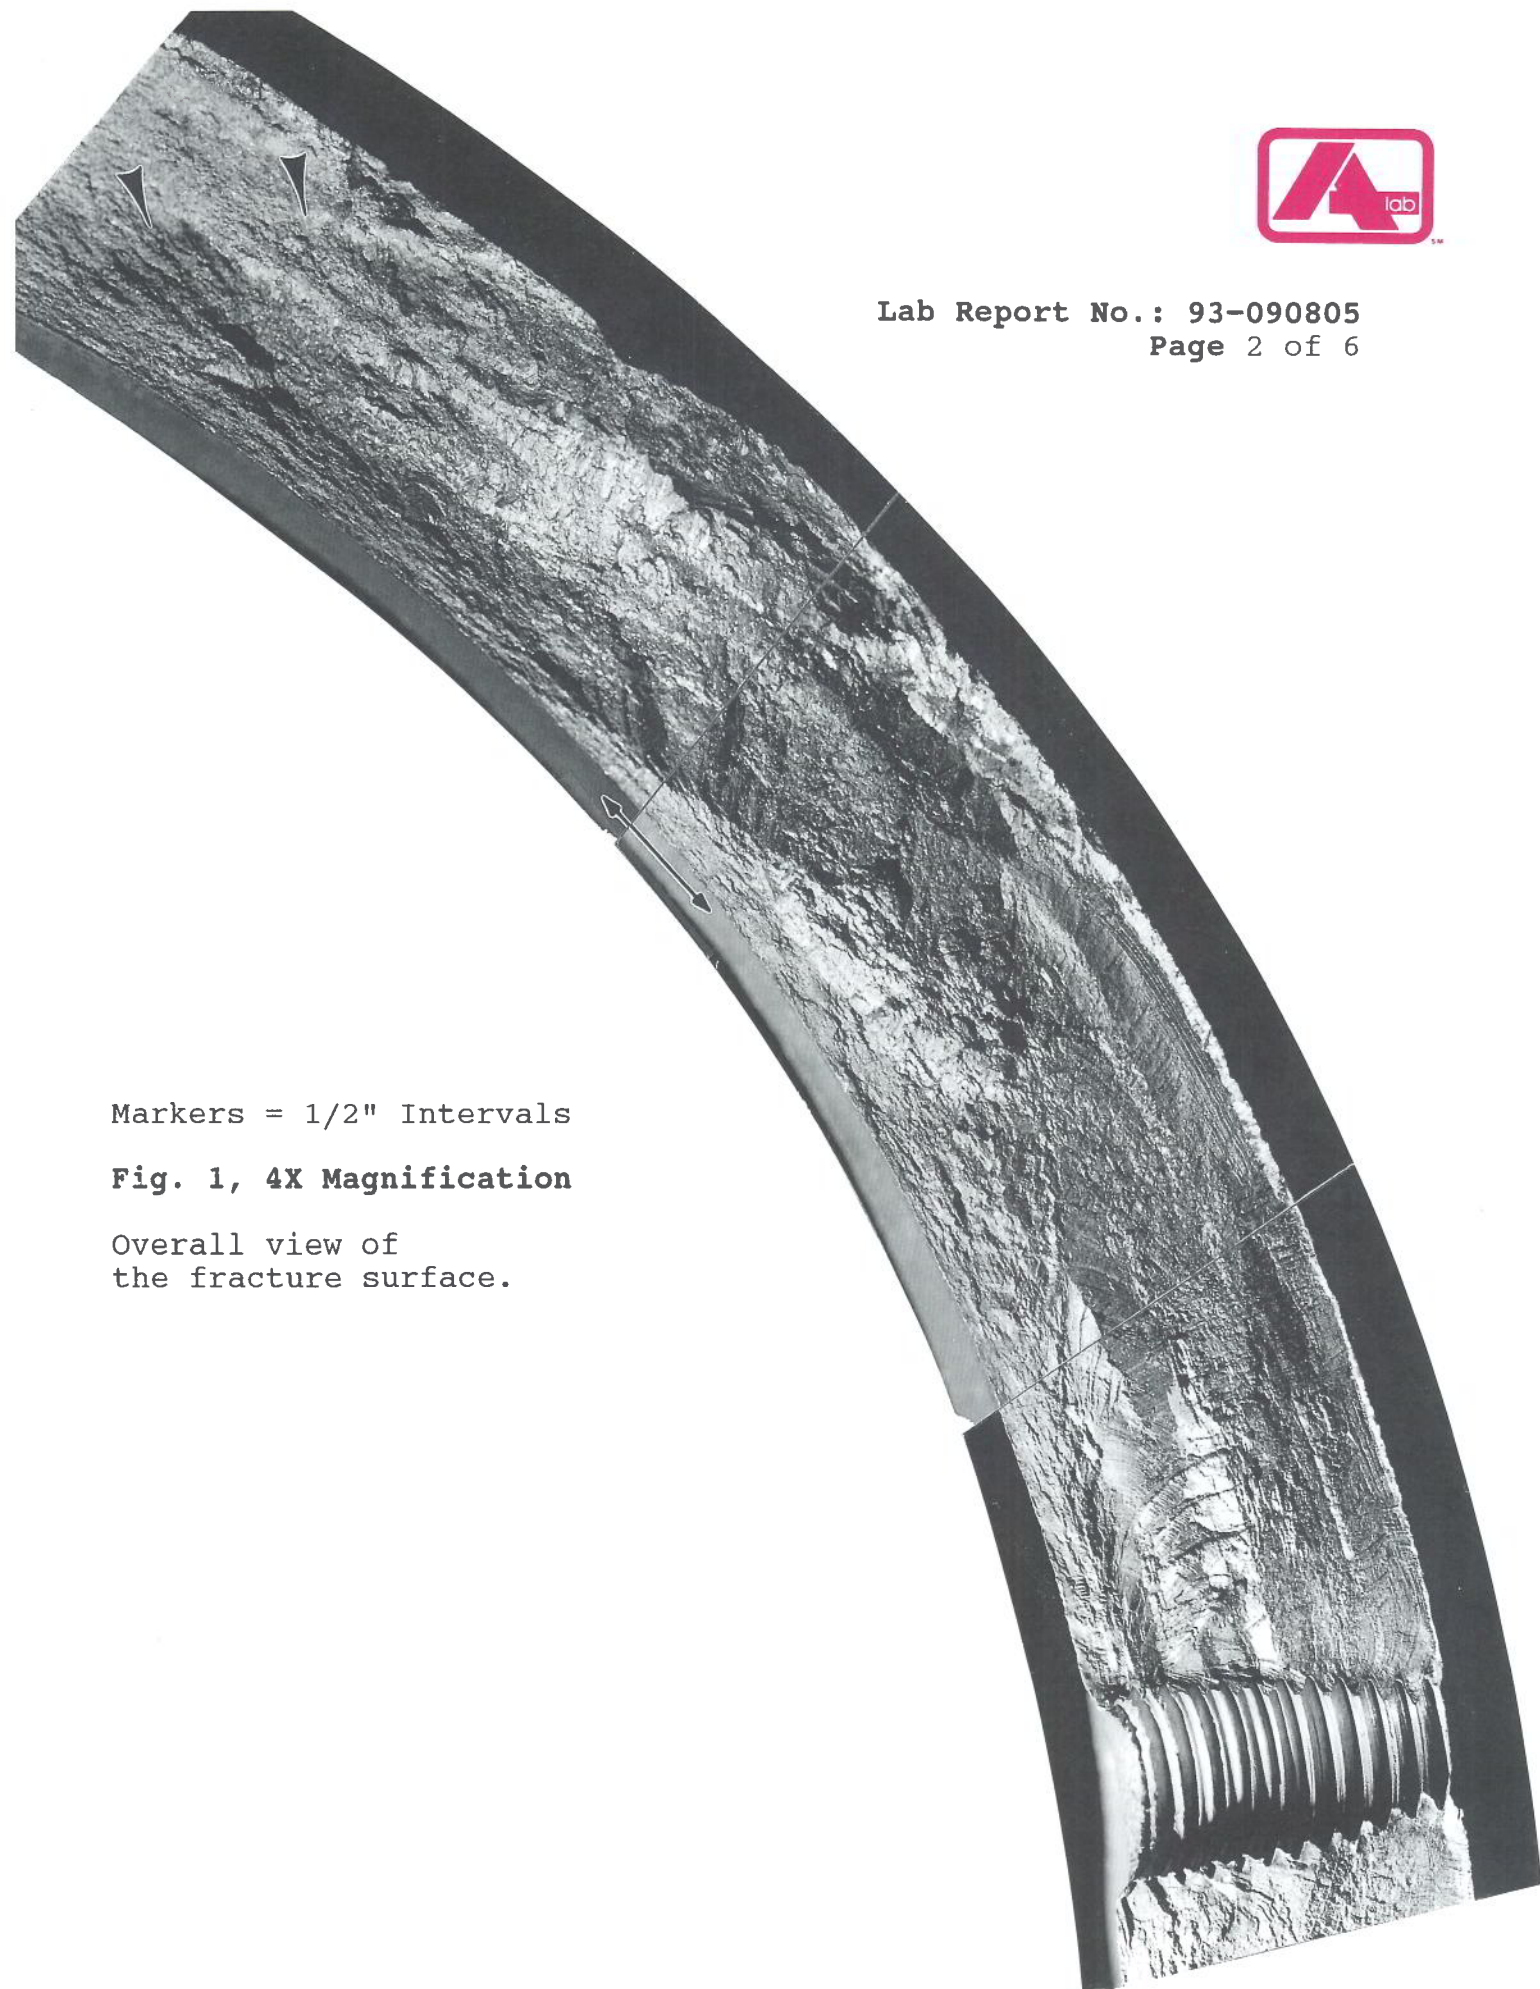
Fig. 1, 4X Magnification

Overall view of
the fracture surface.

Referring to Fig. 1 again, the last striation runs relatively parallel to the fracture surface until about the end of Area 2.

Referring to Fig. 1, the fatigue striations at the outside surface begin to descend towards the inner surface in the latter part of Section 2. The bracket in section 3 suggests the location of the last whole fatigue prior to the crack opening up at the surface. From this observation we can see that the crack on the outside surface become apparent when the crack on the inside was approximately 1 1/4" long. Furthermore the crack on the outside at this time was approximately the same length.

Referring to Fig. 1 again the arrows indicate the boundary between fatigue and instantaneous overload. The fatigue in this latter part of the crack, sections 4 and 5, is made up of numerous small fatigue fronts such as Fig. 4. These small fronts combine as one large progressing crack which is observed macroscopically as a faint semi-circular indication (arrows section 5 of Fig. 1)

From these observations, the approximate length of the crack prior to instantaneous overload can be measured. Referring to Fig. 1 again, using the 1/2" markers, the length of the crack on the outside was approximately 2 1/4" long and was approximately the same length on the inside.

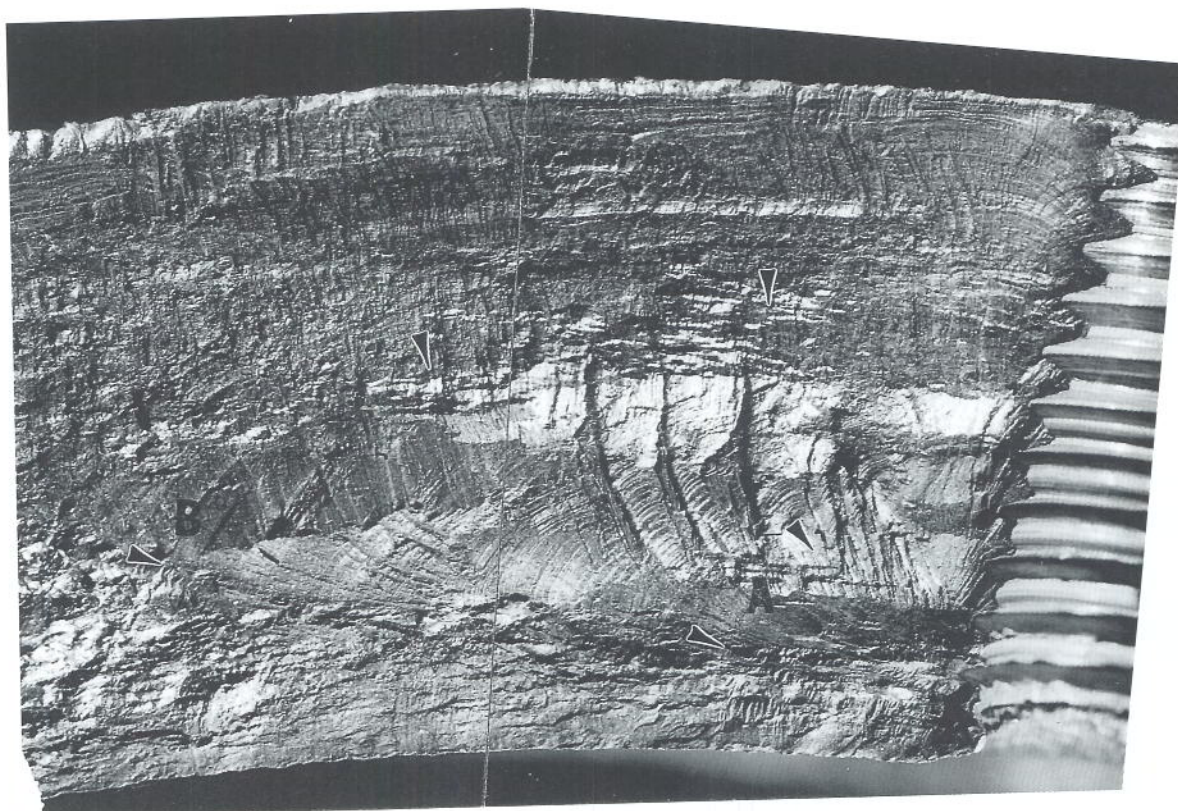
**Fig. 2, 8X Magnification
View of Section 1 of Fig. 1**

The origin of the fatigue is located at the last thread in the grease nipple hole and initiated in a shot peened surface.

The fatigue striation near the fracture origin are relatively uniform, i.e. equal distance along the inside surface as through the cross section. This condition is constant till about $3/16$ " from the origin. The fatigue striations from this point on, elongated, or progressed, faster on the inside until they became parallel to the outside surface. Considering two fatigue striations (A & B in Fig. 2) striation A exhibits a relatively uniform progression through the thickness as along the inside surface. Striation B exhibits a 2 to 1 ratio in length along the inside surface as through the thickness.

Between striation A and B the fatigue striations are 90 degrees to the inside surface. As the crack front approaches striation B however, the angle becomes more acute. This crack progression is necessary for the crack to become parallel to the outside surface.

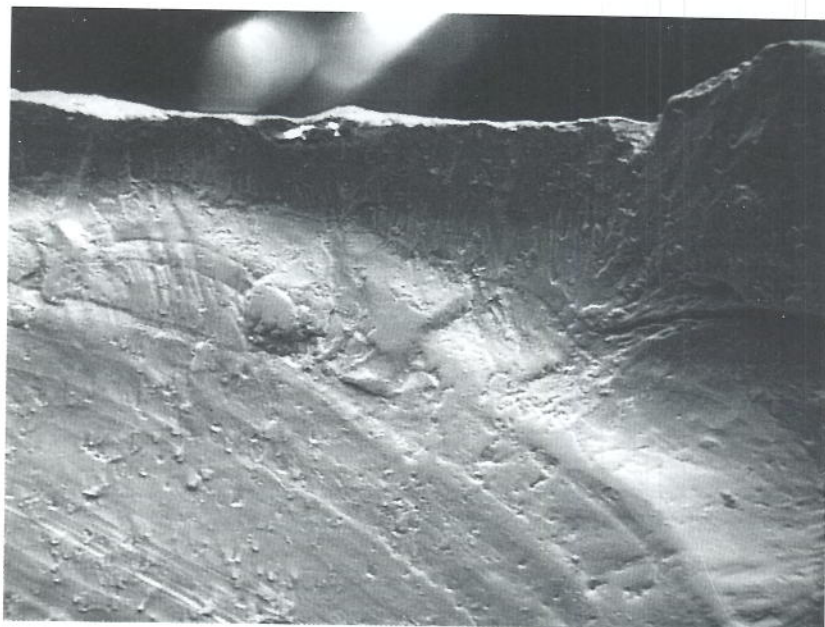
Fig. 3, 100X Magnification

View near the top right edge of the fracture shown in Fig. 2 (near threads)

Referring to Fig. 3, the crack arrested prior to breaking through to the outside surface. The applied stresses on the hub are primarily surface tensile stresses and the residual stresses of the shot peened surface.

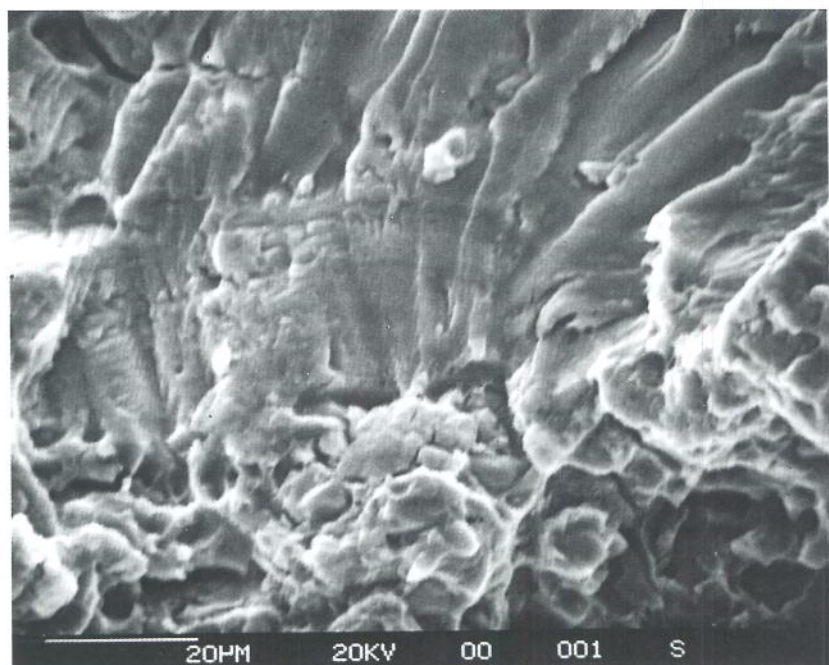
Fig. 4, 1000X Magnification

Scanning Electron Image of the fracture in section 4 and 5 of Fig. 1. Small fatigue zones such as this were observed throughout the area until about mid-way through section 5.

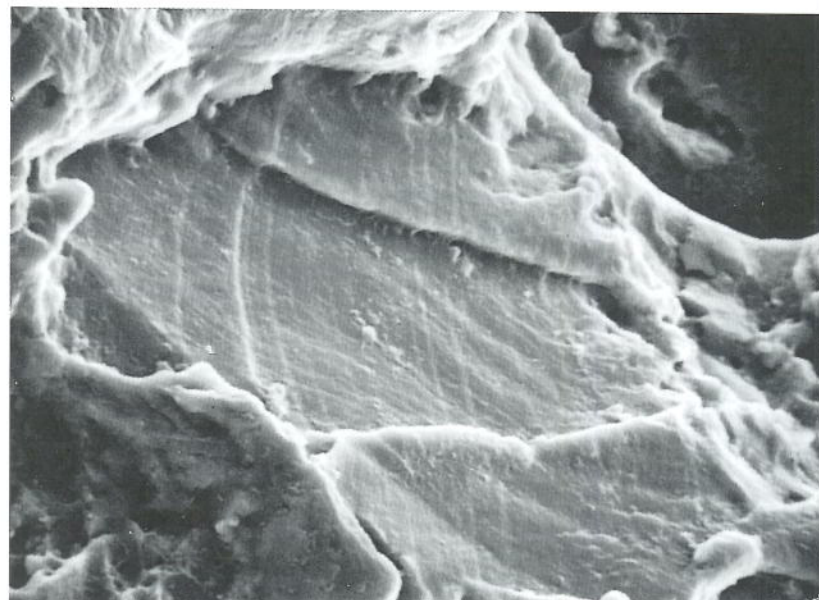
Fig. 5, 1000X Magnification

Additional photomicrograph of the fatigue observed in sections 4-5. The fineness of the striations suggest the mode of crack propagation is high cycle low stress in this area.

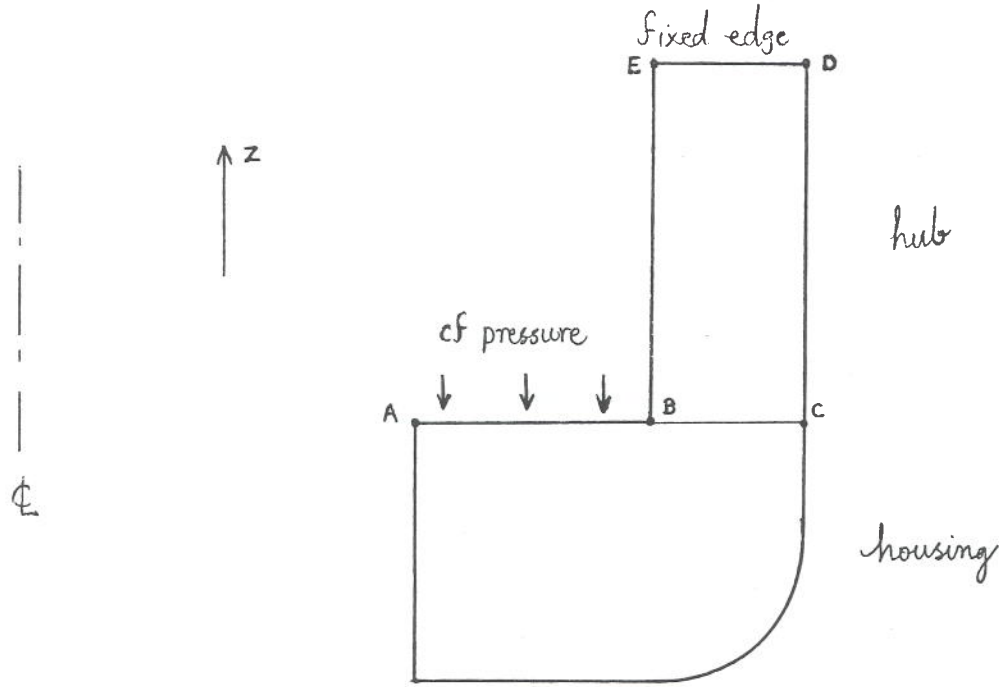
Figure 1 Hub/housing Section for Axisymmetric Analysis

This was applied as a constant pressure to the axisymmetric model of figure 1. The z components of stress across section BC were evaluated. Since in the three dimensional model, 3 elements were to span the thickness BC, the z-stresses were lumped at the centres of each of these elements with the three values of 263 MPa (nearest B), 62 MPa (middle) and -104 MPa (nearest C). This applied to all elements around the hub with a loaded face. The outer, negative, stresses were due to the high degree of bending which the centrifugal forces exert into the hub. This also accounts for the inner grease nipple holes having much higher stresses than at the outer surface.

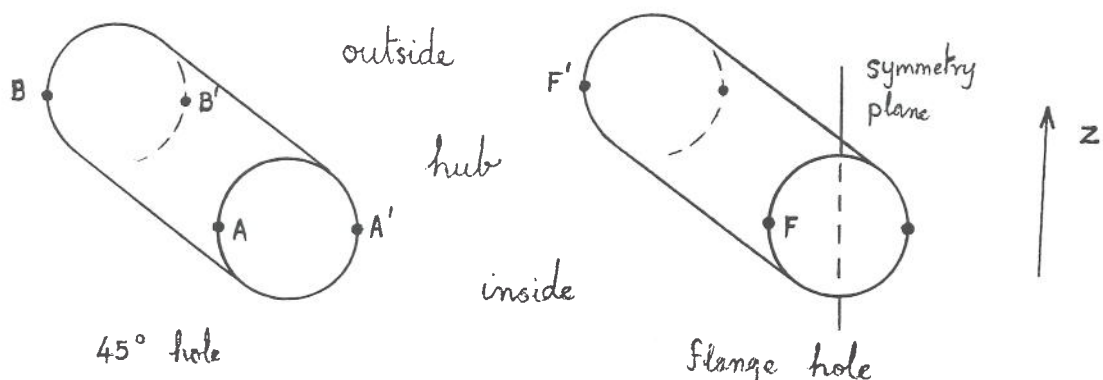
Figure 3 Details of 45° Hole and Flange Hole

The reason for considering the z component of stress instead of other components is because the predominant loading is in the z direction, and it is well known that a hole in a predominantly uniaxial stress field gives rise to stress concentrations along the edges AB and A¹B¹ (or FF¹), and these concentrations are in the local tangential direction.

The results of the finite element analysis show that for the three dimensional analysis of the hub with the 45^0 hole, the maximum z component of stress is on the inside hub surface at the hole and equals 558 MPa under centrifugal loading at 2600 RPM. Without the hole, the corresponding z-stress is 252 MPa, hence the hole gives rise to a stress concentration factor of 2.21.

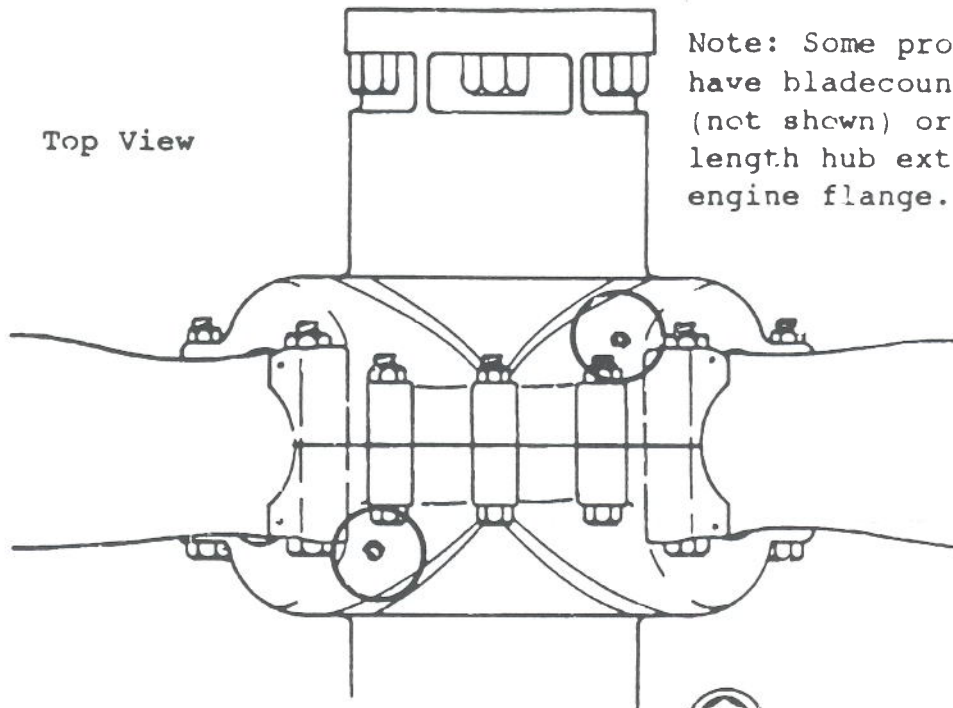
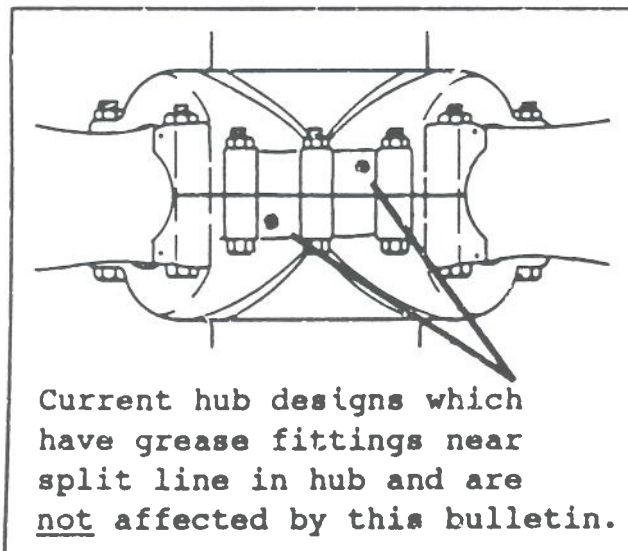
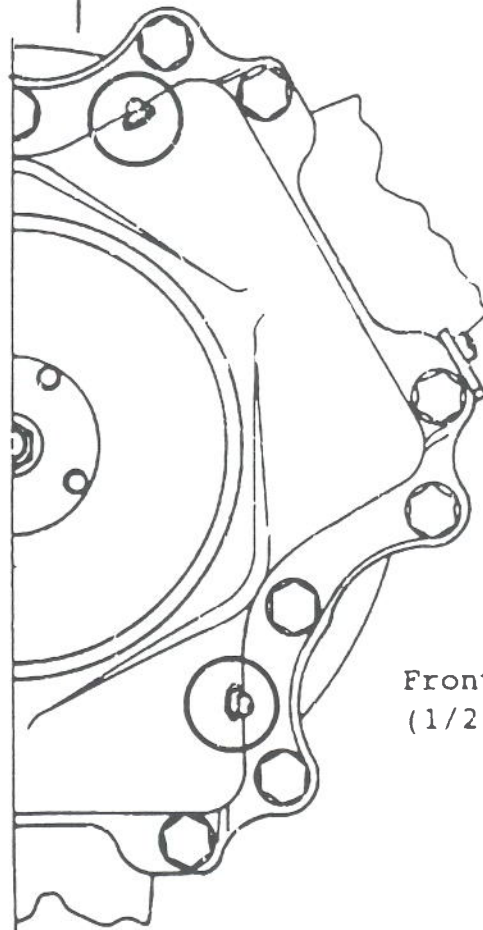
Figure 1. Hub Grease Fittings

Circled areas encompass grease fittings, to be inspected at two points on each blade socket

Current hub designs which have grease fittings near split line in hub and are not affected by this bulletin.

1. Remove spinner dome.
2. If present, remove any paint*, grease or other matter which may hinder visual examination.
3. Use 10X magnifying glass to perform careful visual inspection of the hub for hairline cracks in the general vicinity of blade retention bearings, but primarily, inspect the grease fitting areas as shown in Figure 1.

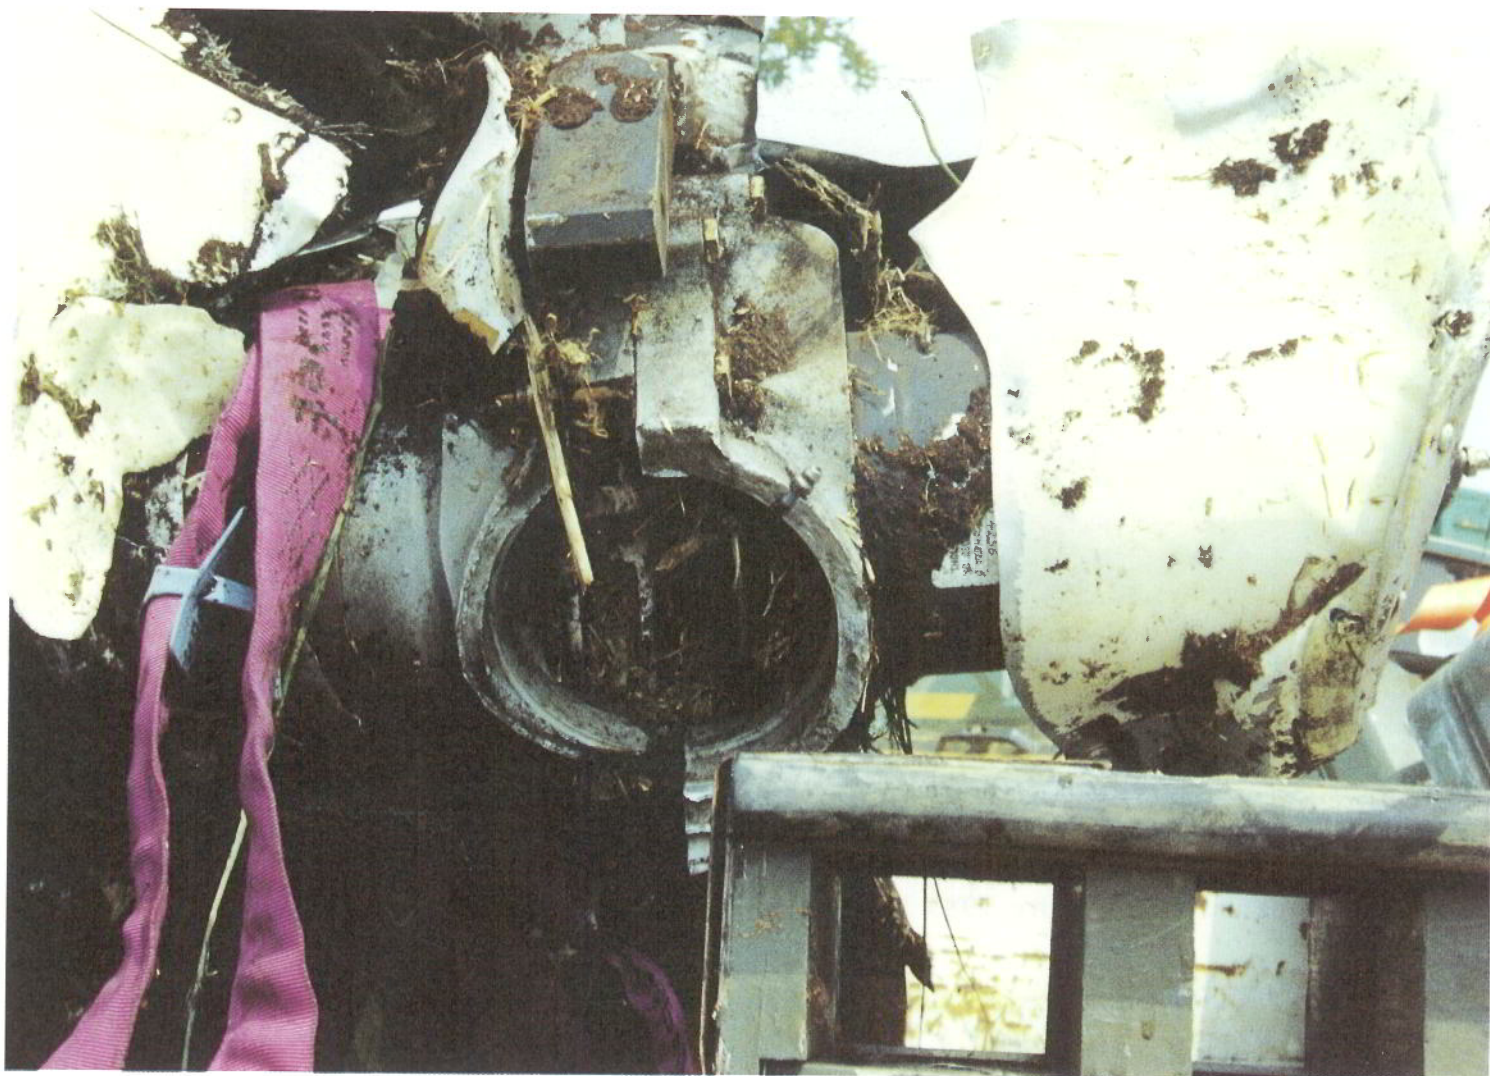
Figure 3 View of the failed propeller hub at the accident site

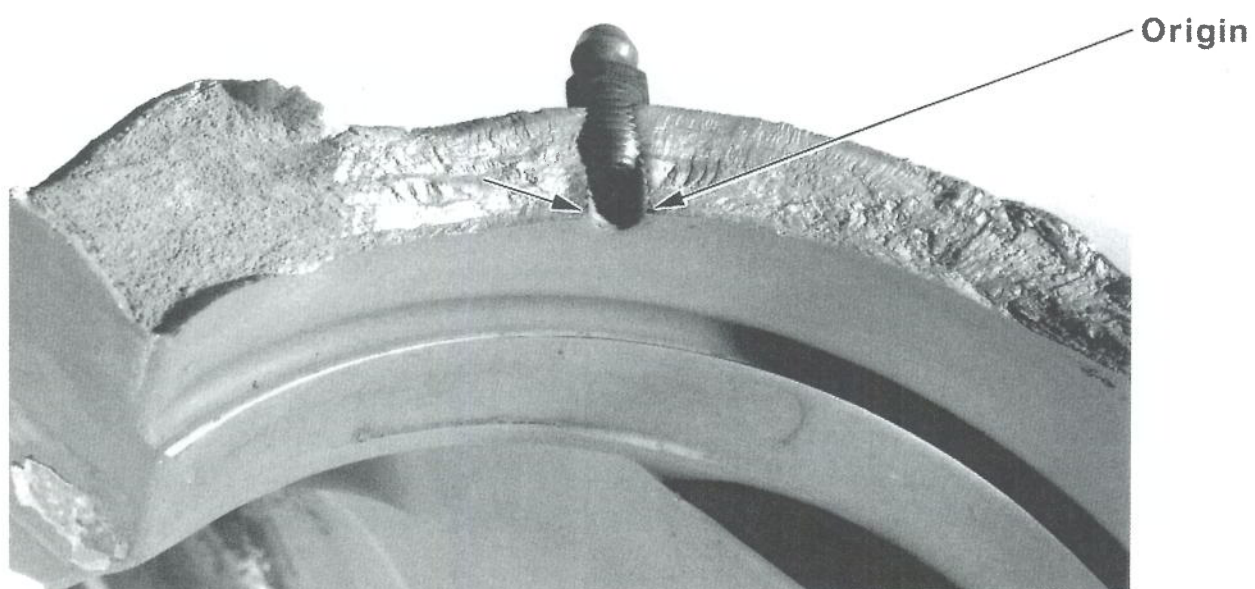
Figure 4 Fatigue cracked region on the inner half of the hub fracture

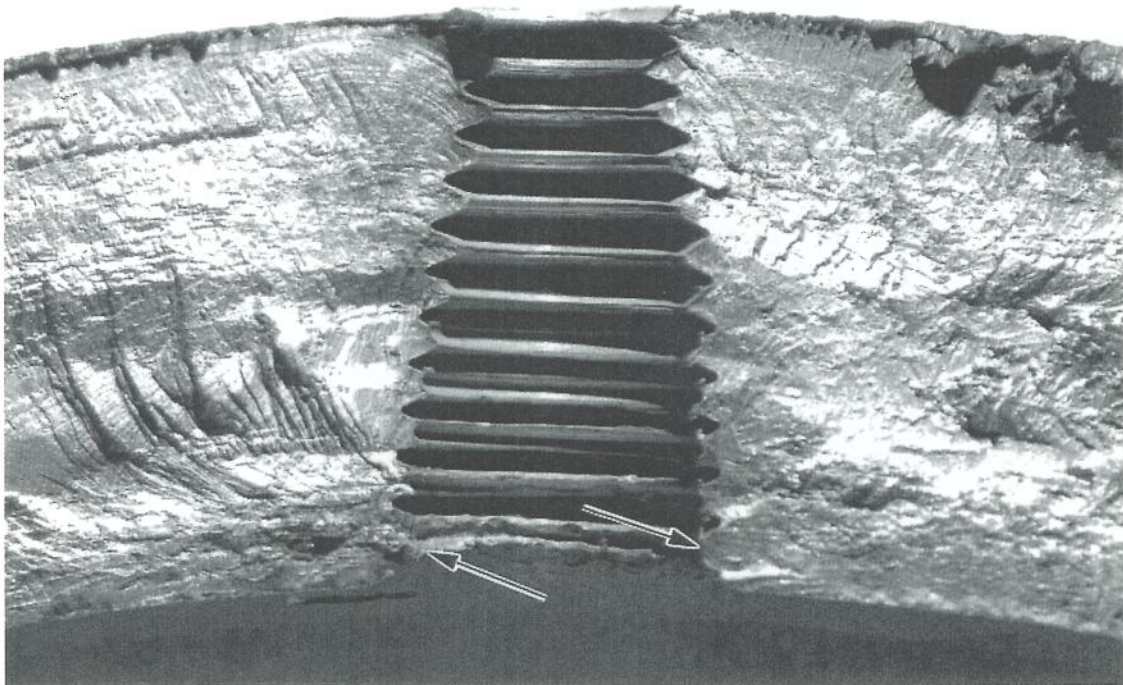
Figure 5 Detail showing the fatigue origins at the inner end of the damaged thread (outer half of the fracture) x6.5

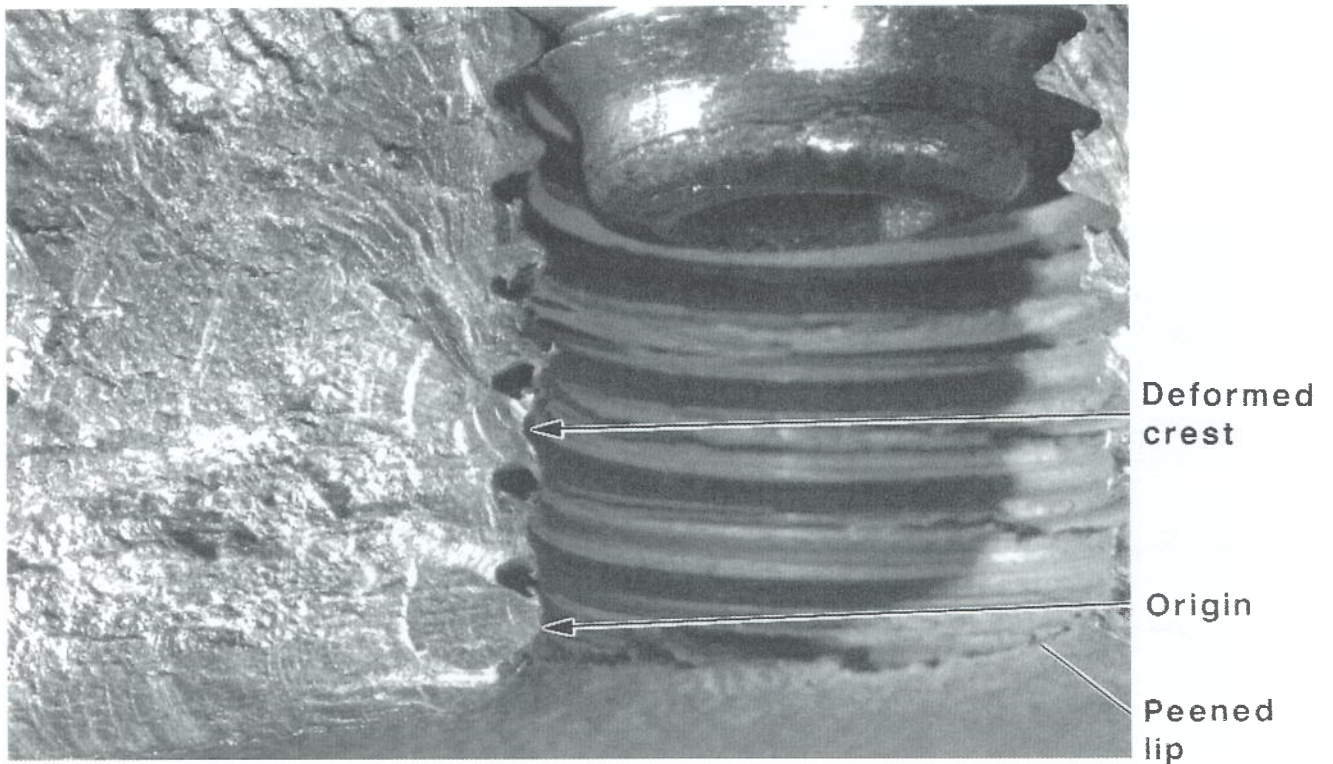
Figure 6 Detail of the features on one side of the hole (inner half)

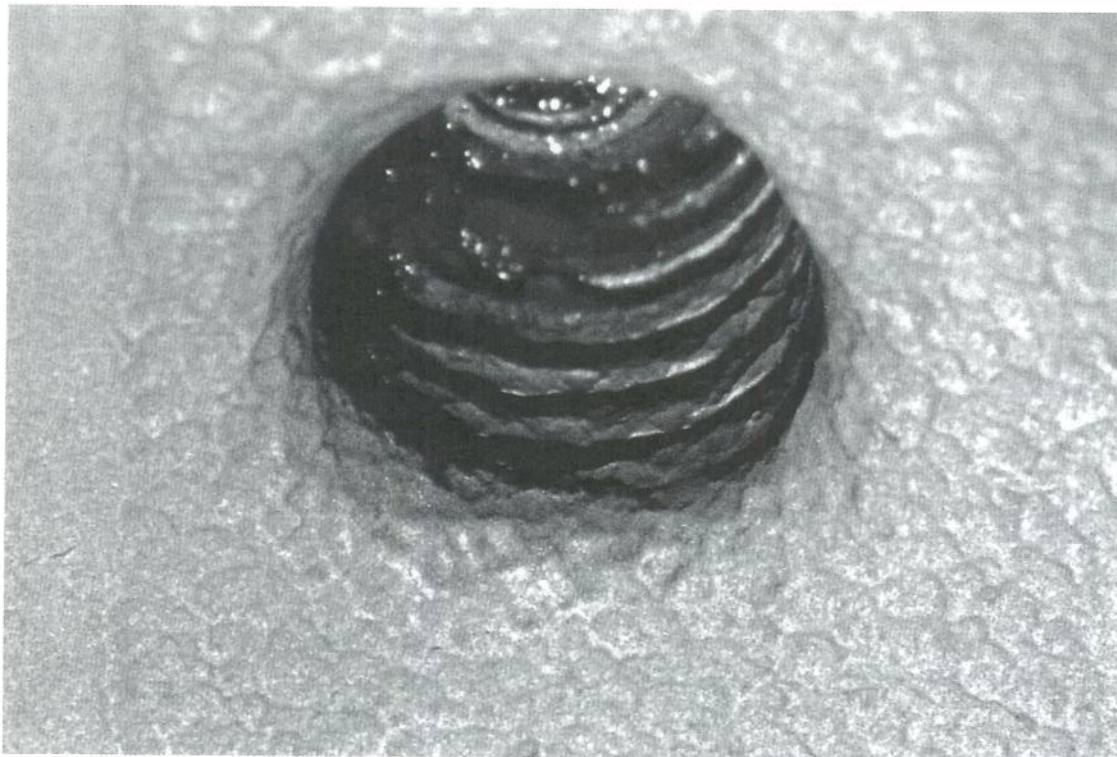
Figure 7 Showing the peening effect as exhibited by other grease nipple holes in the hub

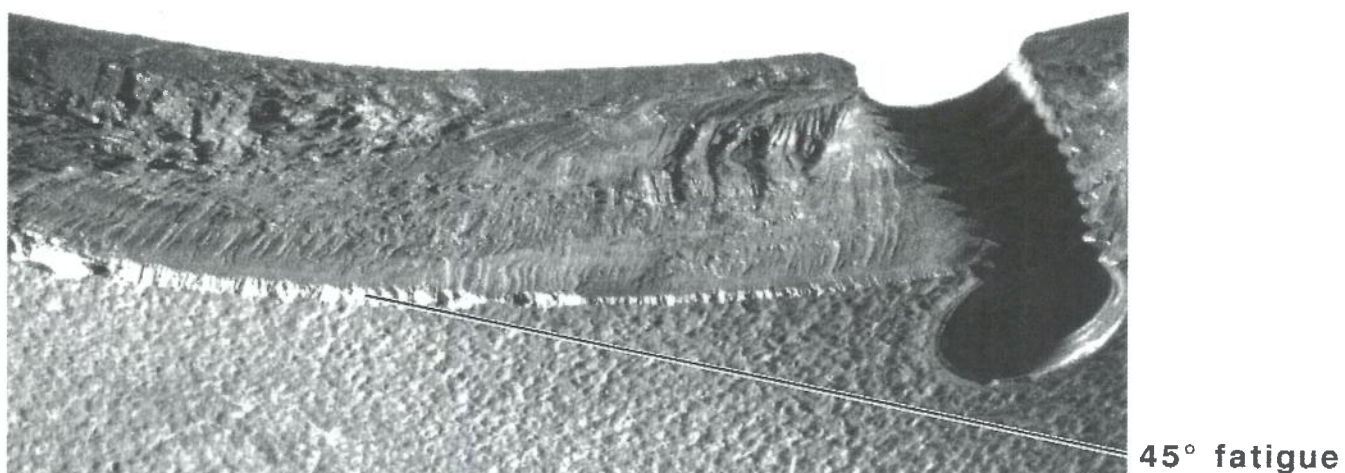
Figure 8 45° fatigue around the outer edge of the crack (inner half)

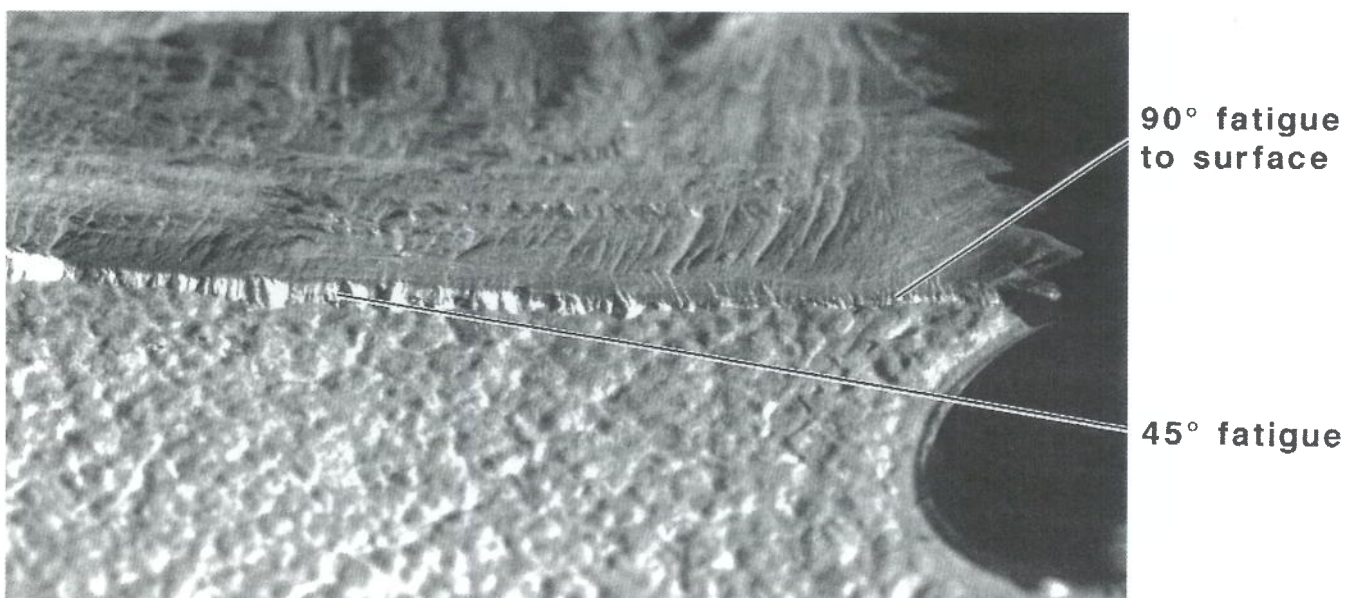
Figure 9 Detail showing the absence of the 45° fatigue close to the grease nipple hole

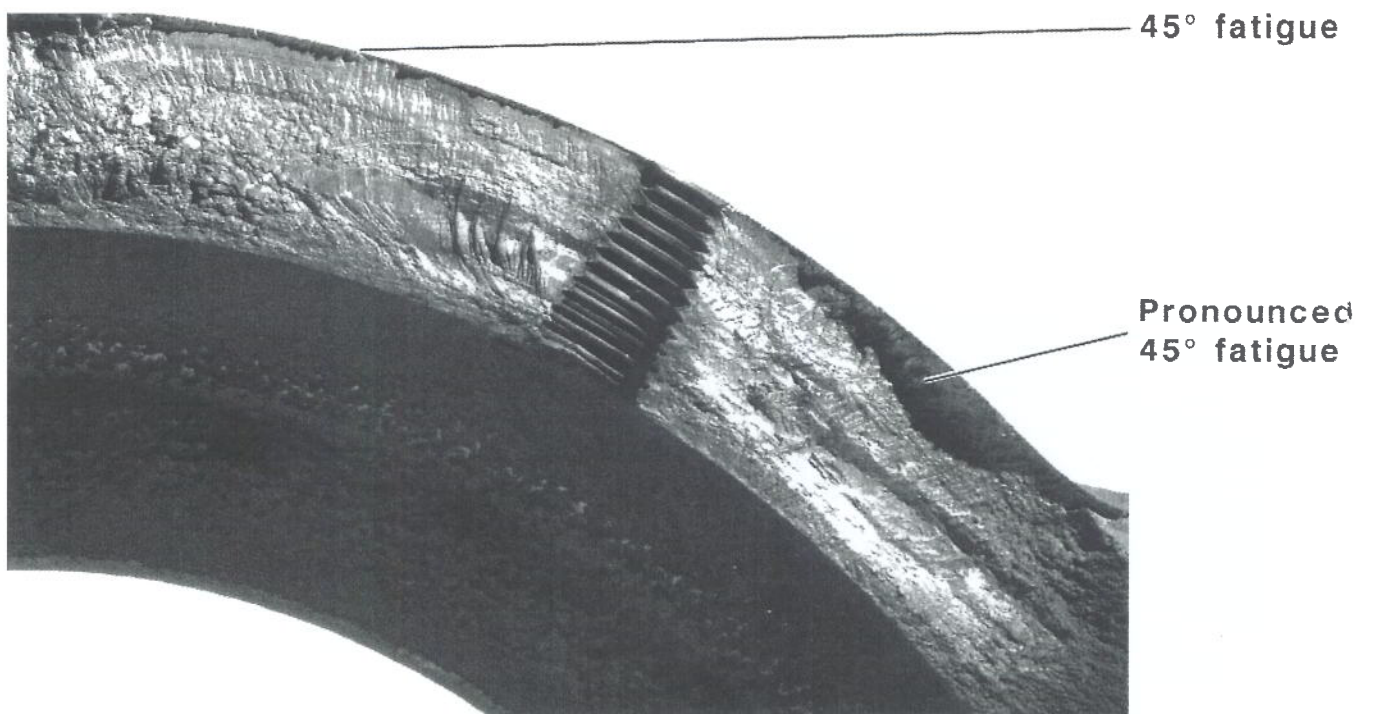
Figure 10 View showing the raised lip on the outer half of the fracture

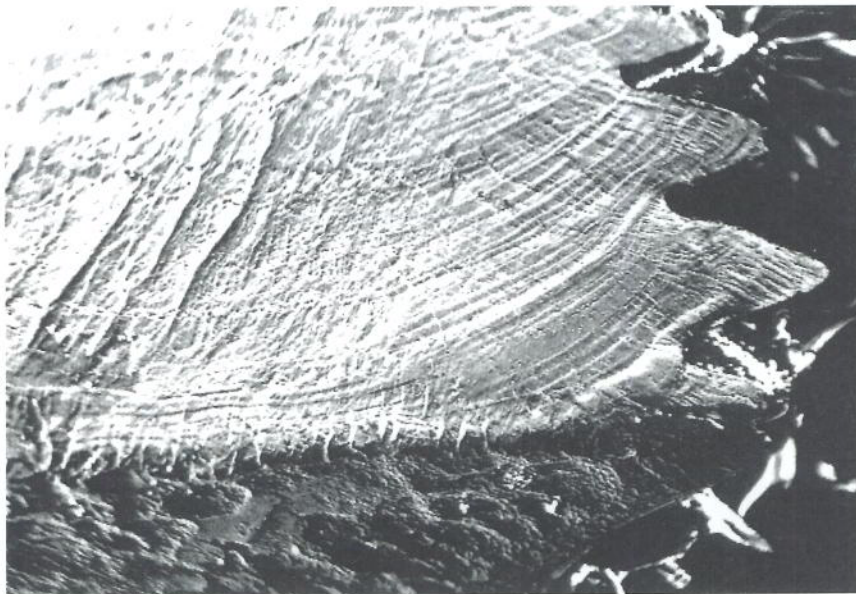
Figure 11 SEM view of the 90° fatigue close to the hole

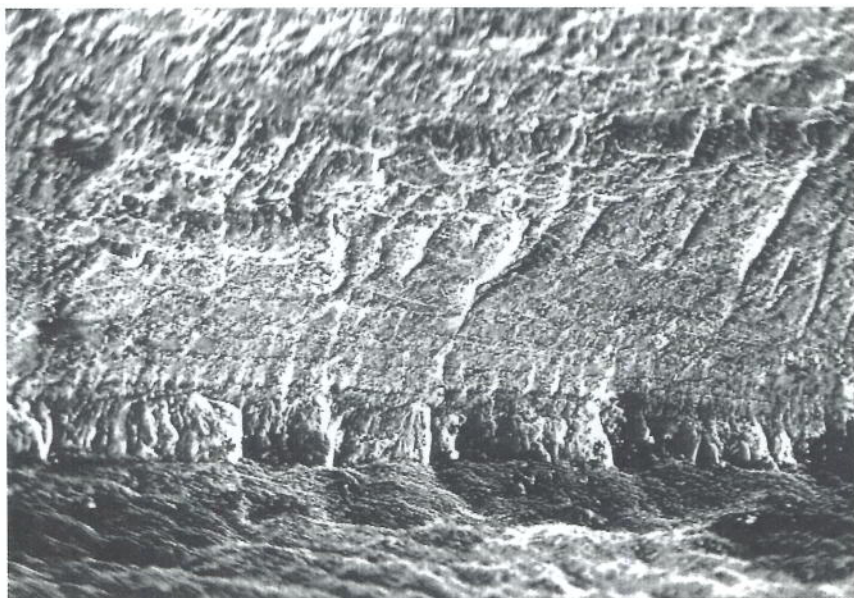
Figure 12 SEM view of the 45° fatigue

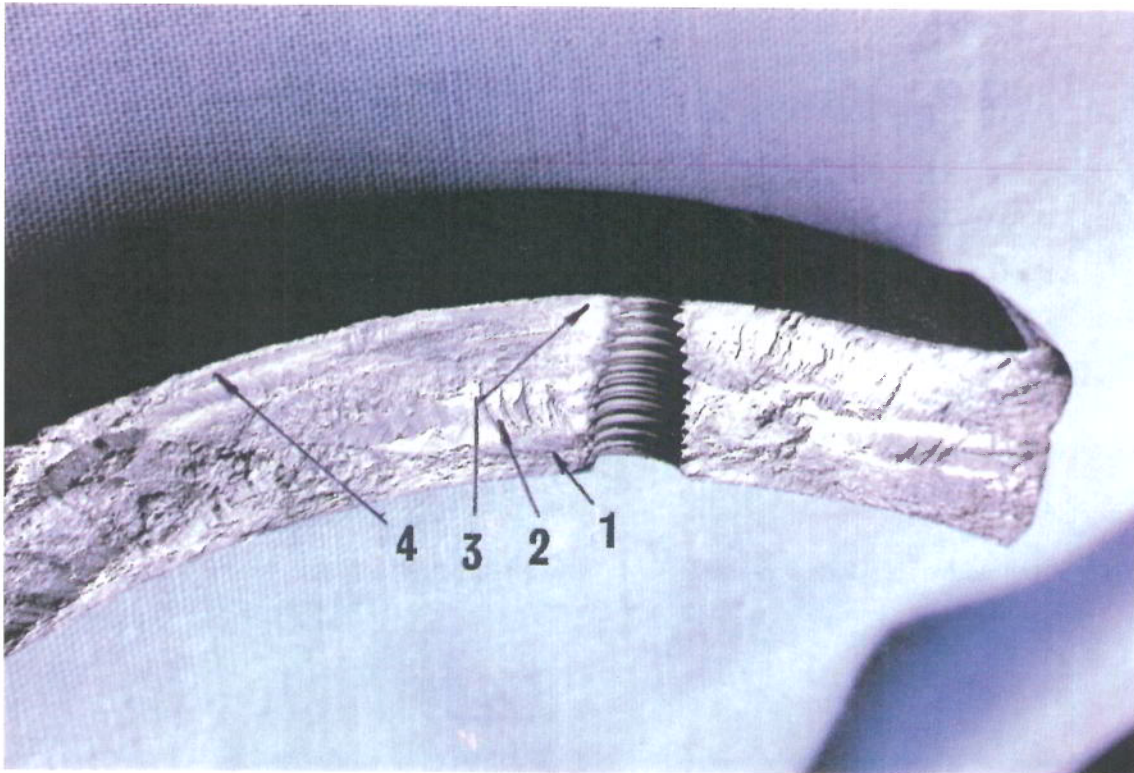
Figure 13 General view of the fracture face on which the progression count was carried out x2.06

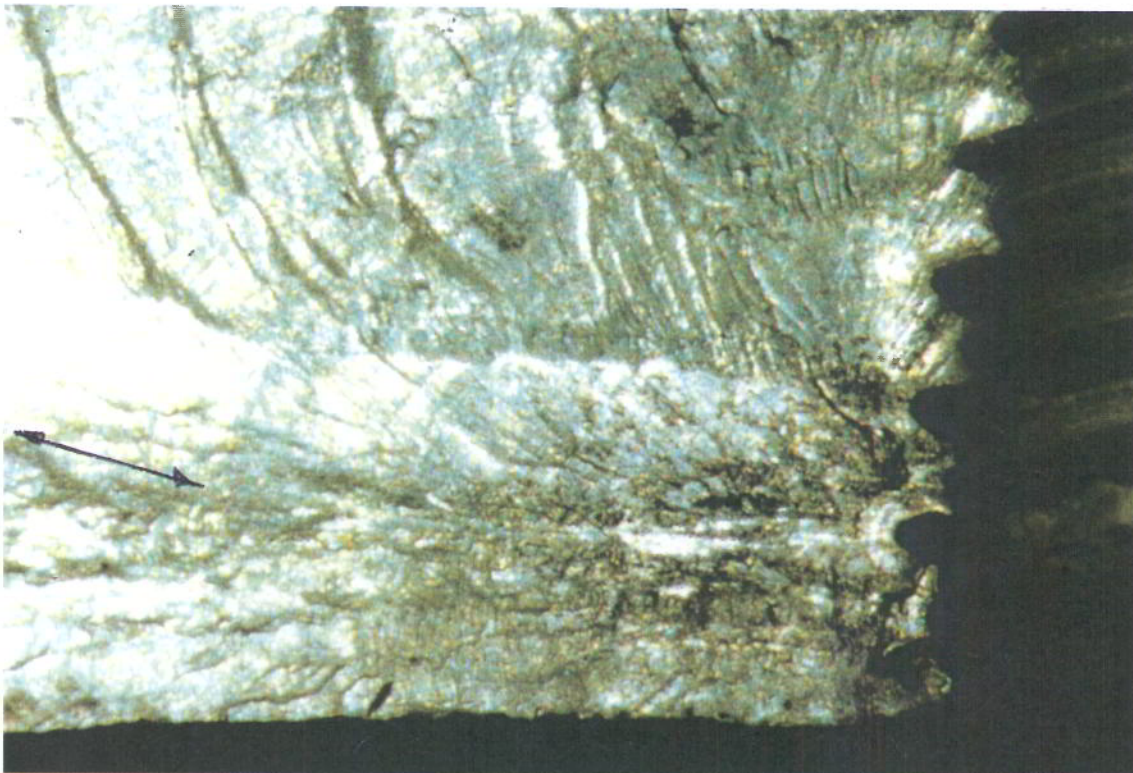
Figure 14 Position 1 on figure 13. First count adjacent to the initiation region
- 12.3 events in 0.1"

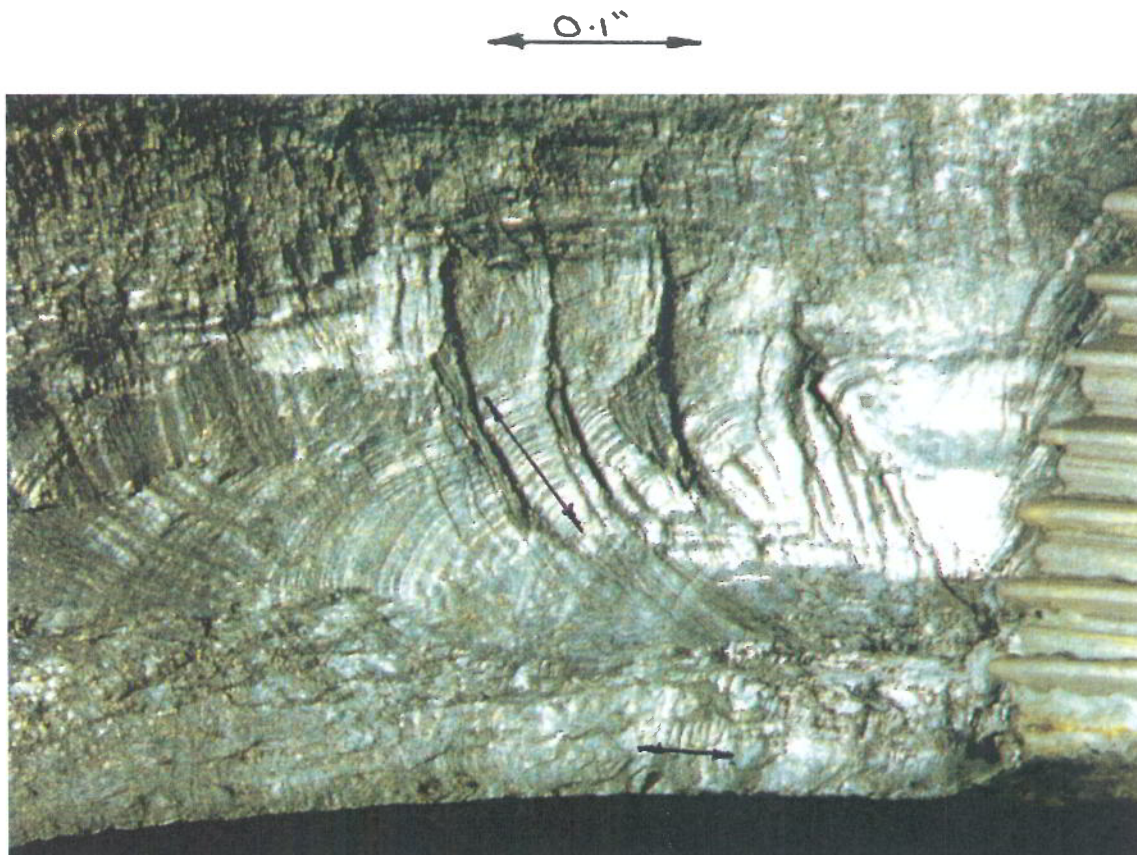
Figure 15 Position 1 on figure 13. Additional counts adjacent to the initiation region - 21 and 22.5 events in 0.1"

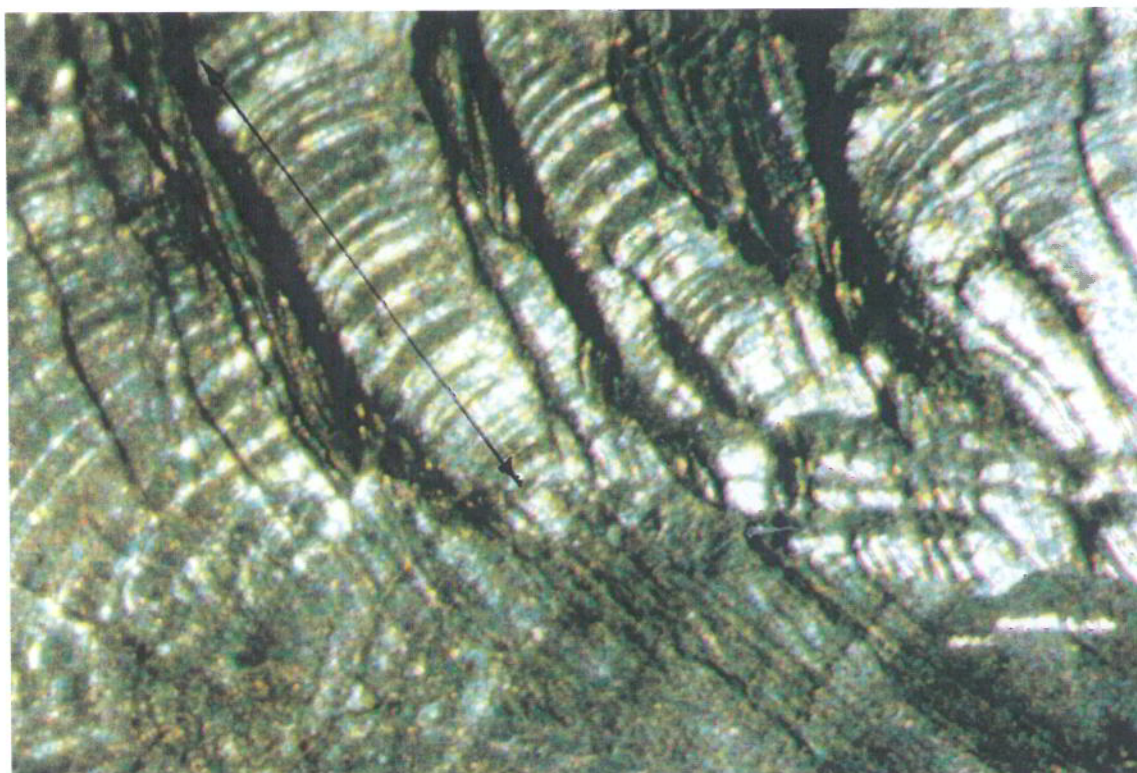
Figure 16 Count at position 2 on figure 13 - 18 events in 0.1"

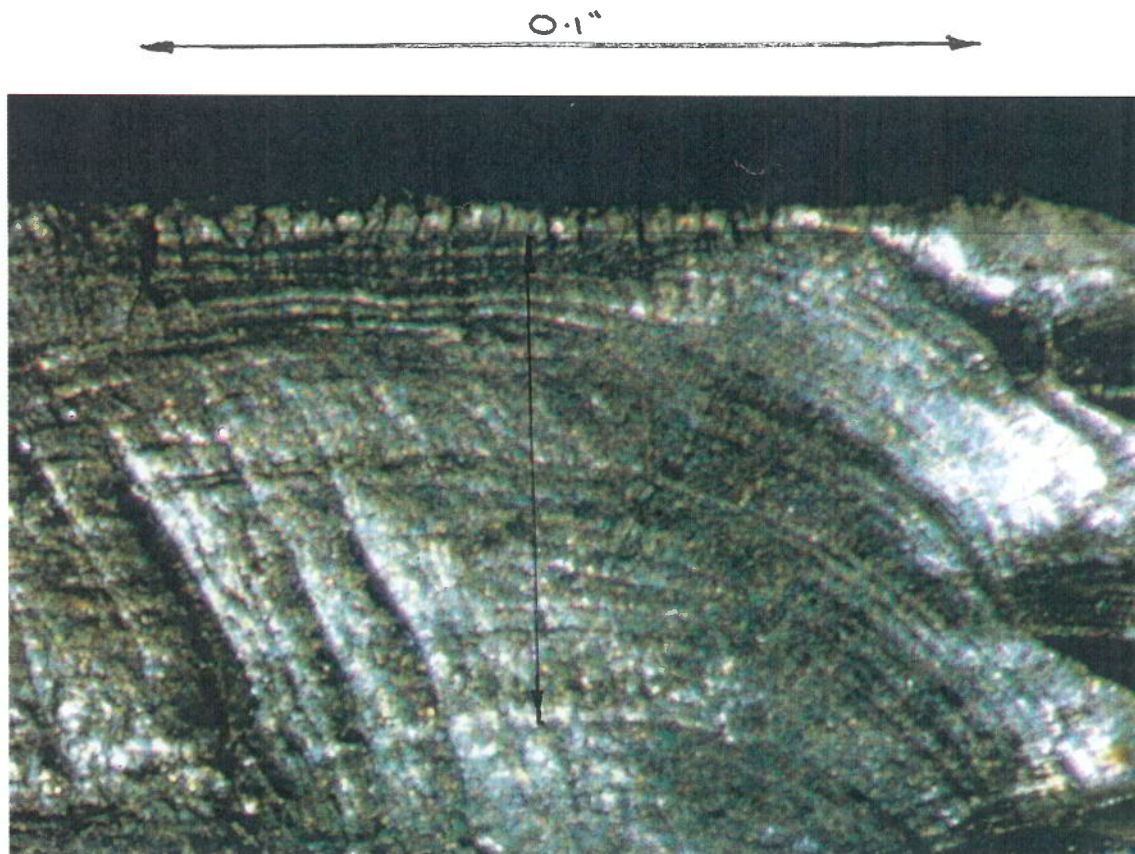
Figure 17 Count at position 3 on figure 13 - 33.8 events in 0.1"
