REPORT ON: Re-evaluation of hub failure - Reference: A-Lab report #93-090805.

SAMPLE IDENTIFICATION: Fracture surfaces of Aluminum Hub
from PA 31-325 G-BMGH.

STRESS ANALYSIS OF PROPELLER HUB FOR FAILED PIPER ENGINE

During a flight on 7th June 1993, a Piper Navajo G-BMGH plane suffered the loss of one of the three propeller blades from the starboard engine. The blade loss was caused by a fracture through the hub at the root of the blade. The crack emanated by fatigue from the inner end of a grease nipple hole. A stress analysis of the hub containing this hole has been made assuming the predominant loading to be the centrifugal loading of the propeller blade. A high stress concentration is seen to exist at the crack propagation site. Another analysis is made when the grease nipple hole lies in the thicker flange region of the hub. There, a reduction in the stress concentration is observed. The results are obtained by three dimensional finite element analysis, from which stresses may be obtained at all locations in the hub. Thus, stresses away from stress raisers like the hole may be compared.

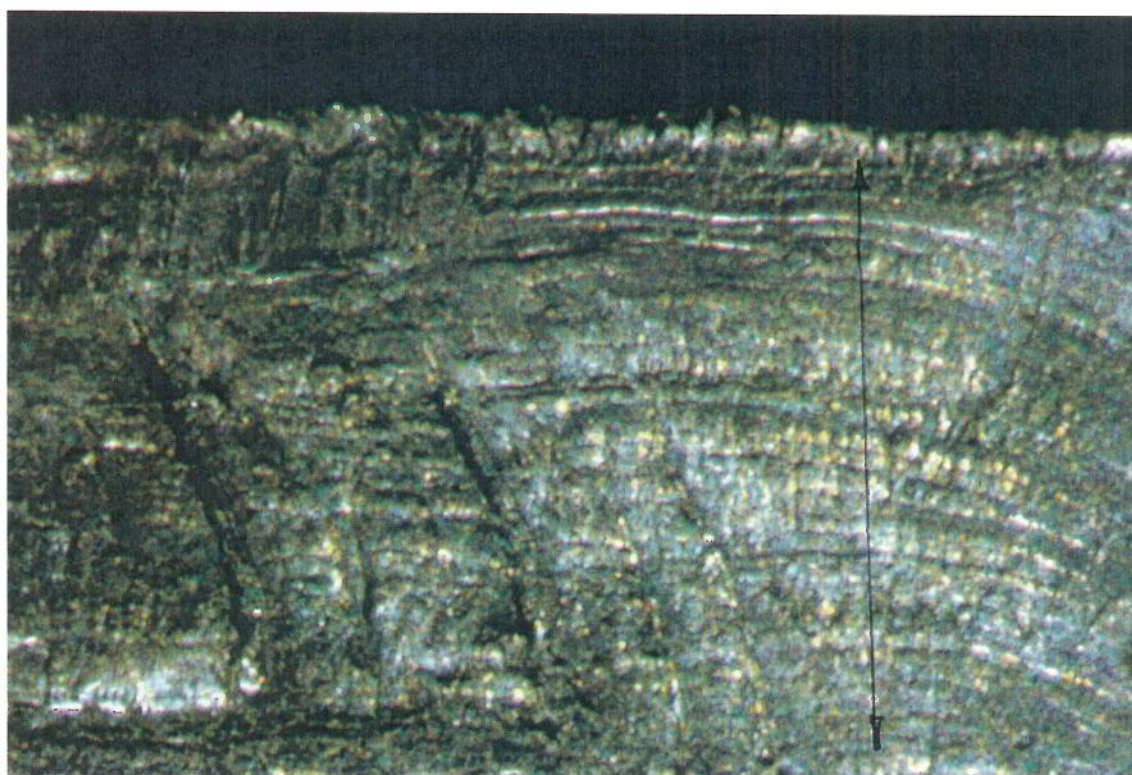
Figure 18 Additional counts at position 3 on figure 13 - 34.1 events in 0.1"

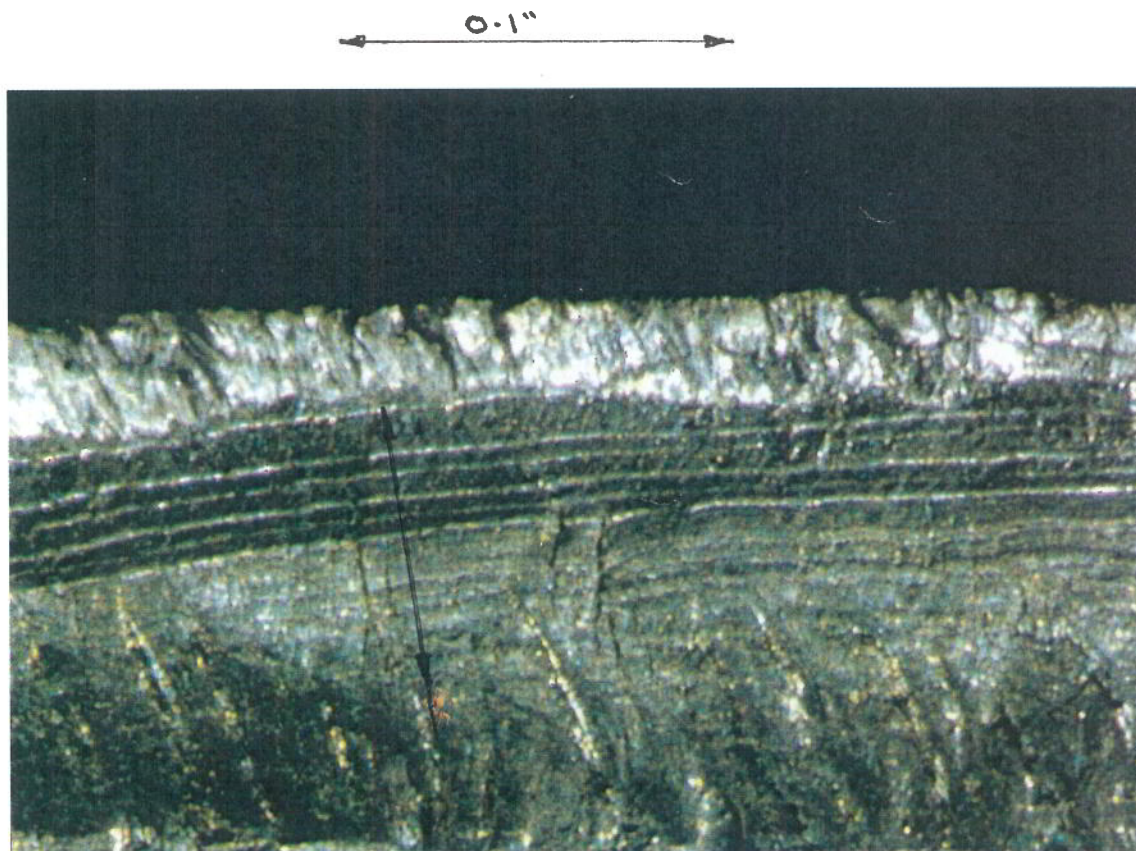
Figure 19 Count at position 4 on figure 13 - 18.6 events in 0.1"

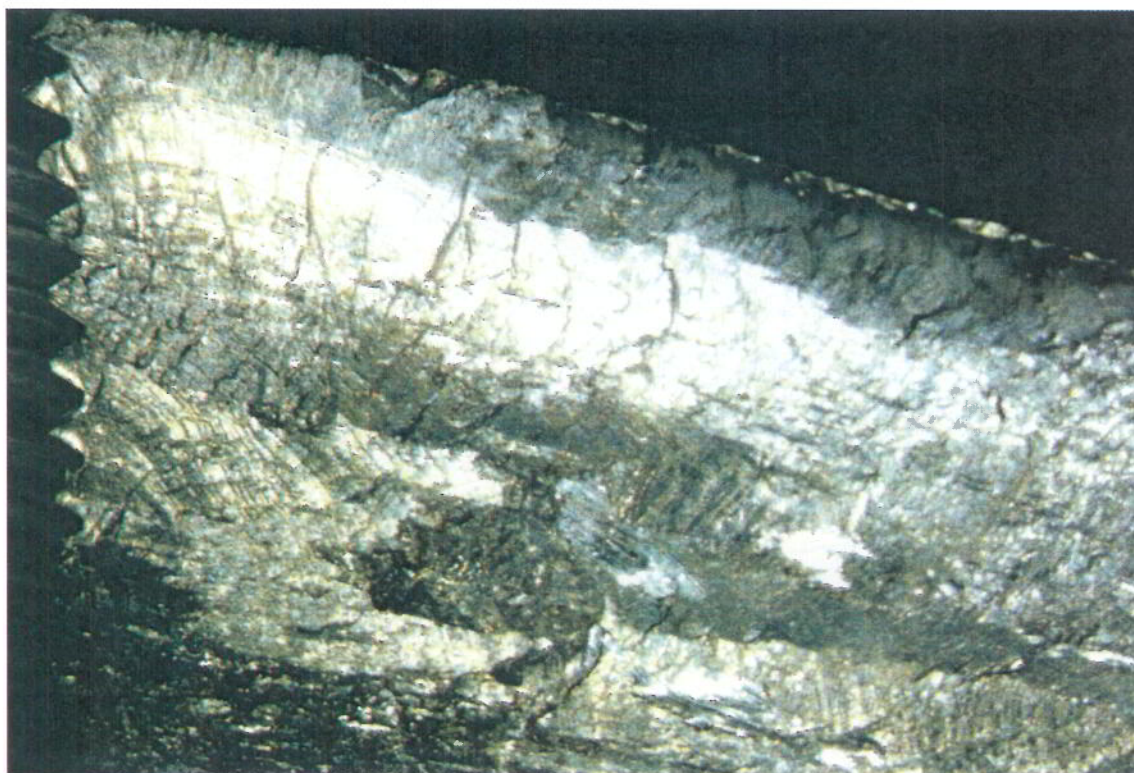
Figure 20 Typical view of the fatigue progression in the fracture face on the opposite side of the hole. The progression rates are very similar to those shown on figures 14 to 19

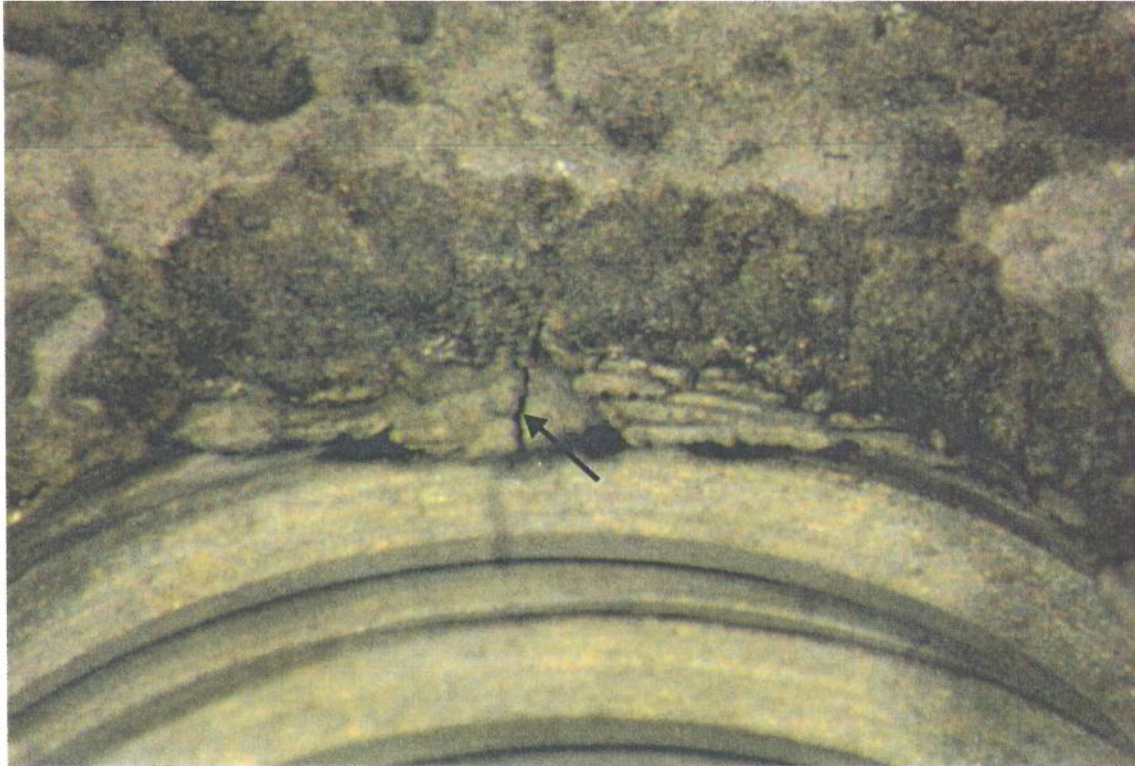
Figure 21 45° view on the inner end of the grease nipple hole showing a radial crack in the material grossly deformed by shot peening x36

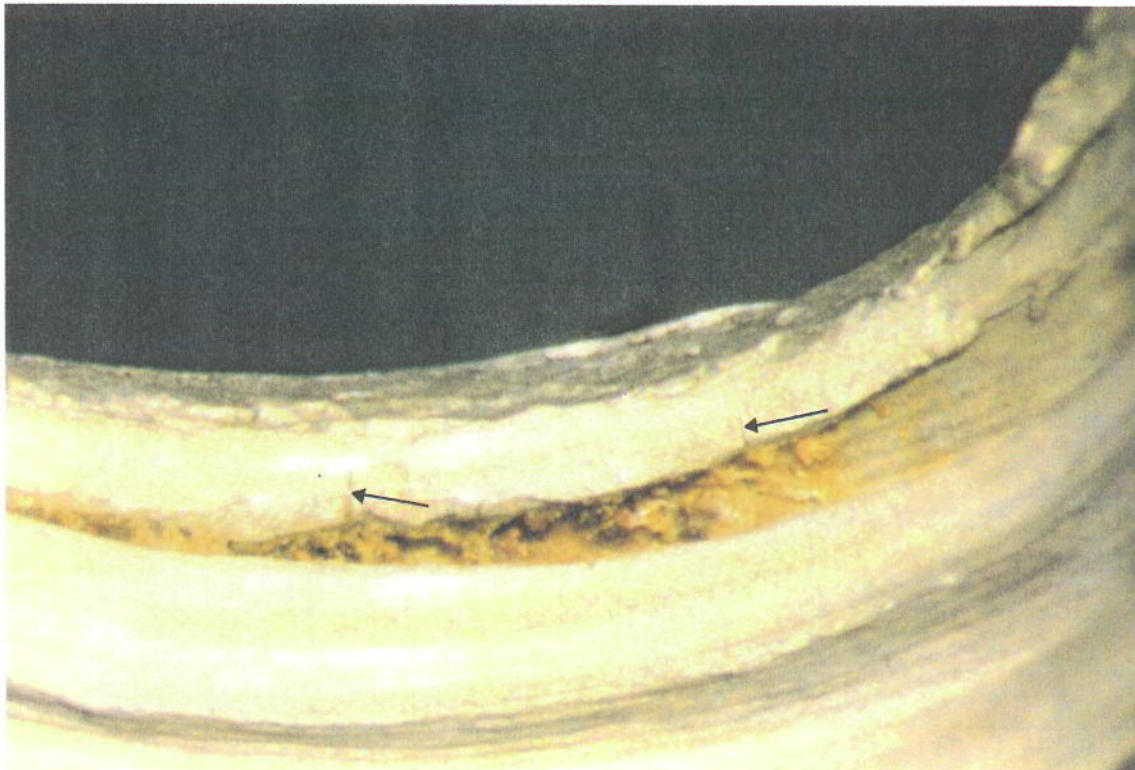
Figure 22 Two other radial cracks in the inner end of the same hole as that shown on figure 21 x36

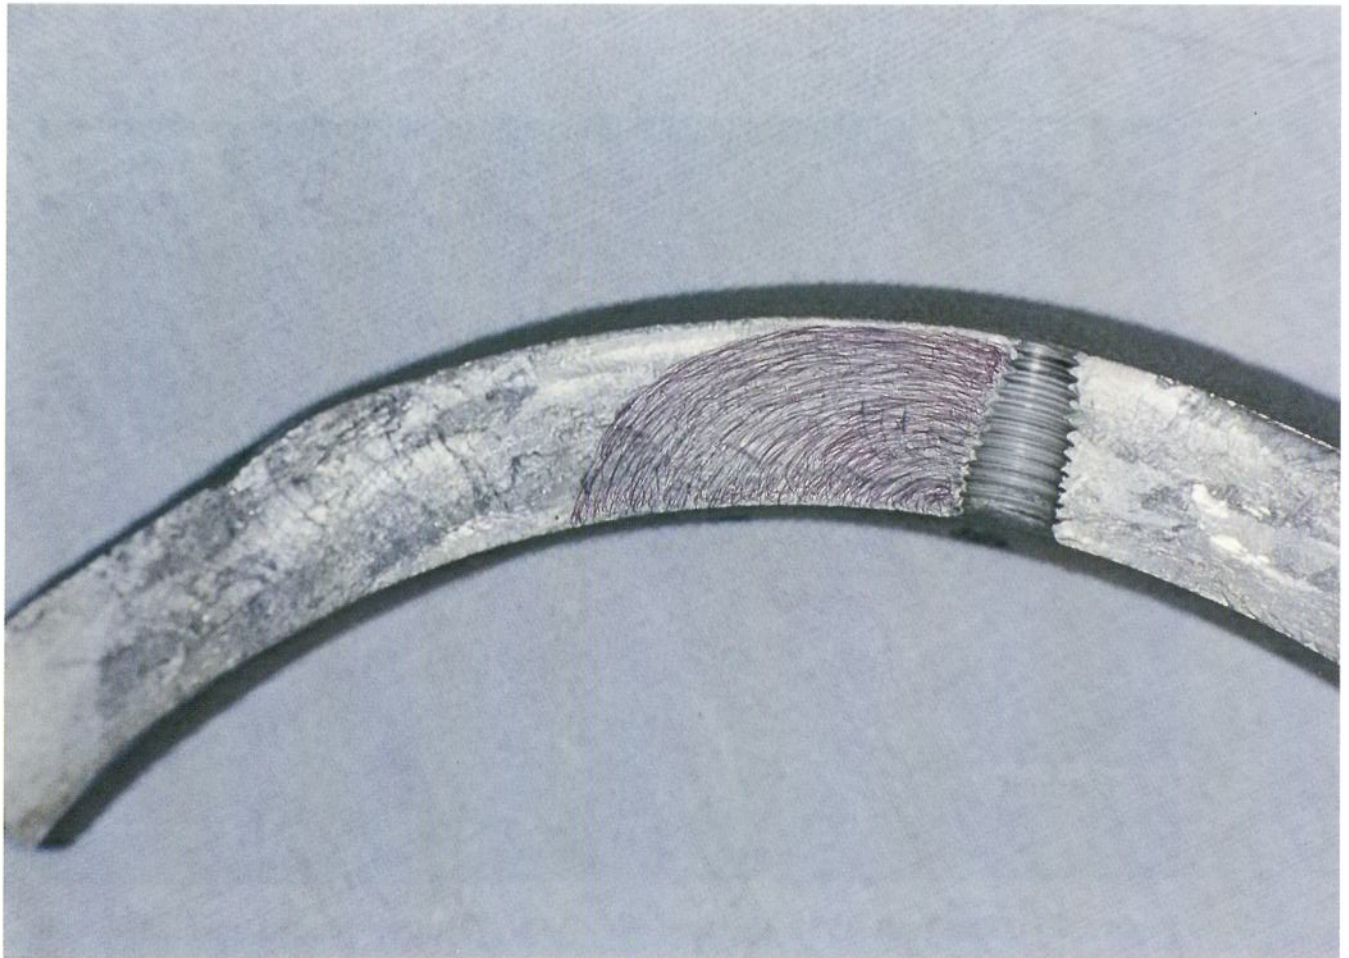
Figure 23 The fracture progression seen in the failure that is the subject of this report

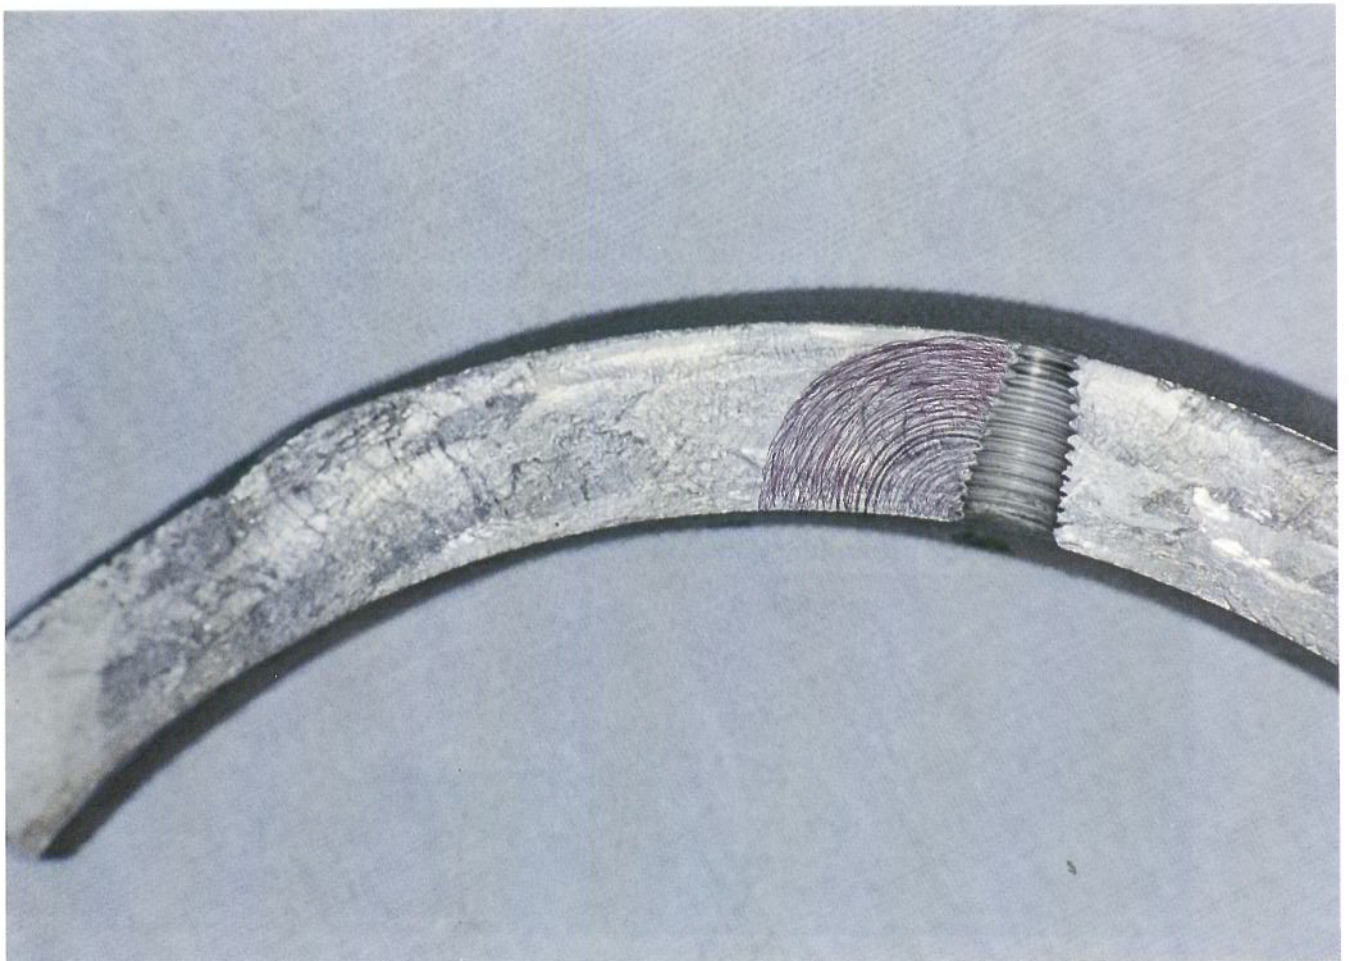
Figure 24 The fracture progression seen in photographs of previous hub failures
