ACCIDENT

Aircraft Type and Registration:	Mooney M20B, G-JDIX	
No & Type of Engines:	One Lycoming O-360-A1D piston engine	
Year of Manufacture:	1961	
Date & Time (UTC):	9 May 2010 at 1705 hrs	
Location:	Old Buckenham Airfield, Norfolk	
Type of Flight:	Private	
Persons on Board:	Crew - 1	Passengers - None
Injuries:	Crew - 1 (Fatal)	Passengers N/A
Nature of Damage:	Aircraft destroyed	
Commander's Licence:	Private Pilot's Licence	
Commander's Age:	66 years	
Commander's Flying Experience:	Not established	
Information Source:	AAIB Field Investigation

Synopsis

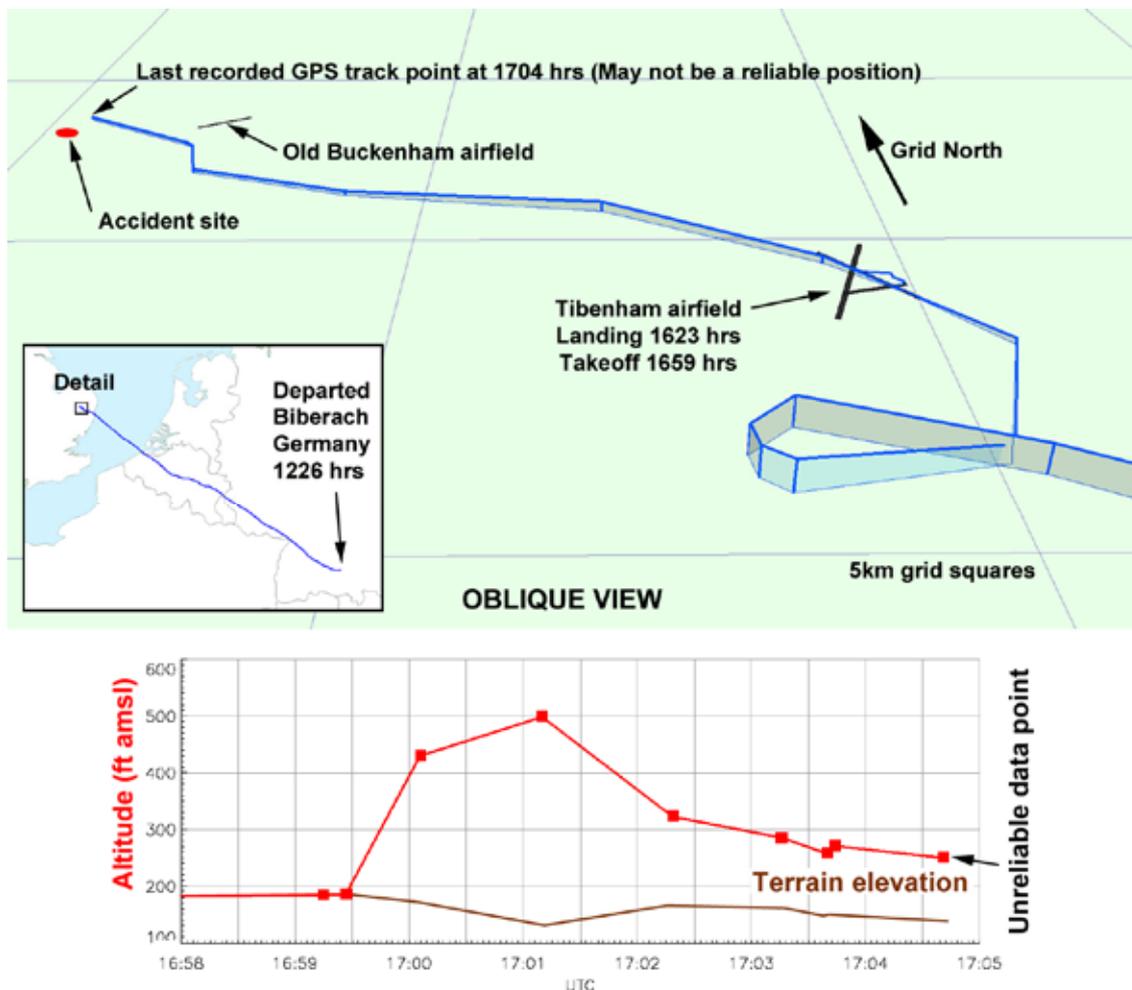
Figure 1

in contact with Old Buckenham, the aircraft was flying in the vicinity of Tibenham, and completed an orbit before making an approach to Runway 33 (Figure 1).

The aircraft took off again at 1659 hrs, after which a further seven GPS points were recorded. Whilst the GPS positions recorded during the take off at Tibenham correlate well with the runway, the final GPS position at 1704:41 hrs appears to be less accurate in its position, possibly due to satellite tracking issues at or near the accident site.

Overview of the last recorded GPS track and an oblique view showing the arrival at Tibenham, ground manoeuvring and onward flight. Graph depicts aircraft altitude for the accident flight

The maximum recorded altitude was 500 ft (370 ft agl) and the maximum groundspeed (averaged between points) was 82 kt. The light wind was generally from abeam, so average groundspeed values would approximate to those for airspeed. For about the last two minutes of flight, the data points show a relatively constant height of about 120 ft agl, with the groundspeed falling to about 60 kt over the final 80 seconds.
