FIG 1 VIEW OF RIGHT INBOARD TRAILING EDGE FLAPS AFTER THE ACCIDENT

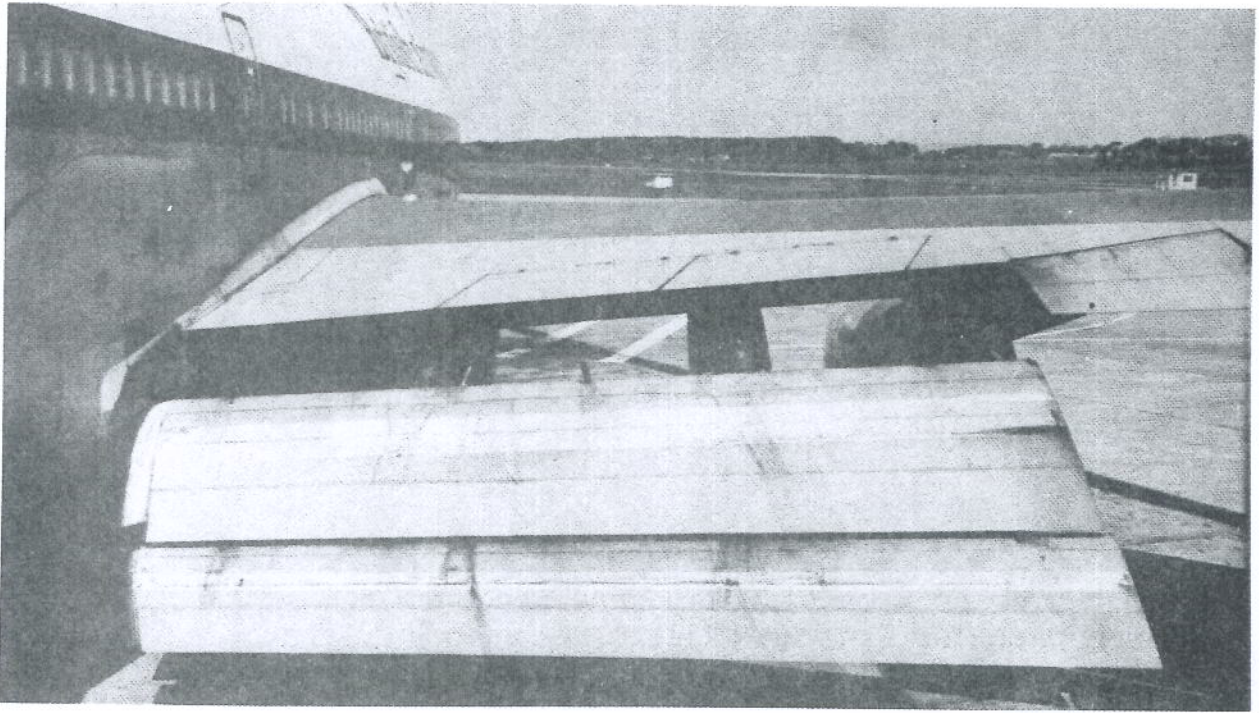
Note: Gap between mid flap and wing trailing edge caused by detachment of foreflap.

Mid and aft flaps are in the fully extended position.

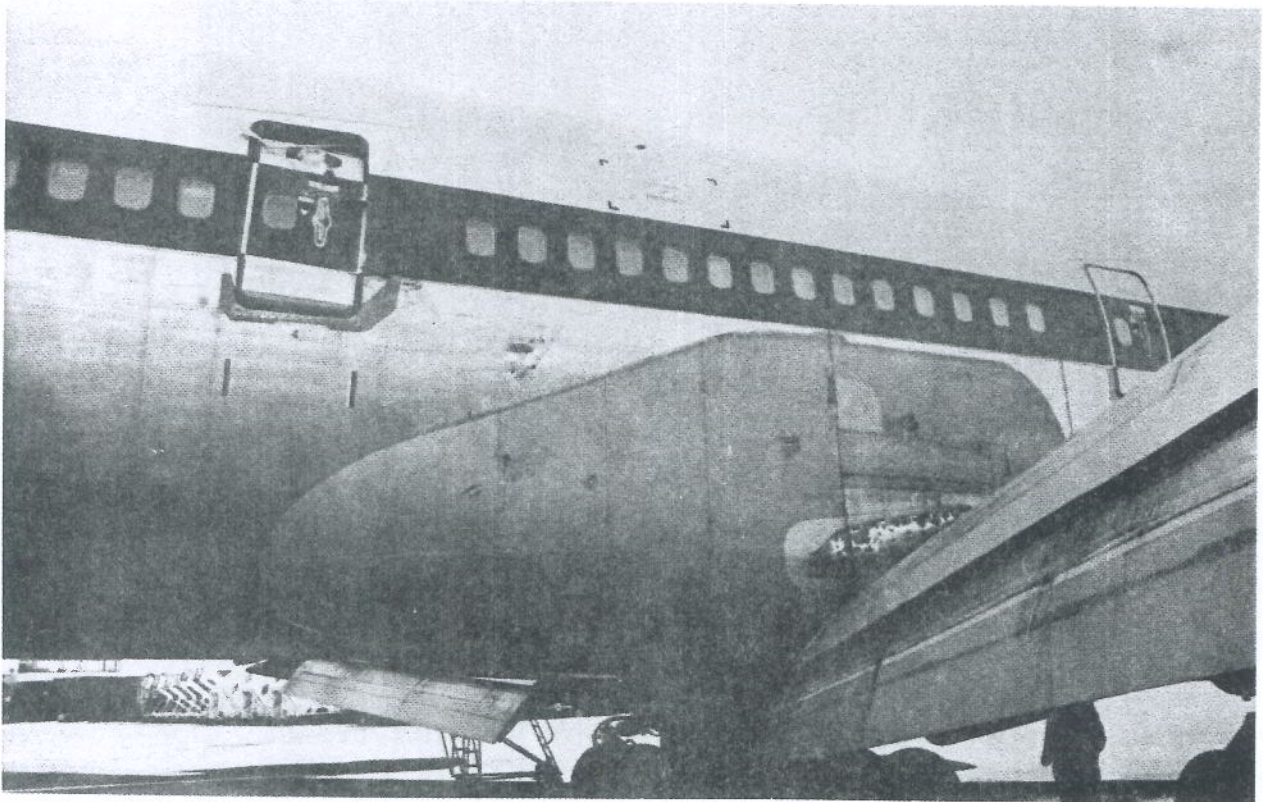
FIG 2 VIEW OF DAMAGE TO FUSELAGE SIDE AND NO 4 DOOR RIGHT

Note displacement of door into cabin and evidence of parts of foreflap striking fuselage side and fairing forward of door.

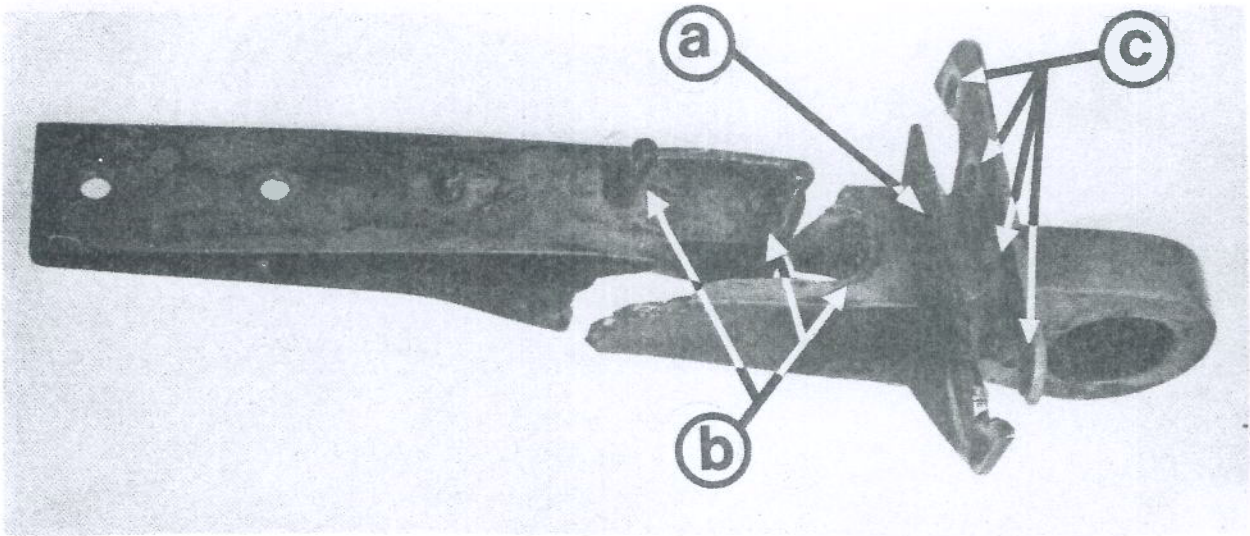
FIG 3 VIEW OF RIGHT INBOARD FOREFLAP OUTBOARD SEQUENCE
CARRIAGE ATTACHMENT FITTING

- a) Primary fatigue area in horizontal flange at base of lug.
- b) Secondary fatigue areas in channel portion.
- c) Areas of fretting around horizontal flange bolt holes.

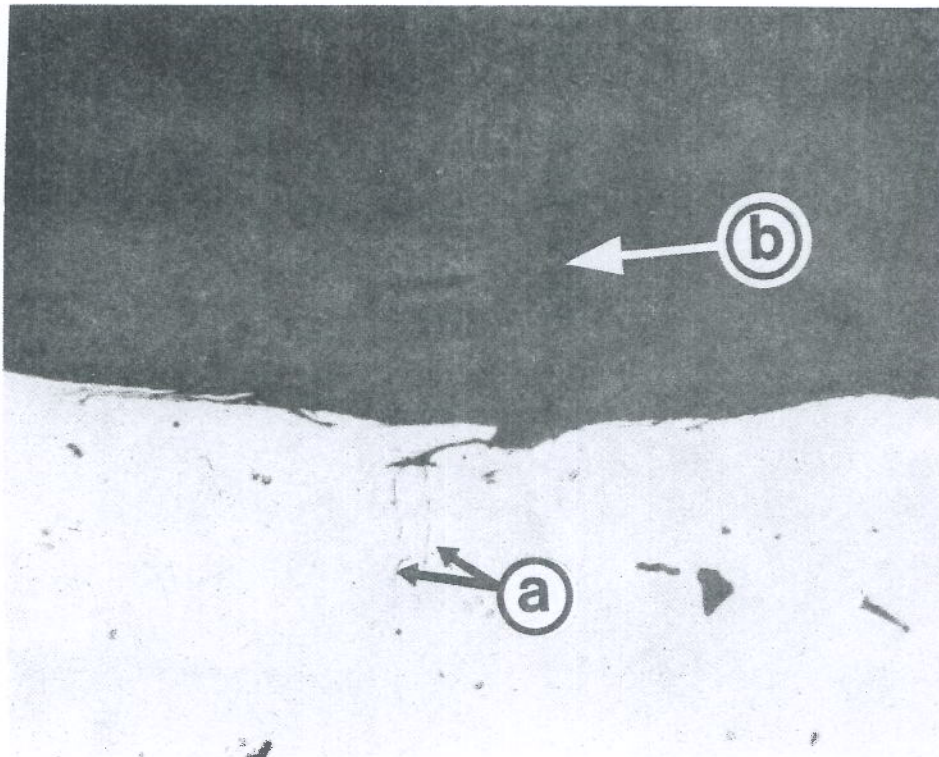
FIG 4 VIEW OF MICROSECTION (x500) SHOWING TYPICAL LAP
DEFECT ATTRIBUTED TO OVERPEENING

- a) Subsurface cracks in metal below lap defect.
- b) Crack in surface finish.
