Status of the investigation

History of the flight

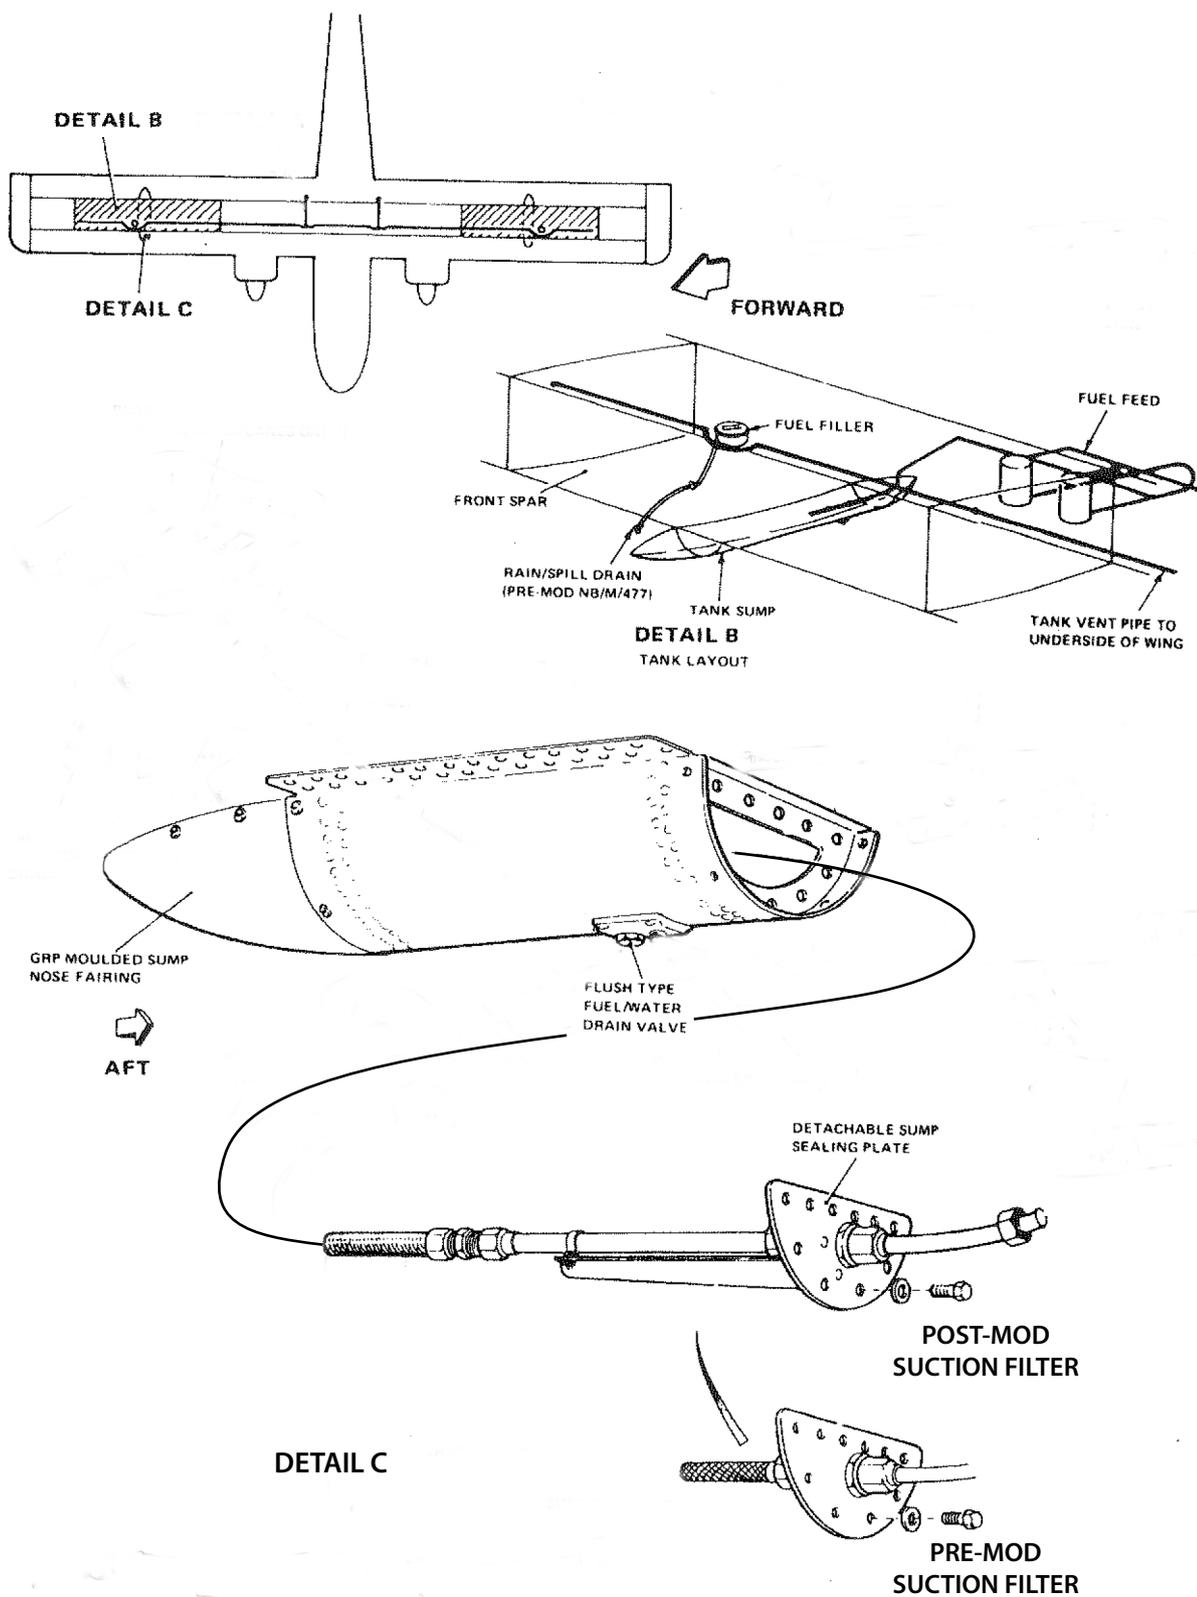
Figure 1 shows the aircraft fuel tank installation and the detail of a modification to the fuel suction filter assembly.

This modification, Mod NB/M/350, mounted the suction filter 8.5 in forward of the sealing plate, on the end of a tube, and raised the filter from 1.05 in to 2.25 in above the bottom of the sump. The modification, issued in 1968, was intended to provide increased protection from water contamination of the fuel. Water, if present, collects at the bottom of the sump and tends to move aft during takeoff and climb. The modified filter is more likely to remain above the water level, as represented in Figure 2.

The modification was not routinely installed on new build aircraft until aircraft Construction Number 091. The investigation has not established how many of the earlier aircraft had been modified. The fuel tank sumps of VP-MON (Construction Number was 082) had not been modified.

It is recommended that the European Aviation Safety Agency takes action to require that Britten-Norman Islander aircraft are equipped with fuel suction filter assemblies which minimise the likelihood of any water present in the fuel tank sumps being fed to the engines.

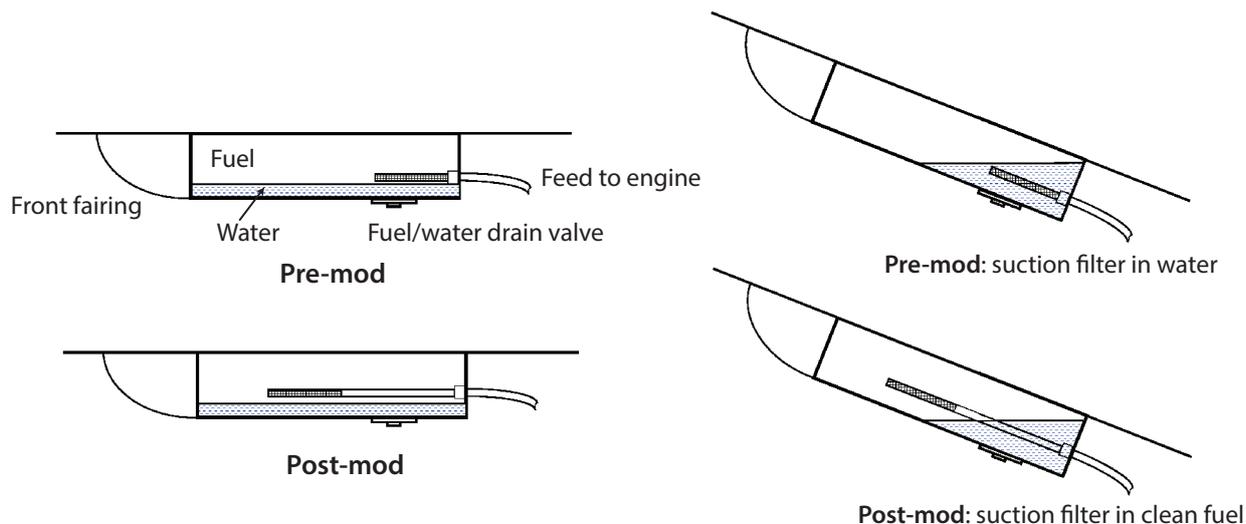
Figure 2

Both N589SA and VP-MON had the same pre-modification fuel suction filters, which drew fuel from the rear of the fuel sump. The modified design appears to offer improved tolerance to water in the fuel tank sump.
